Asbestos Survey Report

Management Survey (With Priority Assessments)

1 SINCLAIR CLOSE
EDINBURGH
EH11 1AN

Project Number: S-61321
Issue Date: 16th January 2017
Issue No: 1

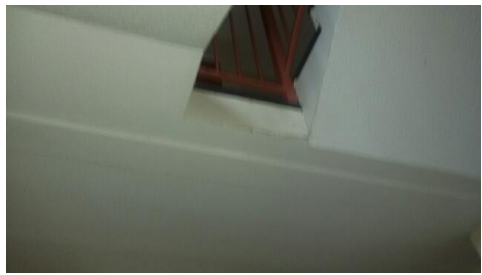
Surveyor		Steven Walker		Room/Area		001 - Ground Floor & Stairs

Survey Date		20 December 2016		Level of Identification		Sampled			
				Sample No		0001			
Building		1 SINCLAIR CLOSE		Item		Textured Coating To Concrete Ceiling			
Floor		0		Amount					
A - Product Type:		B - Extent of Damage:		C - Surface Treatment		D - Asbestos Type		Material Ass (M.A) (A+B+C+D):	
Textured Coating						No Asbestos Detected		0	
1 = Normal Occupant Activity = (E)		E - Main type of activity		Total Priority Score (P.A.) = (1+2+3+4):		Total Risk Ass' Score (P.A. + M.A)		0	
2 = Disturbance = (F+G+H)/3		F - Location		G - Accessibility		H - Extent		Risk Coding	
3 = Exposure potential = (I+J+K)/3		I - Number of occupants		J - Frequency of use		K - Average time in use			
4 = Maintenance activity = (L+M)/2		L - Type of maintenance		M - Frequency of maintenance		Recommendation:		No recommendation required	
Further Information:

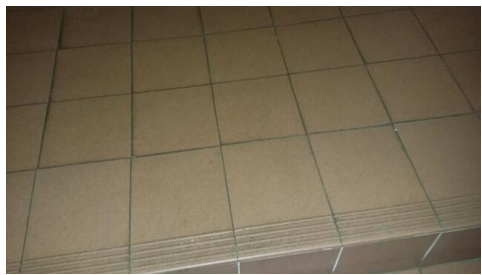
Surveyor		Steven Walker		Room/Area		001 - Ground Floor & Stairs

Survey Date		20 December 2016		Level of Identification		Sampled			
				Sample No		0002			
Building		1 SINCLAIR CLOSE		Item		Ceramic Tile Adhesive To Concrete Floor			
Floor		0		Amount					
A - Product Type:		B - Extent of Damage:		C - Surface Treatment		D - Asbestos Type		Material Ass (M.A) (A+B+C+D):	
Reinforced Composites						No Asbestos Detected		0	
1 = Normal Occupant Activity = (E)		E - Main type of activity		Total Priority Score (P.A.) = (1+2+3+4):		Total Risk Ass' Score (P.A. + M.A)		0	
2 = Disturbance = (F+G+H)/3		F - Location		G - Accessibility		H - Extent		Risk Coding	
3 = Exposure potential = (I+J+K)/3		I - Number of occupants		J - Frequency of use		K - Average time in use			
4 = Maintenance activity = (L+M)/2		L - Type of maintenance		M - Frequency of maintenance		Recommendation:		No recommendation required	
Further Information:

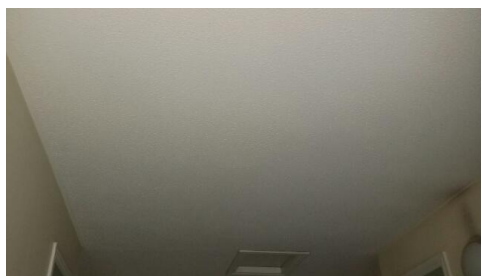
Surveyor		Steven Walker		Room/Area		011 - Landing

Survey Date		20 December 2016		Level of Identification		Sampled			
				Sample No		0005			
Building		1 SINCLAIR CLOSE		Item		Textured Coating To Plasterboard Ceiling			
Floor		2		Amount					
A - Product Type:		B - Extent of Damage:		C - Surface Treatment		D - Asbestos Type		Material Ass (M.A) (A+B+C+D):	
Textured Coating						No Asbestos Detected		0	
1 = Normal Occupant Activity = (E)		E - Main type of activity		Total Priority Score (P.A.) = (1+2+3+4):		Total Risk Ass' Score (P.A. + M.A)		0	
2 = Disturbance = (F+G+H)/3		F - Location		G - Accessibility		H - Extent		Risk Coding	
3 = Exposure potential = (I+J+K)/3		I - Number of occupants		J - Frequency of use		K - Average time in use			
4 = Maintenance activity = (L+M)/2		L - Type of maintenance		M - Frequency of maintenance		Recommendation:		No recommendation required	
Further Information:

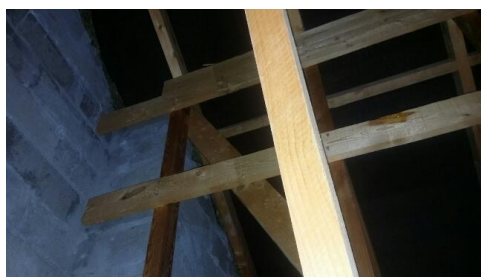
Surveyor		Steven Walker		Room/Area		014 - Loft Above Landing

Survey Date		20 December 2016		Level of Identification		Sampled			
				Sample No		0006			
Building		1 SINCLAIR CLOSE		Item		Roof Felt			
Floor		4		Amount					
A - Product Type:		B - Extent of Damage:		C - Surface Treatment		D - Asbestos Type		Material Ass (M.A) (A+B+C+D):	
Bitumen Products						No Asbestos Detected		0	
1 = Normal Occupant Activity = (E)		E - Main type of activity		Total Priority Score (P.A.) = (1+2+3+4):		Total Risk Ass' Score (P.A. + M.A)		0	
2 = Disturbance = (F+G+H)/3		F - Location		G - Accessibility		H - Extent		Risk Coding	
3 = Exposure potential = (I+J+K)/3		I - Number of occupants		J - Frequency of use		K - Average time in use			
4 = Maintenance activity = (L+M)/2		L - Type of maintenance		M - Frequency of maintenance		Recommendation:		No recommendation required	
Further Information:
