Asbestos Survey Report

Management Survey (With Priority Assessments)

1 SINCLAIR GARDENS
EDINBURGH
EH11 1AN

Project Number: S-61216
Issue Date: 9th January 2017
Issue No: 1

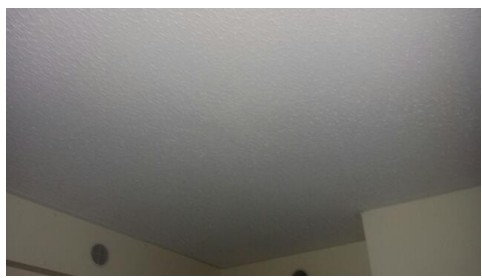
Surveyor		Steven Walker		Room/Area		001 - Ground Floor & Stairs

Survey Date		19 December 2016		Level of Identification		Sampled											
				Sample No		0001											
Building		1 SINCLAIR GARDENS		Item		Textured Coating To Concrete Ceiling											
Floor		0		Amount													
A - Product Type:		B - Extent of Damage:		C - Surface Treatment		D - Asbestos Type		Material Ass (M.A) (A+B+C+D):									
Textured Coating						No Asbestos Detected		0									
1 = Normal Occupant Activity = (E)		1		E - Main type of activity		1		Total Priority Score (P.A.) = (1+2+3+4):		1		Total Risk Ass' Score (P.A. + M.A)		1		Risk Coding	
2 = Disturbance = (F+G+H)/3		0		F - Location				G - Accessibility				H - Extent					
3 = Exposure potential = (I+J+K)/3		0		I - Number of occupants				J - Frequency of use				K - Average time in use					
4 = Maintenance activity = (L+M)/2		0		L - Type of maintenance				M - Frequency of maintenance				Recommendation: No recommendation required

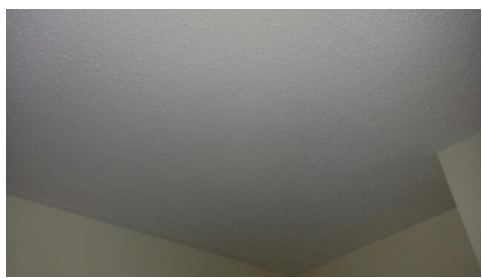
Surveyor		Steven Walker		Room/Area		005 - Landing & Stairs

Survey Date		19 December 2016		Level of Identification		Sampled											
				Sample No		0002											
Building		1 SINCLAIR GARDENS		Item		Textured Coating To Concrete Ceiling											
Floor		1		Amount													
A - Product Type:		B - Extent of Damage:		C - Surface Treatment		D - Asbestos Type		Material Ass (M.A) (A+B+C+D):									
Textured Coating						No Asbestos Detected		0									
1 = Normal Occupant Activity = (E)		1		E - Main type of activity		1		Total Priority Score (P.A.) = (1+2+3+4):		1		Total Risk Ass' Score (P.A. + M.A)		1		Risk Coding	
2 = Disturbance = (F+G+H)/3		0		F - Location				G - Accessibility				H - Extent					
3 = Exposure potential = (I+J+K)/3		0		I - Number of occupants				J - Frequency of use				K - Average time in use					
4 = Maintenance activity = (L+M)/2		0		L - Type of maintenance				M - Frequency of maintenance				Recommendation: No recommendation required

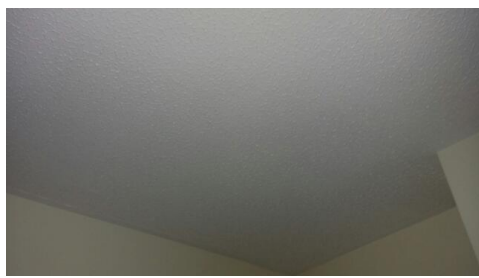
Surveyor		Steven Walker		Room/Area		008 - Landing & Stairs

Survey Date		19 December 2016		Level of Identification		Sampled											
				Sample No		0003											
Building		1 SINCLAIR GARDENS		Item		Textured Coating To Concrete Ceiling											
Floor		2		Amount													
A - Product Type:		B - Extent of Damage:		C - Surface Treatment		D - Asbestos Type		Material Ass (M.A) (A+B+C+D):									
Textured Coating						No Asbestos Detected		0									
1 = Normal Occupant Activity = (E)		1		E - Main type of activity		1		Total Priority Score (P.A.) = (1+2+3+4):		1		Total Risk Ass' Score (P.A. + M.A)		1		Risk Coding	
2 = Disturbance = (F+G+H)/3		0		F - Location				G - Accessibility				H - Extent					
3 = Exposure potential = (I+J+K)/3		0		I - Number of occupants				J - Frequency of use				K - Average time in use					
4 = Maintenance activity = (L+M)/2		0		L - Type of maintenance				M - Frequency of maintenance				Recommendation:		No recommendation required

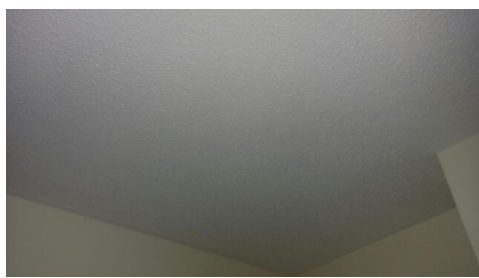
Surveyor		Steven Walker		Room/Area		011 - Landing

Survey Date		19 December 2016		Level of Identification		Sampled											
				Sample No		0004											
Building		1 SINCLAIR GARDENS		Item		Textured Coating To Plasterboard Ceiling											
Floor		3		Amount													
A - Product Type:		B - Extent of Damage:		C - Surface Treatment		D - Asbestos Type		Material Ass (M.A) (A+B+C+D):									
Textured Coating						No Asbestos Detected		0									
1 = Normal Occupant Activity = (E)		1		E - Main type of activity		1		Total Priority Score (P.A.) = (1+2+3+4):		1		Total Risk Ass' Score (P.A. + M.A)		1		Risk Coding	
2 = Disturbance = (F+G+H)/3		0		F - Location				G - Accessibility				H - Extent					
3 = Exposure potential = (I+J+K)/3		0		I - Number of occupants				J - Frequency of use				K - Average time in use					
4 = Maintenance activity = (L+M)/2		0		L - Type of maintenance				M - Frequency of maintenance				Recommendation:		No recommendation required

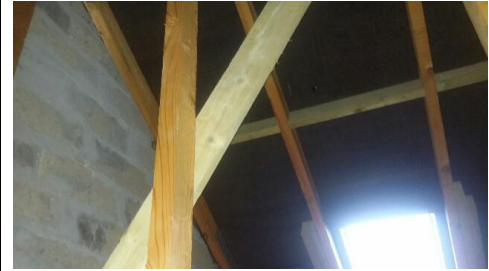
Surveyor		Steven Walker		Room/Area		014 - Loft Above Stairs

Survey Date		19 December 2016		Level of Identification		Sampled			
				Sample No		0005			
Building		1 SINCLAIR GARDENS		Item		Roof Felt			
Floor		4		Amount					
A - Product Type:		B - Extent of Damage:		C - Surface Treatment		D - Asbestos Type		Material Ass (M.A) (A+B+C+D):	
Bitumen Products						No Asbestos Detected		0	
1 = Normal Occupant Activity = (E)		0		E - Main type of activity		0		Total Priority Score (P.A.) = (1+2+3+4):	
2 = Disturbance = (F+G+H)/3		0		F - Location				Total Risk Ass' Score (P.A. + M.A)	
3 = Exposure potential = (I+J+K)/3		0		I - Number of occupants				0	
4 = Maintenance activity = (L+M)/2		0		L - Type of maintenance				Risk Coding	
Further Information:								Recommendation: No recommendation required

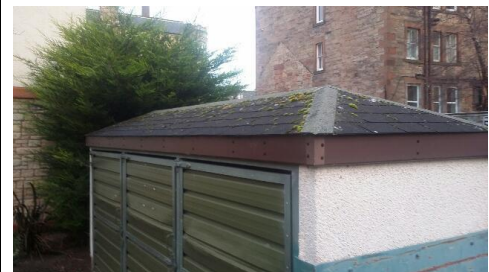
Surveyor		Steven Walker		Room/Area		016 - Bin Store 4

Survey Date		20 December 2016		Level of Identification		Sampled			
				Sample No		0006			
Building		1 SINCLAIR GARDENS		Item		Roof Felt			
Floor		External		Amount					
A - Product Type:		B - Extent of Damage:		C - Surface Treatment		D - Asbestos Type		Material Ass (M.A) (A+B+C+D):	
Bitumen Products						No Asbestos Detected		0	
1 = Normal Occupant Activity = (E)		0		E - Main type of activity		0		Total Priority Score (P.A.) = (1+2+3+4):	
2 = Disturbance = (F+G+H)/3		0		F - Location				Total Risk Ass' Score (P.A. + M.A)	
3 = Exposure potential = (I+J+K)/3		0		I - Number of occupants				0	
4 = Maintenance activity = (L+M)/2		0		L - Type of maintenance				Risk Coding	
Further Information:								Recommendation: No recommendation required

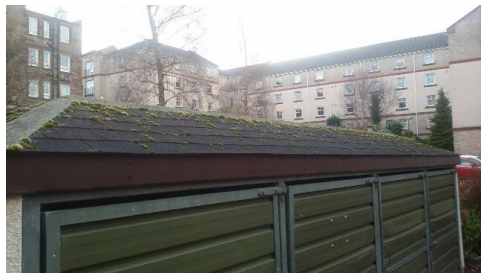
Surveyor		Steven Walker		Room/Area		017 - Bin Store 3

Survey Date		20 December 2016		Level of Identification		Sampled											
				Sample No		0007											
Building		1 SINCLAIR GARDENS		Item		Roof Felt											
Floor		External		Amount													
A - Product Type:		B - Extent of Damage:		C - Surface Treatment		D - Asbestos Type		Material Ass (M.A) (A+B+C+D):									
Bitumen Products						No Asbestos Detected		0									
1 = Normal Occupant Activity = (E)		0		E - Main type of activity		0		Total Priority Score (P.A.) = (1+2+3+4):		0		Total Risk Ass' Score (P.A. + M.A)		0		Risk Coding	
2 = Disturbance = (F+G+H)/3		0		F - Location				G - Accessibility				H - Extent					
3 = Exposure potential = (I+J+K)/3		0		I - Number of occupants				J - Frequency of use				K - Average time in use					
4 = Maintenance activity = (L+M)/2		0		L - Type of maintenance				M - Frequency of maintenance				Recommendation: No recommendation required
