# Asbestos Survey Report

## Management Survey (With Priority Assessments)

1 SINCLAIR PLACE  
EDINBURGH  
EH11 1AN

Project Number: S-61210  
Issue Date: 9 January 2017  
Issue No: 1

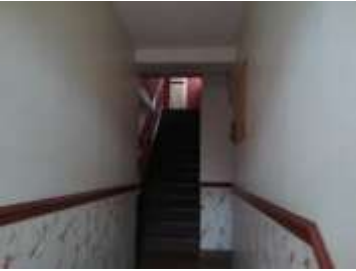
Surveyor		William Stevenson		Room/Area		001 - Ground Floor Landing And Stairs

Survey Date		19 December 2016		Level of Identification		Sampled			
				Sample No		0001			
Building		1 SINCLAIR PLACE		Item		Textured Coating To Plasterboard Ceiling			
Floor		0		Amount					
A - Product Type:		B - Extent of Damage:		C - Surface Treatment		D - Asbestos Type		Material Ass (M.A) (A+B+C+D):	
Textured Coating						No Asbestos Detected		0	
1 = Normal Occupant Activity = (E)		E - Main type of activity		Total Priority Score (P.A.) = (1+2+3+4):		Total Risk Ass' Score (P.A. + M.A)		0	
2 = Disturbance = (F+G+H)/3		F - Location		G - Accessibility		H - Extent		Risk Coding	
3 = Exposure potential = (I+J+K)/3		I - Number of occupants		J - Frequency of use		K - Average time in use			
4 = Maintenance activity = (L+M)/2		L - Type of maintenance		M - Frequency of maintenance		Recommendation:		No recommendation required

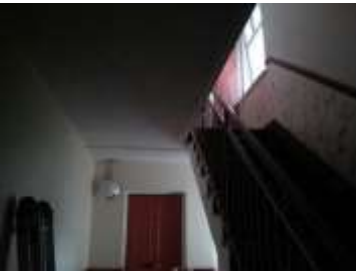
Surveyor		William Stevenson		Room/Area		006 - First Floor Landing And Stairs

Survey Date		19 December 2016		Level of Identification		Sampled			
				Sample No		0002			
Building		1 SINCLAIR PLACE		Item		Textured Coating To Plasterboard Ceiling			
Floor		1		Amount					
A - Product Type:		B - Extent of Damage:		C - Surface Treatment		D - Asbestos Type		Material Ass (M.A) (A+B+C+D):	
Textured Coating						No Asbestos Detected		0	
1 = Normal Occupant Activity = (E)		E - Main type of activity		Total Priority Score (P.A.) = (1+2+3+4):		Total Risk Ass' Score (P.A. + M.A)		0	
2 = Disturbance = (F+G+H)/3		F - Location		G - Accessibility		H - Extent		Risk Coding	
3 = Exposure potential = (I+J+K)/3		I - Number of occupants		J - Frequency of use		K - Average time in use			
4 = Maintenance activity = (L+M)/2		L - Type of maintenance		M - Frequency of maintenance		Recommendation:		No recommendation required

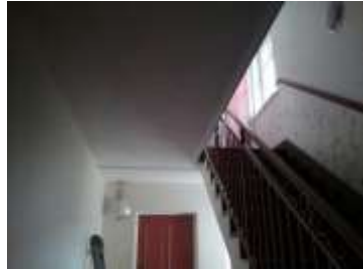
Surveyor		William Stevenson		Room/Area		010 - Second Floor Landing And Stairs

Survey Date		19 December 2016		Level of Identification		Sampled			
				Sample No		0003			
Building		1 SINCLAIR PLACE		Item		Textured Coating To Plasterboard Ceiling			
Floor		2		Amount					
A - Product Type:		B - Extent of Damage:		C - Surface Treatment		D - Asbestos Type		Material Ass (M.A) (A+B+C+D):	
Textured Coating						No Asbestos Detected		0	
1 = Normal Occupant Activity = (E)		E - Main type of activity		Total Priority Score (P.A.) = (1+2+3+4):		Total Risk Ass' Score (P.A. + M.A)		0	
2 = Disturbance = (F+G+H)/3		F - Location		G - Accessibility		H - Extent		Risk Coding	
3 = Exposure potential = (I+J+K)/3		I - Number of occupants		J - Frequency of use		K - Average time in use			
4 = Maintenance activity = (L+M)/2		L - Type of maintenance		M - Frequency of maintenance		Recommendation:		No recommendation required

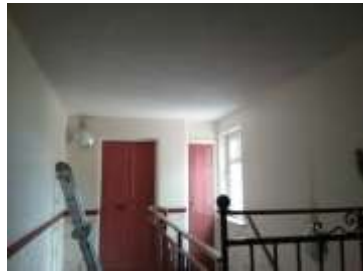
Surveyor		William Stevenson		Room/Area		014 - Third Floor Landing.

Survey Date		19 December 2016		Level of Identification		Sampled			
				Sample No		0004			
Building		1 SINCLAIR PLACE		Item		Textured Coating To Plasterboard Ceiling			
Floor		3		Amount					
A - Product Type:		B - Extent of Damage:		C - Surface Treatment		D - Asbestos Type		Material Ass (M.A) (A+B+C+D):	
Textured Coating						No Asbestos Detected		0	
1 = Normal Occupant Activity = (E)		E - Main type of activity		Total Priority Score (P.A.) = (1+2+3+4):		Total Risk Ass' Score (P.A. + M.A)		0	
2 = Disturbance = (F+G+H)/3		F - Location		G - Accessibility		H - Extent		Risk Coding	
3 = Exposure potential = (I+J+K)/3		I - Number of occupants		J - Frequency of use		K - Average time in use			
4 = Maintenance activity = (L+M)/2		L - Type of maintenance		M - Frequency of maintenance		Recommendation:		No recommendation required	
Further Information:

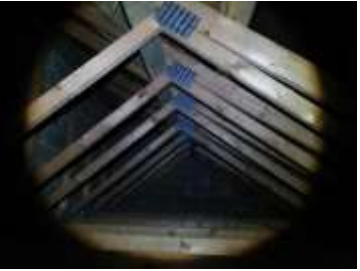
Surveyor		William Stevenson		Room/Area		018 - Roof Void

Survey Date		19 December 2016		Level of Identification		Sampled			
				Sample No		0005			
Building		1 SINCLAIR PLACE		Item		Roof Lining			
Floor		4		Amount					
A - Product Type:		B - Extent of Damage:		C - Surface Treatment		D - Asbestos Type		Material Ass (M.A) (A+B+C+D):	
Roofing Felt / Bitumen						No Asbestos Detected		0	
1 = Normal Occupant Activity = (E)		E - Main type of activity		Total Priority Score (P.A.) = (1+2+3+4):		Total Risk Ass' Score (P.A. + M.A)		0	
2 = Disturbance = (F+G+H)/3		F - Location		G - Accessibility		H - Extent		Risk Coding	
3 = Exposure potential = (I+J+K)/3		I - Number of occupants		J - Frequency of use		K - Average time in use			
4 = Maintenance activity = (L+M)/2		L - Type of maintenance		M - Frequency of maintenance		Recommendation:		No recommendation required	
Further Information:
