# **Asbestos Survey Report**

## **Management Survey (With Priority Assessments)**

**18 SINCLAIR PLACE  
EDINBURGH  
EH11 1AN**

Project Number: S-61255  
Issue Date: 13<sup>th</sup> January 2017  
Issue No: 1

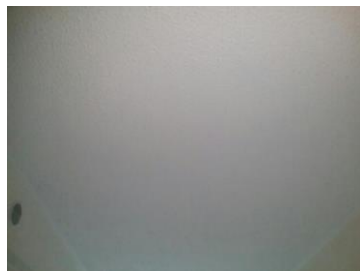
| Surveyor | | Colin Kemley | | Room/Area | | 001 - Corridor | | | |

| 4 = Maintenance activity = (L+M)/2 | | L - Type of maintenance | | M - Frequency of maintenance | | Recommendation: | | No recommendation required | |

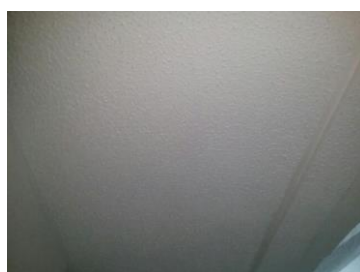
| Surveyor | | Colin Kemley | | Room/Area | | 005 - Corridor | | | |

| 4 = Maintenance activity = (L+M)/2 | | L - Type of maintenance | | M - Frequency of maintenance | | Recommendation: | | No recommendation required | |

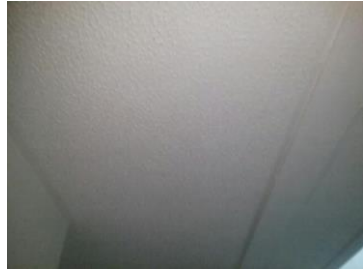
| Surveyor | | Colin Kemley | | Room/Area | | 008 - Corridor | | | |

| 4 = Maintenance activity = (L+M)/2 | | L - Type of maintenance | | M - Frequency of maintenance | | Recommendation: | | No recommendation required | |

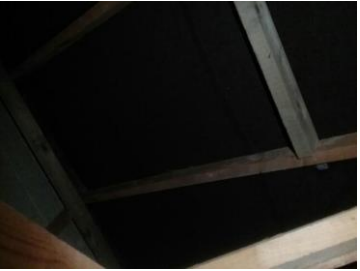
| Surveyor | | Colin Kemley | | Room/Area | | 014 - Loft Space | | | |

| 4 = Maintenance activity = (L+M)/2 | | L - Type of maintenance | | M - Frequency of maintenance | | Recommendation: | | No recommendation required | |

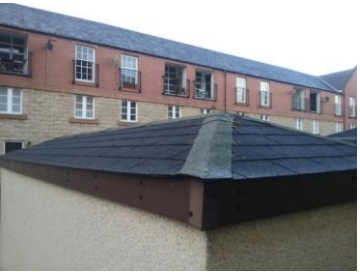
| Surveyor | | Colin Kemley | | Room/Area | | BS6 - Externals | | | |

| 4 = Maintenance activity = (L+M)/2 | | L - Type of maintenance | | M - Frequency of maintenance | | Recommendation: | | No recommendation required | |

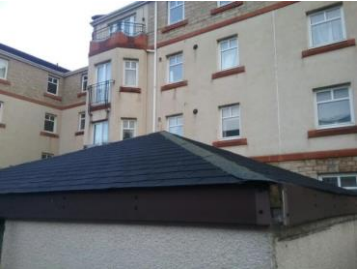
| Surveyor | | Colin Kemley | | Room/Area | | CS7 - Externals | | | |

| 4 = Maintenance activity = (L+M)/2 | | L - Type of maintenance | | M - Frequency of maintenance | | Recommendation: | | No recommendation required | |
