Asbestos Survey Report

Management Survey (With Priority Assessments)

**19 SINCLAIR PLACE
EDINBURGH
EH11 1AN**

Project Number: S-61293
Issue Date: 11 January 2017
Issue No: 1

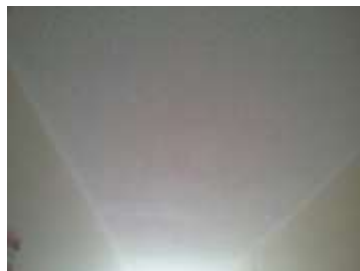
Surveyor		Colin Kemley		Room/Area		001 - Corridor

Survey Date		21 December 2016		Level of Identification		Sampled											
				Sample No		0001											
Building		19 SINCLAIR PLACE		Item		Textured Coating To Concrete Ceiling											
Floor		0		Amount													
A - Product Type:		B - Extent of Damage:		C - Surface Treatment		D - Asbestos Type		Material Ass (M.A) (A+B+C+D):									
Textured Coating						No Asbestos Detected		0									
1 = Normal Occupant Activity = (E)		1		E - Main type of activity		1		Total Priority Score (P.A.) = (1+2+3+4):		1		Total Risk Ass' Score (P.A. + M.A)		1		Risk Coding	
2 = Disturbance = (F+G+H)/3		0		F - Location				G - Accessibility				H - Extent					
3 = Exposure potential = (I+J+K)/3		0		I - Number of occupants				J - Frequency of use				K - Average time in use					
4 = Maintenance activity = (L+M)/2		0		L - Type of maintenance				M - Frequency of maintenance				Recommendation: No recommendation required

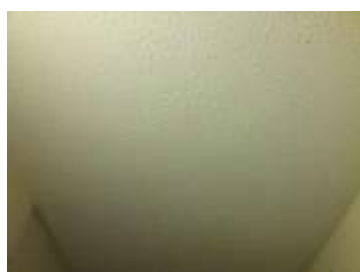
Surveyor		Colin Kemley		Room/Area		002 - Lobby

Survey Date		21 December 2016		Level of Identification		Strong Presumed (X)											
				Sample No		As 0001											
Building		19 SINCLAIR PLACE		Item		Textured Coating To Concrete Ceiling											
Floor		0		Amount													
A - Product Type:		B - Extent of Damage:		C - Surface Treatment		D - Asbestos Type		Material Ass (M.A) (A+B+C+D):									
Textured Coating						No Asbestos Detected		0									
1 = Normal Occupant Activity = (E)		1		E - Main type of activity		1		Total Priority Score (P.A.) = (1+2+3+4):		1		Total Risk Ass' Score (P.A. + M.A)		1		Risk Coding	
2 = Disturbance = (F+G+H)/3		0		F - Location				G - Accessibility				H - Extent					
3 = Exposure potential = (I+J+K)/3		0		I - Number of occupants				J - Frequency of use				K - Average time in use					
4 = Maintenance activity = (L+M)/2		0		L - Type of maintenance				M - Frequency of maintenance				Recommendation: No recommendation required

Further Information: Visually consistent with sample number 0001.

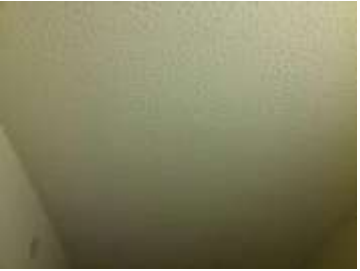
Surveyor		Colin Kemley		Room/Area		006 - Lobby

Survey Date		21 December 2016		Level of Identification		Strong Presumed (X)											
				Sample No		As 0001											
Building		19 SINCLAIR PLACE		Item		Textured Coating To Concrete Ceiling											
Floor		0		Amount													
A - Product Type:		B - Extent of Damage:		C - Surface Treatment		D - Asbestos Type		Material Ass (M.A) (A+B+C+D):									
Textured Coating						No Asbestos Detected		0									
1 = Normal Occupant Activity = (E)		1		E - Main type of activity		1		Total Priority Score (P.A.) = (1+2+3+4):		1		Total Risk Ass' Score (P.A. + M.A)		1		Risk Coding	
2 = Disturbance = (F+G+H)/3		0		F - Location				G - Accessibility				H - Extent					
3 = Exposure potential = (I+J+K)/3		0		I - Number of occupants				J - Frequency of use				K - Average time in use					
4 = Maintenance activity = (L+M)/2		0		L - Type of maintenance				M - Frequency of maintenance				Recommendation: No recommendation required

Further Information: Visually consistent with sample number 0001.

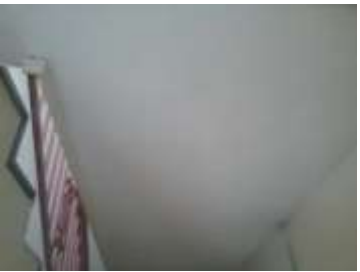
Surveyor		Colin Kemley		Room/Area		009 - Corridor

Survey Date		21 December 2016		Level of Identification		Sampled											
				Sample No		0002											
Building		19 SINCLAIR PLACE		Item		Textured Coating To Concrete Ceiling											
Floor		1		Amount													
A - Product Type:		B - Extent of Damage:		C - Surface Treatment		D - Asbestos Type		Material Ass (M.A) (A+B+C+D):									
Textured Coating						No Asbestos Detected		0									
1 = Normal Occupant Activity = (E)		1		E - Main type of activity		1		Total Priority Score (P.A.) = (1+2+3+4):		1		Total Risk Ass' Score (P.A. + M.A)		1		Risk Coding	
2 = Disturbance = (F+G+H)/3		0		F - Location				G - Accessibility				H - Extent					
3 = Exposure potential = (I+J+K)/3		0		I - Number of occupants				J - Frequency of use				K - Average time in use					
4 = Maintenance activity = (L+M)/2		0		L - Type of maintenance				M - Frequency of maintenance				Recommendation: No recommendation required

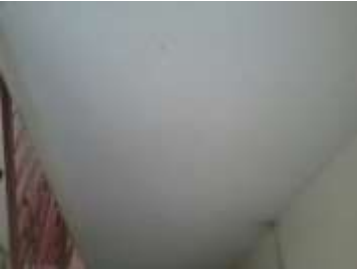
Surveyor		Colin Kemley		Room/Area		016 - Corridor

Survey Date		21 December 2016		Level of Identification		Sampled											
				Sample No		0003											
Building		19 SINCLAIR PLACE		Item		Textured Coating To Concrete Ceiling											
Floor		2		Amount													
A - Product Type:		B - Extent of Damage:		C - Surface Treatment		D - Asbestos Type		Material Ass (M.A) (A+B+C+D):									
Textured Coating						No Asbestos Detected		0									
1 = Normal Occupant Activity = (E)		1		E - Main type of activity		1		Total Priority Score (P.A.) = (1+2+3+4):		1		Total Risk Ass' Score (P.A. + M.A)		1		Risk Coding	
2 = Disturbance = (F+G+H)/3		0		F - Location				G - Accessibility				H - Extent					
3 = Exposure potential = (I+J+K)/3		0		I - Number of occupants				J - Frequency of use				K - Average time in use					
4 = Maintenance activity = (L+M)/2		0		L - Type of maintenance				M - Frequency of maintenance				Recommendation: No recommendation required

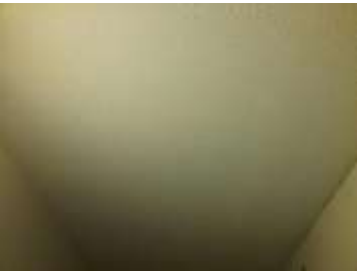
Surveyor		Colin Kemley		Room/Area		018 - Cupboard

Survey Date		21 December 2016		Level of Identification		Strong Presumed (X)											
				Sample No		As 0003											
Building		19 SINCLAIR PLACE		Item		Textured Coating To Concrete Ceiling											
Floor		2		Amount													
A - Product Type:		B - Extent of Damage:		C - Surface Treatment		D - Asbestos Type		Material Ass (M.A) (A+B+C+D):									
Textured Coating						No Asbestos Detected		0									
1 = Normal Occupant Activity = (E)		1		E - Main type of activity		1		Total Priority Score (P.A.) = (1+2+3+4):		1		Total Risk Ass' Score (P.A. + M.A)		1		Risk Coding	
2 = Disturbance = (F+G+H)/3		0		F - Location				G - Accessibility				H - Extent					
3 = Exposure potential = (I+J+K)/3		0		I - Number of occupants				J - Frequency of use				K - Average time in use					
4 = Maintenance activity = (L+M)/2		0		L - Type of maintenance				M - Frequency of maintenance				Recommendation: No recommendation required

Further Information: Visually consistent with sample number 0003.

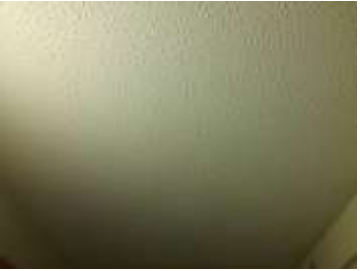
Surveyor		Colin Kemley		Room/Area		024 - Lobby

Survey Date		21 December 2016		Level of Identification		Strong Presumed (X)											
				Sample No		As 0004											
Building		19 SINCLAIR PLACE		Item		Textured Coating To Concrete Ceiling											
Floor		3		Amount													
A - Product Type:		B - Extent of Damage:		C - Surface Treatment		D - Asbestos Type		Material Ass (M.A) (A+B+C+D):									
Textured Coating						No Asbestos Detected		0									
1 = Normal Occupant Activity = (E)		1		E - Main type of activity		1		Total Priority Score (P.A.) = (1+2+3+4):		1		Total Risk Ass' Score (P.A. + M.A)		1		Risk Coding	
2 = Disturbance = (F+G+H)/3		0		F - Location				G - Accessibility				H - Extent					
3 = Exposure potential = (I+J+K)/3		0		I - Number of occupants				J - Frequency of use				K - Average time in use					
4 = Maintenance activity = (L+M)/2		0		L - Type of maintenance				M - Frequency of maintenance				Recommendation: No recommendation required

Further Information: Visually consistent with sample number 0004.

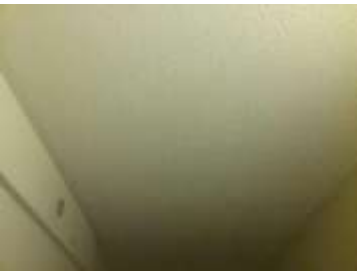
Surveyor		Colin Kemley		Room/Area		028 - Lobby

Survey Date		21 December 2016		Level of Identification		Strong Presumed (X)											
				Sample No		As 0004											
Building		19 SINCLAIR PLACE		Item		Textured Coating To Concrete Ceiling											
Floor		3		Amount													
A - Product Type:		B - Extent of Damage:		C - Surface Treatment		D - Asbestos Type		Material Ass (M.A) (A+B+C+D):									
Textured Coating						No Asbestos Detected		0									
1 = Normal Occupant Activity = (E)		1		E - Main type of activity		1		Total Priority Score (P.A.) = (1+2+3+4):		1		Total Risk Ass' Score (P.A. + M.A)		1		Risk Coding	
2 = Disturbance = (F+G+H)/3		0		F - Location				G - Accessibility				H - Extent					
3 = Exposure potential = (I+J+K)/3		0		I - Number of occupants				J - Frequency of use				K - Average time in use					
4 = Maintenance activity = (L+M)/2		0		L - Type of maintenance				M - Frequency of maintenance				Recommendation: No recommendation required

Further Information: Visually consistent with sample number 0004.
