# Asbestos Survey Report

## Management Survey (With Priority Assessments)

2 SINCLAIR CLOSE  
EDINBURGH  
EH11 1AN

Project Number: S-61322  
Issue Date: 13<sup>th</sup> January 2017  
Issue No: 1

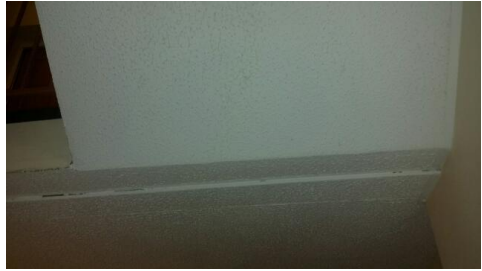
Surveyor		Steven Walker		Room/Area		001 - Ground Floor & Stairs

Survey Date		20 December 2016		Level of Identification		Sampled			
				Sample No		0001			
Building		2 SINCLAIR CLOSE		Item		Textured Coating To Concrete Ceiling			
Floor		0		Amount					
A - Product Type:		B - Extent of Damage:		C - Surface Treatment		D - Asbestos Type		Material Ass (M.A) (A+B+C+D):	
Textured Coating						No Asbestos Detected		0	
1 = Normal Occupant Activity = (E)		E - Main type of activity		Total Priority Score (P.A.) = (1+2+3+4):		Total Risk Ass' Score (P.A. + M.A)		0	
2 = Disturbance = (F+G+H)/3		F - Location		G - Accessibility		H - Extent		Risk Coding	
3 = Exposure potential = (I+J+K)/3		I - Number of occupants		J - Frequency of use		K - Average time in use			
4 = Maintenance activity = (L+M)/2		L - Type of maintenance		M - Frequency of maintenance		Recommendation:		No recommendation required	
Further Information:

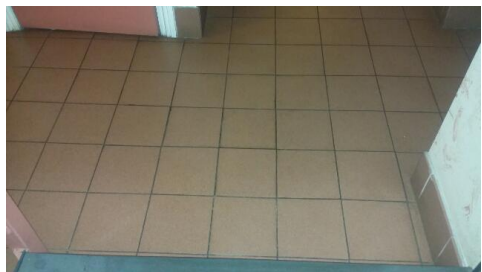
Surveyor		Steven Walker		Room/Area		001 - Ground Floor & Stairs

Survey Date		20 December 2016		Level of Identification		Sampled			
				Sample No		0002			
Building		2 SINCLAIR CLOSE		Item		Ceramic Tile Adhesive To Concrete Floor			
Floor		0		Amount					
A - Product Type:		B - Extent of Damage:		C - Surface Treatment		D - Asbestos Type		Material Ass (M.A) (A+B+C+D):	
Reinforced Composites						No Asbestos Detected		0	
1 = Normal Occupant Activity = (E)		E - Main type of activity		Total Priority Score (P.A.) = (1+2+3+4):		Total Risk Ass' Score (P.A. + M.A)		0	
2 = Disturbance = (F+G+H)/3		F - Location		G - Accessibility		H - Extent		Risk Coding	
3 = Exposure potential = (I+J+K)/3		I - Number of occupants		J - Frequency of use		K - Average time in use			
4 = Maintenance activity = (L+M)/2		L - Type of maintenance		M - Frequency of maintenance		Recommendation:		No recommendation required	
Further Information:

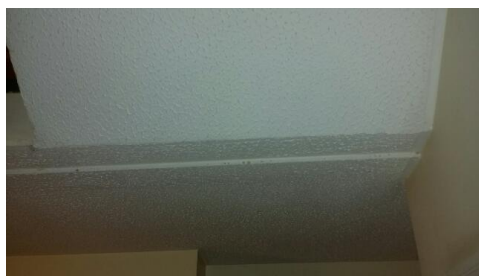
Surveyor		Steven Walker		Room/Area		005 - Landing & Stairs

Survey Date		20 December 2016		Level of Identification		Sampled			
				Sample No		0003			
Building		2 SINCLAIR CLOSE		Item		Textured Coating To Concrete Ceiling			
Floor		1		Amount					
A - Product Type:		B - Extent of Damage:		C - Surface Treatment		D - Asbestos Type		Material Ass (M.A) (A+B+C+D):	
Textured Coating						No Asbestos Detected		0	
1 = Normal Occupant Activity = (E)		E - Main type of activity		Total Priority Score (P.A.) = (1+2+3+4):		Total Risk Ass' Score (P.A. + M.A)		0	
2 = Disturbance = (F+G+H)/3		F - Location		G - Accessibility		H - Extent		Risk Coding	
3 = Exposure potential = (I+J+K)/3		I - Number of occupants		J - Frequency of use		K - Average time in use			
4 = Maintenance activity = (L+M)/2		L - Type of maintenance		M - Frequency of maintenance		Recommendation:		No recommendation required	
Further Information:

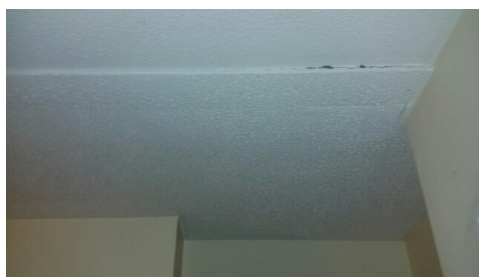
Surveyor		Steven Walker		Room/Area		008 - Landing & Stairs

Survey Date		20 December 2016		Level of Identification		Sampled			
				Sample No		0004			
Building		2 SINCLAIR CLOSE		Item		Textured Coating To Concrete Ceiling			
Floor		2		Amount					
A - Product Type:		B - Extent of Damage:		C - Surface Treatment		D - Asbestos Type		Material Ass (M.A) (A+B+C+D):	
Textured Coating						No Asbestos Detected		0	
1 = Normal Occupant Activity = (E)		E - Main type of activity		Total Priority Score (P.A.) = (1+2+3+4):		Total Risk Ass' Score (P.A. + M.A)		0	
2 = Disturbance = (F+G+H)/3		F - Location		G - Accessibility		H - Extent		Risk Coding	
3 = Exposure potential = (I+J+K)/3		I - Number of occupants		J - Frequency of use		K - Average time in use			
4 = Maintenance activity = (L+M)/2		L - Type of maintenance		M - Frequency of maintenance		Recommendation:		No recommendation required	
Further Information:

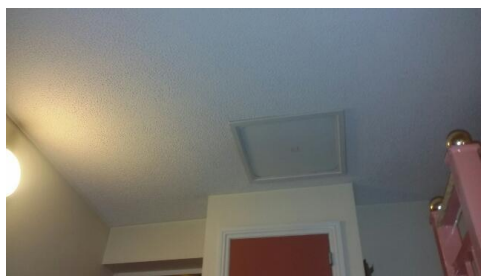
Surveyor		Steven Walker		Room/Area		011 - Landing

Survey Date		20 December 2016		Level of Identification		Sampled			
Building		2 SINCLAIR CLOSE		Sample No		0005			
Floor		3		Item		Textured Coating To Plasterboard Ceiling			
A - Product Type:		B - Extent of Damage:		C - Surface Treatment		D - Asbestos Type		Material Ass (M.A) (A+B+C+D):	
Textured Coating						No Asbestos Detected		0	
1 = Normal Occupant Activity = (E)		E - Main type of activity		Total Priority Score (P.A.) = (1+2+3+4):		Total Risk Ass' Score (P.A. + M.A)		0	
2 = Disturbance = (F+G+H)/3		F - Location		G - Accessibility		H - Extent		Risk Coding	
3 = Exposure potential = (I+J+K)/3		I - Number of occupants		J - Frequency of use		K - Average time in use			
4 = Maintenance activity = (L+M)/2		L - Type of maintenance		M - Frequency of maintenance		Recommendation:		No recommendation required	
Further Information:

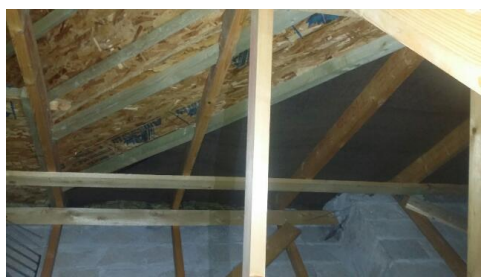
Surveyor		Steven Walker		Room/Area		014 - Loft Above Landing

Survey Date		20 December 2016		Level of Identification		Sampled			
Building		2 SINCLAIR CLOSE		Sample No		0006			
Floor		4		Item		Roof Felt			
A - Product Type:		B - Extent of Damage:		C - Surface Treatment		D - Asbestos Type		Material Ass (M.A) (A+B+C+D):	
Bitumen Products						No Asbestos Detected		0	
1 = Normal Occupant Activity = (E)		E - Main type of activity		Total Priority Score (P.A.) = (1+2+3+4):		Total Risk Ass' Score (P.A. + M.A)		0	
2 = Disturbance = (F+G+H)/3		F - Location		G - Accessibility		H - Extent		Risk Coding	
3 = Exposure potential = (I+J+K)/3		I - Number of occupants		J - Frequency of use		K - Average time in use			
4 = Maintenance activity = (L+M)/2		L - Type of maintenance		M - Frequency of maintenance		Recommendation:		No recommendation required	
Further Information:
