Asbestos Survey Report

Management Survey (With Priority Assessments)

**2 SINCLAIR GARDENS
EDINBURGH
EH11 1AN**

Project Number: S-61217
Issue Date: 11th January 2017
Issue No: 1

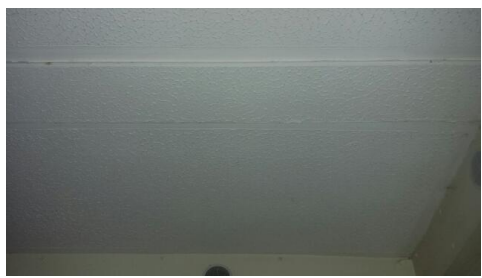
Surveyor		Steven Walker		Room/Area		001 - Ground Floor & Stairs

Survey Date		19 December 2016		Level of Identification		Sampled			
				Sample No		0001			
Building		2 SINCLAIR GARDENS		Item		Textured Coating To Concrete Ceiling			
Floor		0		Amount					
A - Product Type:		B - Extent of Damage:		C - Surface Treatment		D - Asbestos Type		Material Ass (M.A) (A+B+C+D):	
Textured Coating						No Asbestos Detected		0	
1 = Normal Occupant Activity = (E)		E - Main type of activity		Total Priority Score (P.A.) = (1+2+3+4):		Total Risk Ass' Score (P.A. + M.A)		0	
2 = Disturbance = (F+G+H)/3		F - Location		G - Accessibility		H - Extent		Risk Coding	
3 = Exposure potential = (I+J+K)/3		I - Number of occupants		J - Frequency of use		K - Average time in use			
4 = Maintenance activity = (L+M)/2		L - Type of maintenance		M - Frequency of maintenance		Recommendation:		No recommendation required	
Further Information:

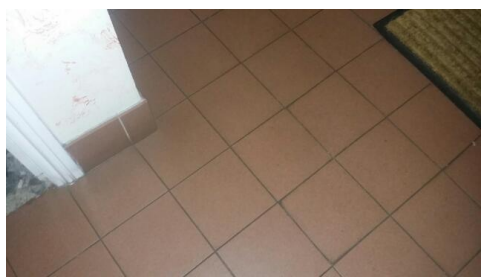
Surveyor		Steven Walker		Room/Area		001 - Ground Floor & Stairs

Survey Date		19 December 2016		Level of Identification		Sampled			
				Sample No		0002			
Building		2 SINCLAIR GARDENS		Item		Ceramic Tile Adhesive To Concrete Floor			
Floor		0		Amount					
A - Product Type:		B - Extent of Damage:		C - Surface Treatment		D - Asbestos Type		Material Ass (M.A) (A+B+C+D):	
Reinforced Composites						No Asbestos Detected		0	
1 = Normal Occupant Activity = (E)		E - Main type of activity		Total Priority Score (P.A.) = (1+2+3+4):		Total Risk Ass' Score (P.A. + M.A)		0	
2 = Disturbance = (F+G+H)/3		F - Location		G - Accessibility		H - Extent		Risk Coding	
3 = Exposure potential = (I+J+K)/3		I - Number of occupants		J - Frequency of use		K - Average time in use			
4 = Maintenance activity = (L+M)/2		L - Type of maintenance		M - Frequency of maintenance		Recommendation:		No recommendation required	
Further Information:

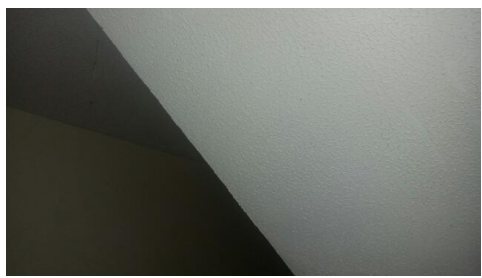
Surveyor		Steven Walker		Room/Area		006 - Landing & Stairs

Survey Date		19 December 2016		Level of Identification		Sampled			
				Sample No		0003			
Building		2 SINCLAIR GARDENS		Item		Textured Coating To Concrete Ceiling			
Floor		1		Amount					
A - Product Type:		B - Extent of Damage:		C - Surface Treatment		D - Asbestos Type		Material Ass (M.A) (A+B+C+D):	
Textured Coating						No Asbestos Detected		0	
1 = Normal Occupant Activity = (E)		E - Main type of activity		Total Priority Score (P.A.) = (1+2+3+4):		Total Risk Ass' Score (P.A. + M.A)		0	
2 = Disturbance = (F+G+H)/3		F - Location		G - Accessibility		H - Extent		Risk Coding	
3 = Exposure potential = (I+J+K)/3		I - Number of occupants		J - Frequency of use		K - Average time in use			
4 = Maintenance activity = (L+M)/2		L - Type of maintenance		M - Frequency of maintenance		Recommendation:		No recommendation required	
Further Information:

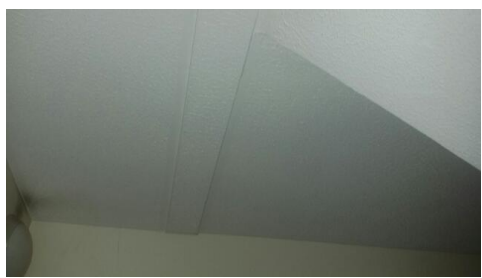
Surveyor		Steven Walker		Room/Area		010 - Landing & Stairs

Survey Date		19 December 2016		Level of Identification		Sampled			
				Sample No		0004			
Building		2 SINCLAIR GARDENS		Item		Textured Coating To Concrete Ceiling			
Floor		2		Amount					
A - Product Type:		B - Extent of Damage:		C - Surface Treatment		D - Asbestos Type		Material Ass (M.A) (A+B+C+D):	
Textured Coating						No Asbestos Detected		0	
1 = Normal Occupant Activity = (E)		E - Main type of activity		Total Priority Score (P.A.) = (1+2+3+4):		Total Risk Ass' Score (P.A. + M.A)		0	
2 = Disturbance = (F+G+H)/3		F - Location		G - Accessibility		H - Extent		Risk Coding	
3 = Exposure potential = (I+J+K)/3		I - Number of occupants		J - Frequency of use		K - Average time in use			
4 = Maintenance activity = (L+M)/2		L - Type of maintenance		M - Frequency of maintenance		Recommendation:		No recommendation required	
Further Information:

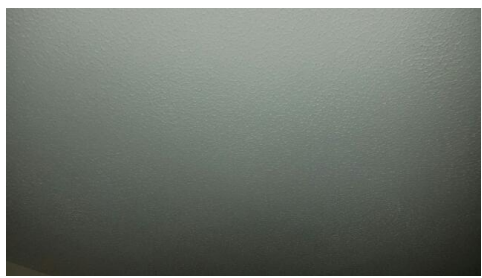
Surveyor		Steven Walker		Room/Area		014 - Landing

Survey Date		19 December 2016		Level of Identification		Sampled			
				Sample No		0005			
Building		2 SINCLAIR GARDENS		Item		Textured Coating To Concrete Ceiling			
Floor		3		Amount					
A - Product Type:		B - Extent of Damage:		C - Surface Treatment		D - Asbestos Type		Material Ass (M.A) (A+B+C+D):	
Textured Coating						No Asbestos Detected		0	
1 = Normal Occupant Activity = (E)		E - Main type of activity		Total Priority Score (P.A.) = (1+2+3+4):		Total Risk Ass' Score (P.A. + M.A)		0	
2 = Disturbance = (F+G+H)/3		F - Location		G - Accessibility		H - Extent		Risk Coding	
3 = Exposure potential = (I+J+K)/3		I - Number of occupants		J - Frequency of use		K - Average time in use			
4 = Maintenance activity = (L+M)/2		L - Type of maintenance		M - Frequency of maintenance		Recommendation:		No recommendation required	
Further Information:

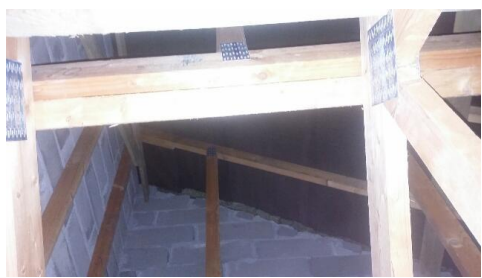
Surveyor		Steven Walker		Room/Area		018 - Loft Above Stairs

Survey Date		19 December 2016		Level of Identification		Sampled			
				Sample No		0006			
Building		2 SINCLAIR GARDENS		Item		Roof Felt			
Floor		4		Amount					
A - Product Type:		B - Extent of Damage:		C - Surface Treatment		D - Asbestos Type		Material Ass (M.A) (A+B+C+D):	
Bitumen Products						No Asbestos Detected		0	
1 = Normal Occupant Activity = (E)		E - Main type of activity		Total Priority Score (P.A.) = (1+2+3+4):		Total Risk Ass' Score (P.A. + M.A)		0	
2 = Disturbance = (F+G+H)/3		F - Location		G - Accessibility		H - Extent		Risk Coding	
3 = Exposure potential = (I+J+K)/3		I - Number of occupants		J - Frequency of use		K - Average time in use			
4 = Maintenance activity = (L+M)/2		L - Type of maintenance		M - Frequency of maintenance		Recommendation:		No recommendation required	
Further Information:
