Asbestos Survey Report

Management Survey (With Priority Assessments)

2 SINCLAIR PLACE
EDINBURGH
EH11 1AN

Project Number: S-61211
Issue Date: 10th January 2017
Issue No: 1

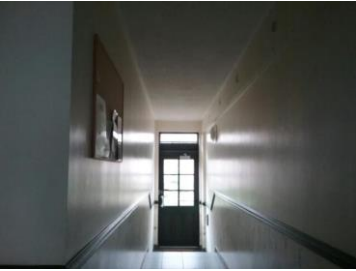
| Surveyor | | William Stevenson | | Room/Area | | 001 - Ground Floor Landing And Stairs | | | |

| 4 = Maintenance activity = (L+M)/2 | | L - Type of maintenance | | M - Frequency of maintenance | | Recommendation: | | No recommendation required | |

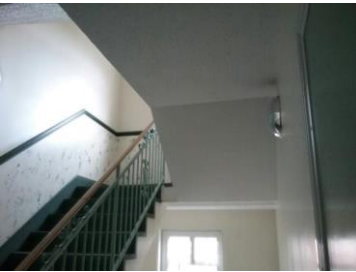
| Surveyor | | William Stevenson | | Room/Area | | 005 - First Floor Landing And Stairs | | | |

| 4 = Maintenance activity = (L+M)/2 | | L - Type of maintenance | | M - Frequency of maintenance | | Recommendation: | | No recommendation required | |

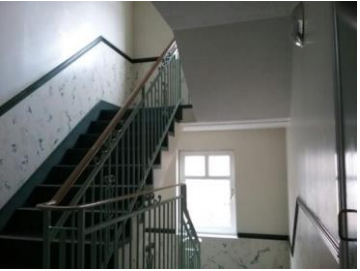
| Surveyor | | William Stevenson | | Room/Area | | 008 - Second Floor Landing And Stairs | | | |

| 4 = Maintenance activity = (L+M)/2 | | L - Type of maintenance | | M - Frequency of maintenance | | Recommendation: | | No recommendation required | |

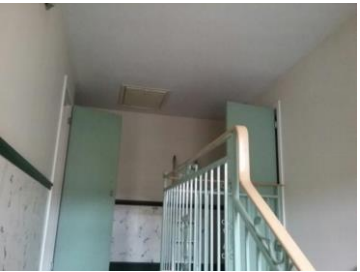
| Surveyor | | William Stevenson | | Room/Area | | 011 - Third Floor Landing | | | |

| 4 = Maintenance activity = (L+M)/2 | | L - Type of maintenance | | M - Frequency of maintenance | | Recommendation: | | No recommendation required | |

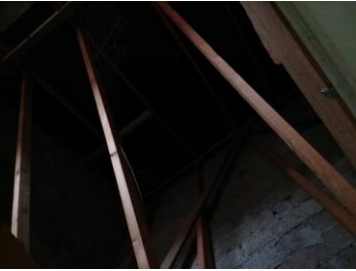
| Surveyor | | William Stevenson | | Room/Area | | 014 - Roof Void | | | |

| 4 = Maintenance activity = (L+M)/2 | | L - Type of maintenance | | M - Frequency of maintenance | | Recommendation: | | No recommendation required | |
