Asbestos Survey Report

Management Survey (With Priority Assessments)

20 SINCLAIR PLACE
EDINBURGH
EH11 1AN

Project Number: S-61294
Issue Date: 11 January 2017
Issue No: 1

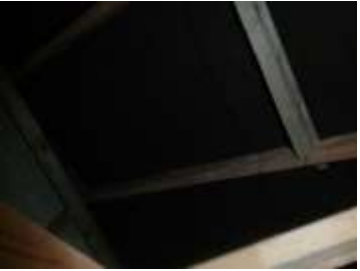
Surveyor		Colin Kemley		Room/Area		018 - Loft Space

Survey Date		21 December 2016		Level of Identification		Sampled											
				Sample No		0005											
Building		20 SINCLAIR PLACE		Item		Felt To Ceiling											
Floor		4		Amount													
A - Product Type:		B - Extent of Damage:		C - Surface Treatment		D - Asbestos Type		Material Ass (M.A) (A+B+C+D):									
Bitumen Products						No Asbestos Detected		0									
1 = Normal Occupant Activity = (E)		1		E - Main type of activity		1		Total Priority Score (P.A.) = (1+2+3+4):		1		Total Risk Ass' Score (P.A. + M.A)		1		Risk Coding	
2 = Disturbance = (F+G+H)/3		0		F - Location				G - Accessibility				H - Extent					
3 = Exposure potential = (I+J+K)/3		0		I - Number of occupants				J - Frequency of use				K - Average time in use					
4 = Maintenance activity = (L+M)/2		0		L - Type of maintenance				M - Frequency of maintenance				Recommendation: No recommendation required
