Asbestos Survey Report

Management Survey (With Priority Assessments)

**24 SINCLAIR PLACE
Edinburgh
EH11 1AN**

Project Number: S-61248
Issue Date: 12th January 2017
Issue No: 1

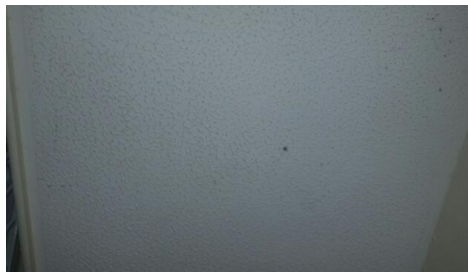
Surveyor		Steven Walker		Room/Area		001 - Ground Floor & Stairs

Survey Date		20 December 2016		Level of Identification		Sampled			
				Sample No		0001			
Building		24 SINCLAIR PLACE		Item		Textured Coating To Concrete Ceiling			
Floor		0		Amount					
A - Product Type:		B - Extent of Damage:		C - Surface Treatment		D - Asbestos Type		Material Ass (M.A) (A+B+C+D):	
Textured Coating						No Asbestos Detected		0	
1 = Normal Occupant Activity = (E)				E - Main type of activity		Total Priority Score (P.A.) = (1+2+3+4):		Total Risk Ass' Score (P.A. + M.A)	
2 = Disturbance = (F+G+H)/3				F - Location		G - Accessibility		H - Extent	
3 = Exposure potential = (I+J+K)/3				I - Number of occupants		J - Frequency of use		K - Average time in use	
4 = Maintenance activity = (L+M)/2				L - Type of maintenance		M - Frequency of maintenance		Recommendation:	
Further Information:								No recommendation required

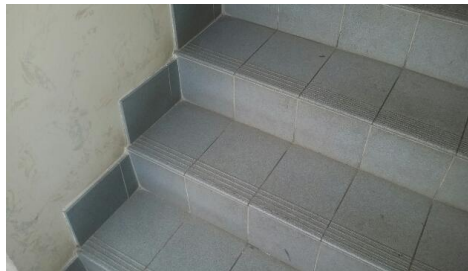
Surveyor		Steven Walker		Room/Area		001 - Ground Floor & Stairs

Survey Date		20 December 2016		Level of Identification		Sampled			
				Sample No		0002			
Building		24 SINCLAIR PLACE		Item		Ceramic Tile Adhesive To Concrete Floor			
Floor		0		Amount					
A - Product Type:		B - Extent of Damage:		C - Surface Treatment		D - Asbestos Type		Material Ass (M.A) (A+B+C+D):	
Reinforced Composites						No Asbestos Detected		0	
1 = Normal Occupant Activity = (E)				E - Main type of activity		Total Priority Score (P.A.) = (1+2+3+4):		Total Risk Ass' Score (P.A. + M.A)	
2 = Disturbance = (F+G+H)/3				F - Location		G - Accessibility		H - Extent	
3 = Exposure potential = (I+J+K)/3				I - Number of occupants		J - Frequency of use		K - Average time in use	
4 = Maintenance activity = (L+M)/2				L - Type of maintenance		M - Frequency of maintenance		Recommendation:	
Further Information:								No recommendation required

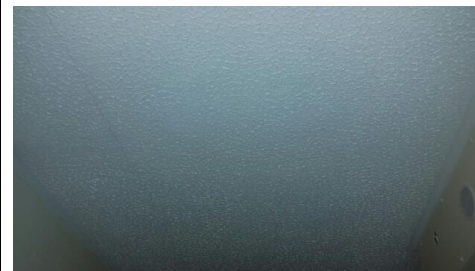
Surveyor		Steven Walker		Room/Area		003 - Ground Floor Vestibule 1

Survey Date		20 December 2016		Level of Identification		Sampled			
				Sample No		0003			
Building		24 SINCLAIR PLACE		Item		Textured Coating To Concrete Ceiling			
Floor		0		Amount					
A - Product Type:		B - Extent of Damage:		C - Surface Treatment		D - Asbestos Type		Material Ass (M.A) (A+B+C+D):	
Textured Coating						No Asbestos Detected		0	
1 = Normal Occupant Activity = (E)				E - Main type of activity		Total Priority Score (P.A.) = (1+2+3+4):		Total Risk Ass' Score (P.A. + M.A)	
2 = Disturbance = (F+G+H)/3				F - Location		G - Accessibility		H - Extent	
3 = Exposure potential = (I+J+K)/3				I - Number of occupants		J - Frequency of use		K - Average time in use	
4 = Maintenance activity = (L+M)/2				L - Type of maintenance		M - Frequency of maintenance		Recommendation:	
Further Information:								No recommendation required

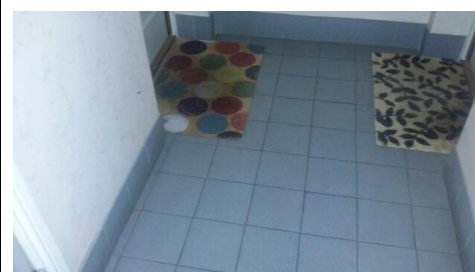
Surveyor		Steven Walker		Room/Area		003 - Ground Floor Vestibule 1

Survey Date		20 December 2016		Level of Identification		Strong Presumed (X)			
				Sample No		As 0002			
Building		24 SINCLAIR PLACE		Item		Ceramic Tile Adhesive To Concrete Floor			
Floor		0		Amount					
A - Product Type:		B - Extent of Damage:		C - Surface Treatment		D - Asbestos Type		Material Ass (M.A) (A+B+C+D):	
Reinforced Composites						No Asbestos Detected		0	
1 = Normal Occupant Activity = (E)				E - Main type of activity		Total Priority Score (P.A.) = (1+2+3+4):		Total Risk Ass' Score (P.A. + M.A)	
2 = Disturbance = (F+G+H)/3				F - Location		G - Accessibility		H - Extent	
3 = Exposure potential = (I+J+K)/3				I - Number of occupants		J - Frequency of use		K - Average time in use	
4 = Maintenance activity = (L+M)/2				L - Type of maintenance		M - Frequency of maintenance		Recommendation:	
Further Information:		Visually consistent with sample number 0002.						No recommendation required

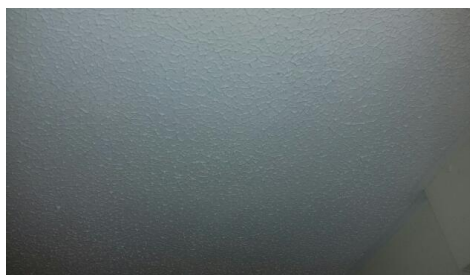
Surveyor		Steven Walker		Room/Area		007 - Ground Floor Vestibule 2

Survey Date		20 December 2016		Level of Identification		Sampled			
				Sample No		0004			
Building		24 SINCLAIR PLACE		Item		Textured Coating To Concrete Ceiling			
Floor		0		Amount					
A - Product Type:		B - Extent of Damage:		C - Surface Treatment		D - Asbestos Type		Material Ass (M.A) (A+B+C+D):	
Textured Coating						No Asbestos Detected		0	
1 = Normal Occupant Activity = (E)				E - Main type of activity		Total Priority Score (P.A.) = (1+2+3+4):		Total Risk Ass' Score (P.A. + M.A)	
2 = Disturbance = (F+G+H)/3				F - Location		G - Accessibility		H - Extent	
3 = Exposure potential = (I+J+K)/3				I - Number of occupants		J - Frequency of use		K - Average time in use	
4 = Maintenance activity = (L+M)/2				L - Type of maintenance		M - Frequency of maintenance		Recommendation:	
Further Information:								No recommendation required

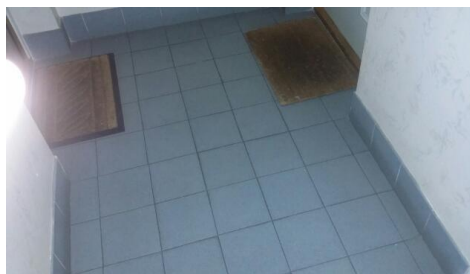
Surveyor		Steven Walker		Room/Area		007 - Ground Floor Vestibule 2

Survey Date		20 December 2016		Level of Identification		Strong Presumed (X)			
				Sample No		As 0002			
Building		24 SINCLAIR PLACE		Item		Ceramic Tile Adhesive To Concrete Floor			
Floor		0		Amount					
A - Product Type:		B - Extent of Damage:		C - Surface Treatment		D - Asbestos Type		Material Ass (M.A) (A+B+C+D):	
Reinforced Composites						No Asbestos Detected		0	
1 = Normal Occupant Activity = (E)				E - Main type of activity		Total Priority Score (P.A.) = (1+2+3+4):		Total Risk Ass' Score (P.A. + M.A)	
2 = Disturbance = (F+G+H)/3				F - Location		G - Accessibility		H - Extent	
3 = Exposure potential = (I+J+K)/3				I - Number of occupants		J - Frequency of use		K - Average time in use	
4 = Maintenance activity = (L+M)/2				L - Type of maintenance		M - Frequency of maintenance		Recommendation:	
Further Information:		Visually consistent with sample number 0002.						No recommendation required

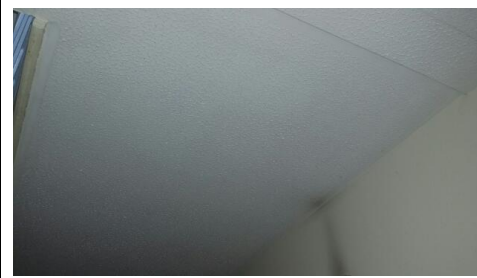
Surveyor		Steven Walker		Room/Area		009 - Landing & Stairs

Survey Date		20 December 2016		Level of Identification		Sampled			
				Sample No		0005			
Building		24 SINCLAIR PLACE		Item		Textured Coating To Concrete Ceiling			
Floor		1		Amount					
A - Product Type:		B - Extent of Damage:		C - Surface Treatment		D - Asbestos Type		Material Ass (M.A) (A+B+C+D):	
Textured Coating						No Asbestos Detected		0	
1 = Normal Occupant Activity = (E)				E - Main type of activity		Total Priority Score (P.A.) = (1+2+3+4):		Total Risk Ass' Score (P.A. + M.A)	
2 = Disturbance = (F+G+H)/3				F - Location		G - Accessibility		H - Extent	
3 = Exposure potential = (I+J+K)/3				I - Number of occupants		J - Frequency of use		K - Average time in use	
4 = Maintenance activity = (L+M)/2				L - Type of maintenance		M - Frequency of maintenance		Recommendation:	
Further Information:								No recommendation required

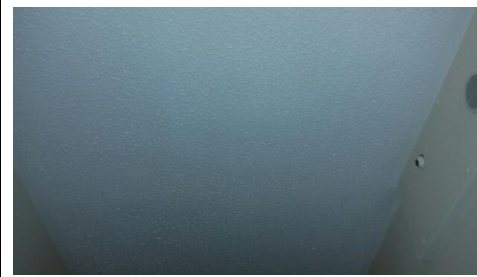
Surveyor		Steven Walker		Room/Area		010 - Landing Vestibule 1

Survey Date		20 December 2016		Level of Identification		Sampled			
				Sample No		0006			
Building		24 SINCLAIR PLACE		Item		Textured Coating To Concrete Ceiling			
Floor		1		Amount					
A - Product Type:		B - Extent of Damage:		C - Surface Treatment		D - Asbestos Type		Material Ass (M.A) (A+B+C+D):	
Textured Coating						No Asbestos Detected		0	
1 = Normal Occupant Activity = (E)				E - Main type of activity		Total Priority Score (P.A.) = (1+2+3+4):		Total Risk Ass' Score (P.A. + M.A)	
2 = Disturbance = (F+G+H)/3				F - Location		G - Accessibility		H - Extent	
3 = Exposure potential = (I+J+K)/3				I - Number of occupants		J - Frequency of use		K - Average time in use	
4 = Maintenance activity = (L+M)/2				L - Type of maintenance		M - Frequency of maintenance		Recommendation:	
Further Information:								No recommendation required

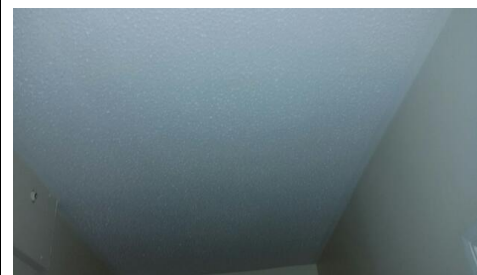
Surveyor		Steven Walker		Room/Area		014 - Landing Vestibule 2

Survey Date		20 December 2016		Level of Identification		Sampled			
				Sample No		0007			
Building		24 SINCLAIR PLACE		Item		Textured Coating To Concrete Ceiling			
Floor		1		Amount					
A - Product Type:		B - Extent of Damage:		C - Surface Treatment		D - Asbestos Type		Material Ass (M.A) (A+B+C+D):	
Textured Coating						No Asbestos Detected		0	
1 = Normal Occupant Activity = (E)				E - Main type of activity		Total Priority Score (P.A.) = (1+2+3+4):		Total Risk Ass' Score (P.A. + M.A)	
2 = Disturbance = (F+G+H)/3				F - Location		G - Accessibility		H - Extent	
3 = Exposure potential = (I+J+K)/3				I - Number of occupants		J - Frequency of use		K - Average time in use	
4 = Maintenance activity = (L+M)/2				L - Type of maintenance		M - Frequency of maintenance		Recommendation:	
Further Information:								No recommendation required

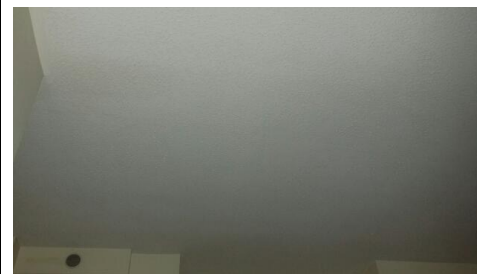
Surveyor		Steven Walker		Room/Area		016 - Landing & Stairs

Survey Date		20 December 2016		Level of Identification		Sampled			
				Sample No		0008			
Building		24 SINCLAIR PLACE		Item		Textured Coating To Concrete Ceiling			
Floor		2		Amount					
A - Product Type:		B - Extent of Damage:		C - Surface Treatment		D - Asbestos Type		Material Ass (M.A) (A+B+C+D):	
Textured Coating						No Asbestos Detected		0	
1 = Normal Occupant Activity = (E)				E - Main type of activity		Total Priority Score (P.A.) = (1+2+3+4):		Total Risk Ass' Score (P.A. + M.A)	
2 = Disturbance = (F+G+H)/3				F - Location		G - Accessibility		H - Extent	
3 = Exposure potential = (I+J+K)/3				I - Number of occupants		J - Frequency of use		K - Average time in use	
4 = Maintenance activity = (L+M)/2				L - Type of maintenance		M - Frequency of maintenance		Recommendation:	
Further Information:								No recommendation required

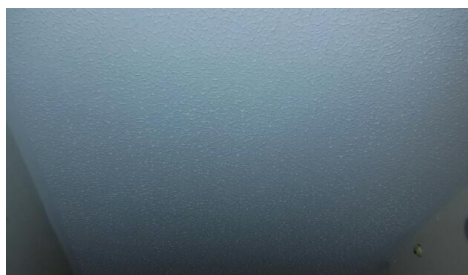
Surveyor		Steven Walker		Room/Area		017 - Landing Vestibule 1

Survey Date		20 December 2016		Level of Identification		Sampled			
				Sample No		0009			
Building		24 SINCLAIR PLACE		Item		Textured Coating To Concrete Ceiling			
Floor		2		Amount					
A - Product Type:		B - Extent of Damage:		C - Surface Treatment		D - Asbestos Type		Material Ass (M.A) (A+B+C+D):	
Textured Coating						No Asbestos Detected		0	
1 = Normal Occupant Activity = (E)				E - Main type of activity		Total Priority Score (P.A.) = (1+2+3+4):		Total Risk Ass' Score (P.A. + M.A)	
2 = Disturbance = (F+G+H)/3				F - Location		G - Accessibility		H - Extent	
3 = Exposure potential = (I+J+K)/3				I - Number of occupants		J - Frequency of use		K - Average time in use	
4 = Maintenance activity = (L+M)/2				L - Type of maintenance		M - Frequency of maintenance		Recommendation:	
Further Information:								No recommendation required

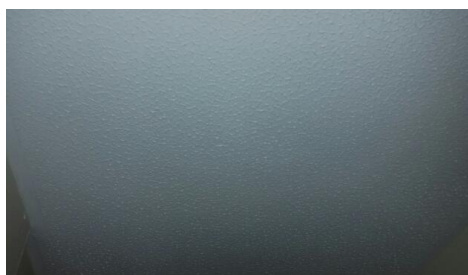
Surveyor		Steven Walker		Room/Area		021 - Landing Vestibule 2

Survey Date		20 December 2016		Level of Identification		Sampled			
				Sample No		0010			
Building		24 SINCLAIR PLACE		Item		Textured Coating To Concrete Ceiling			
Floor		2		Amount					
A - Product Type:		B - Extent of Damage:		C - Surface Treatment		D - Asbestos Type		Material Ass (M.A) (A+B+C+D):	
Textured Coating						No Asbestos Detected		0	
1 = Normal Occupant Activity = (E)				E - Main type of activity		Total Priority Score (P.A.) = (1+2+3+4):		Total Risk Ass' Score (P.A. + M.A)	
2 = Disturbance = (F+G+H)/3				F - Location		G - Accessibility		H - Extent	
3 = Exposure potential = (I+J+K)/3				I - Number of occupants		J - Frequency of use		K - Average time in use	
4 = Maintenance activity = (L+M)/2				L - Type of maintenance		M - Frequency of maintenance		Recommendation:	
Further Information:								No recommendation required

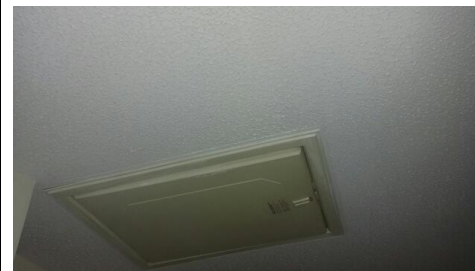
Surveyor		Steven Walker		Room/Area		023 - Landing

Survey Date		20 December 2016		Level of Identification		Sampled			
				Sample No		0011			
Building		24 SINCLAIR PLACE		Item		Textured Coating To Plasterboard Ceiling			
Floor		2		Amount					
A - Product Type:		B - Extent of Damage:		C - Surface Treatment		D - Asbestos Type		Material Ass (M.A) (A+B+C+D):	
Textured Coating						No Asbestos Detected		0	
1 = Normal Occupant Activity = (E)				E - Main type of activity		Total Priority Score (P.A.) = (1+2+3+4):		Total Risk Ass' Score (P.A. + M.A)	
2 = Disturbance = (F+G+H)/3				F - Location		G - Accessibility		H - Extent	
3 = Exposure potential = (I+J+K)/3				I - Number of occupants		J - Frequency of use		K - Average time in use	
4 = Maintenance activity = (L+M)/2				L - Type of maintenance		M - Frequency of maintenance		Recommendation:	
Further Information:								No recommendation required

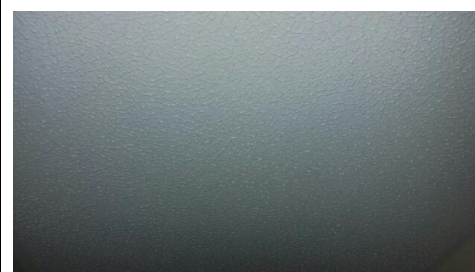
Surveyor		Steven Walker		Room/Area		024 - Landing Vestibule 1

Survey Date		20 December 2016		Level of Identification		Sampled			
				Sample No		0012			
Building		24 SINCLAIR PLACE		Item		Textured Coating To Plasterboard Ceiling			
Floor		3		Amount					
A - Product Type:		B - Extent of Damage:		C - Surface Treatment		D - Asbestos Type		Material Ass (M.A) (A+B+C+D):	
Textured Coating						No Asbestos Detected		0	
1 = Normal Occupant Activity = (E)				E - Main type of activity		Total Priority Score (P.A.) = (1+2+3+4):		Total Risk Ass' Score (P.A. + M.A)	
2 = Disturbance = (F+G+H)/3				F - Location		G - Accessibility		H - Extent	
3 = Exposure potential = (I+J+K)/3				I - Number of occupants		J - Frequency of use		K - Average time in use	
4 = Maintenance activity = (L+M)/2				L - Type of maintenance		M - Frequency of maintenance		Recommendation:	
Further Information:								No recommendation required

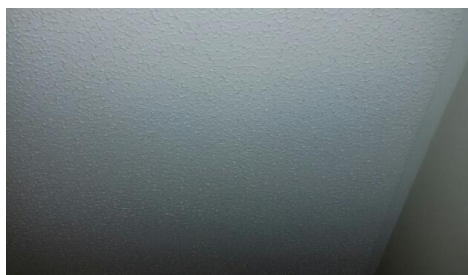
Surveyor		Steven Walker		Room/Area		028 - Landing Vestibule 2

Survey Date		20 December 2016		Level of Identification		Sampled			
				Sample No		0013			
Building		24 SINCLAIR PLACE		Item		Textured Coating To Plasterboard Ceiling			
Floor		3		Amount					
A - Product Type:		B - Extent of Damage:		C - Surface Treatment		D - Asbestos Type		Material Ass (M.A) (A+B+C+D):	
Textured Coating						No Asbestos Detected		0	
1 = Normal Occupant Activity = (E)				E - Main type of activity		Total Priority Score (P.A.) = (1+2+3+4):		Total Risk Ass' Score (P.A. + M.A)	
2 = Disturbance = (F+G+H)/3				F - Location		G - Accessibility		H - Extent	
3 = Exposure potential = (I+J+K)/3				I - Number of occupants		J - Frequency of use		K - Average time in use	
4 = Maintenance activity = (L+M)/2				L - Type of maintenance		M - Frequency of maintenance		Recommendation:	
Further Information:								No recommendation required

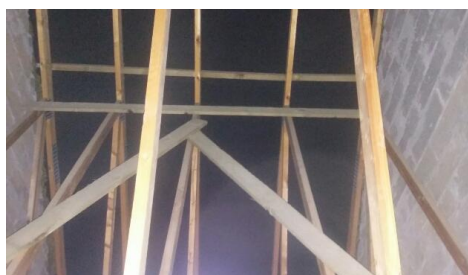
Surveyor		Steven Walker		Room/Area		030 - Loft Above Landing

Survey Date		20 December 2016		Level of Identification		Sampled			
				Sample No		0014			
Building		24 SINCLAIR PLACE		Item		Roof Felt			
Floor		4		Amount					
A - Product Type:		B - Extent of Damage:		C - Surface Treatment		D - Asbestos Type		Material Ass (M.A) (A+B+C+D):	
Bitumen Products						No Asbestos Detected		0	
1 = Normal Occupant Activity = (E)				E - Main type of activity		Total Priority Score (P.A.) = (1+2+3+4):		Total Risk Ass' Score (P.A. + M.A)	
2 = Disturbance = (F+G+H)/3				F - Location		G - Accessibility		H - Extent	
3 = Exposure potential = (I+J+K)/3				I - Number of occupants		J - Frequency of use		K - Average time in use	
4 = Maintenance activity = (L+M)/2				L - Type of maintenance		M - Frequency of maintenance		Recommendation:	
Further Information:								No recommendation required

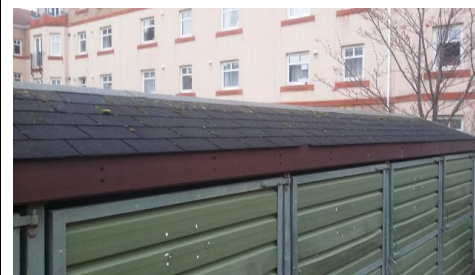
Surveyor		Steven Walker		Room/Area		032 - Bin Store 5

Survey Date		20 December 2016		Level of Identification		Sampled			
				Sample No		0015			
Building		24 SINCLAIR PLACE		Item		Roof Felt			
Floor		External		Amount					
A - Product Type:		B - Extent of Damage:		C - Surface Treatment		D - Asbestos Type		Material Ass (M.A) (A+B+C+D):	
Bitumen Products						No Asbestos Detected		0	
1 = Normal Occupant Activity = (E)				E - Main type of activity		Total Priority Score (P.A.) = (1+2+3+4):		Total Risk Ass' Score (P.A. + M.A)	
2 = Disturbance = (F+G+H)/3				F - Location		G - Accessibility		H - Extent	
3 = Exposure potential = (I+J+K)/3				I - Number of occupants		J - Frequency of use		K - Average time in use	
4 = Maintenance activity = (L+M)/2				L - Type of maintenance		M - Frequency of maintenance		Recommendation:	
Further Information:								No recommendation required
