# **Asbestos Survey Report**

## **Management Survey (With Priority Assessments)**

**25 SINCLAIR PLACE  
Edinburgh  
EH11 1AN**

Project Number: S-61249  
Issue Date: 11<sup>th</sup> January 2017  
Issue No: 1

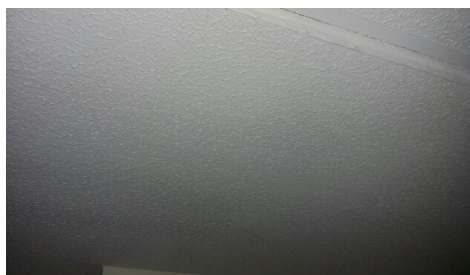
Surveyor		Steven Walker		Room/Area		001 - Ground Floor & Stairs

Survey Date		20 December 2016		Level of Identification		Sampled			
				Sample No		0001			
Building		25 SINCLAIR PLACE		Item		Textured Coating To Concrete Ceiling			
Floor		0		Amount					
A - Product Type:		B - Extent of Damage:		C - Surface Treatment		D - Asbestos Type		Material Ass (M.A) (A+B+C+D):	
Textured Coating						No Asbestos Detected		0	
1 = Normal Occupant Activity = (E)				E - Main type of activity		Total Priority Score (P.A.) = (1+2+3+4):		Total Risk Ass' Score (P.A. + M.A)	
2 = Disturbance = (F+G+H)/3				F - Location		G - Accessibility		H - Extent	
3 = Exposure potential = (I+J+K)/3				I - Number of occupants		J - Frequency of use		K - Average time in use	
4 = Maintenance activity = (L+M)/2				L - Type of maintenance		M - Frequency of maintenance		Recommendation:	
Further Information:								No recommendation required

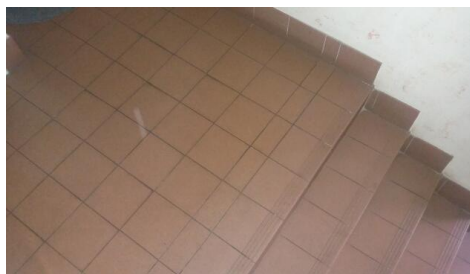
Surveyor		Steven Walker		Room/Area		001 - Ground Floor & Stairs

Survey Date		20 December 2016		Level of Identification		Sampled			
				Sample No		0002			
Building		25 SINCLAIR PLACE		Item		Ceramic Tile Adhesive To Concrete Floor			
Floor		0		Amount					
A - Product Type:		B - Extent of Damage:		C - Surface Treatment		D - Asbestos Type		Material Ass (M.A) (A+B+C+D):	
Reinforced Composites						No Asbestos Detected		0	
1 = Normal Occupant Activity = (E)				E - Main type of activity		Total Priority Score (P.A.) = (1+2+3+4):		Total Risk Ass' Score (P.A. + M.A)	
2 = Disturbance = (F+G+H)/3				F - Location		G - Accessibility		H - Extent	
3 = Exposure potential = (I+J+K)/3				I - Number of occupants		J - Frequency of use		K - Average time in use	
4 = Maintenance activity = (L+M)/2				L - Type of maintenance		M - Frequency of maintenance		Recommendation:	
Further Information:								No recommendation required

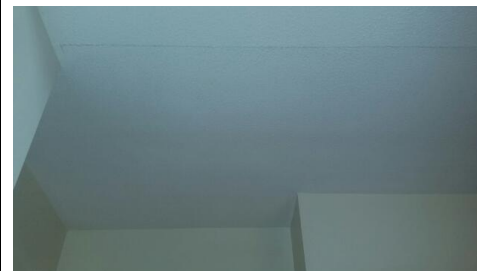
Surveyor		Steven Walker		Room/Area		005 - Landing & Stairs

Survey Date		20 December 2016		Level of Identification		Sampled			
				Sample No		0003			
Building		25 SINCLAIR PLACE		Item		Textured Coating To Concrete Ceiling			
Floor		1		Amount					
A - Product Type:		B - Extent of Damage:		C - Surface Treatment		D - Asbestos Type		Material Ass (M.A) (A+B+C+D):	
Textured Coating						No Asbestos Detected		0	
1 = Normal Occupant Activity = (E)				E - Main type of activity		Total Priority Score (P.A.) = (1+2+3+4):		Total Risk Ass' Score (P.A. + M.A)	
2 = Disturbance = (F+G+H)/3				F - Location		G - Accessibility		H - Extent	
3 = Exposure potential = (I+J+K)/3				I - Number of occupants		J - Frequency of use		K - Average time in use	
4 = Maintenance activity = (L+M)/2				L - Type of maintenance		M - Frequency of maintenance		Recommendation:	
Further Information:								No recommendation required

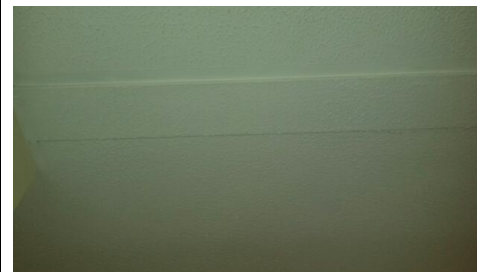
Surveyor		Steven Walker		Room/Area		008 - Landing & Stairs

Survey Date		20 December 2016		Level of Identification		Sampled			
				Sample No		0004			
Building		25 SINCLAIR PLACE		Item		Textured Coating To Concrete Ceiling			
Floor		2		Amount					
A - Product Type:		B - Extent of Damage:		C - Surface Treatment		D - Asbestos Type		Material Ass (M.A) (A+B+C+D):	
Textured Coating						No Asbestos Detected		0	
1 = Normal Occupant Activity = (E)				E - Main type of activity		Total Priority Score (P.A.) = (1+2+3+4):		Total Risk Ass' Score (P.A. + M.A)	
2 = Disturbance = (F+G+H)/3				F - Location		G - Accessibility		H - Extent	
3 = Exposure potential = (I+J+K)/3				I - Number of occupants		J - Frequency of use		K - Average time in use	
4 = Maintenance activity = (L+M)/2				L - Type of maintenance		M - Frequency of maintenance		Recommendation:	
Further Information:								No recommendation required

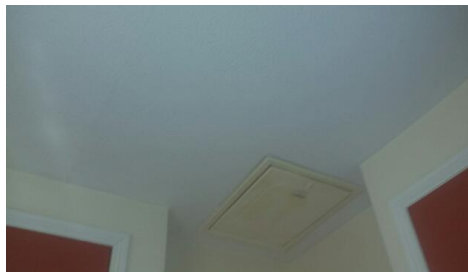
Surveyor		Steven Walker		Room/Area		011 - Landing

Survey Date		20 December 2016		Level of Identification		Sampled			
				Sample No		0005			
Building		25 SINCLAIR PLACE		Item		Textured Coating To Plasterboard Ceiling			
Floor		3		Amount					
A - Product Type:		B - Extent of Damage:		C - Surface Treatment		D - Asbestos Type		Material Ass (M.A) (A+B+C+D):	
Textured Coating						No Asbestos Detected		0	
1 = Normal Occupant Activity = (E)				E - Main type of activity		Total Priority Score (P.A.) = (1+2+3+4):		Total Risk Ass' Score (P.A. + M.A)	
2 = Disturbance = (F+G+H)/3				F - Location		G - Accessibility		H - Extent	
3 = Exposure potential = (I+J+K)/3				I - Number of occupants		J - Frequency of use		K - Average time in use	
4 = Maintenance activity = (L+M)/2				L - Type of maintenance		M - Frequency of maintenance		Recommendation:	
Further Information:								No recommendation required

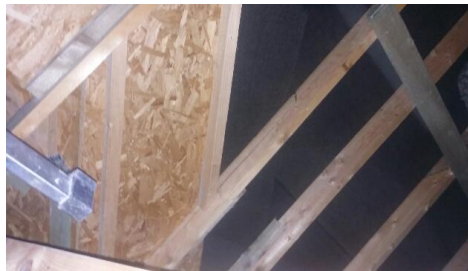
Surveyor		Steven Walker		Room/Area		014 - Loft Above Landing

Survey Date		20 December 2016		Level of Identification		Sampled			
				Sample No		0006			
Building		25 SINCLAIR PLACE		Item		Roof Felt			
Floor		4		Amount					
A - Product Type:		B - Extent of Damage:		C - Surface Treatment		D - Asbestos Type		Material Ass (M.A) (A+B+C+D):	
Bitumen Products						No Asbestos Detected		0	
1 = Normal Occupant Activity = (E)				E - Main type of activity		Total Priority Score (P.A.) = (1+2+3+4):		Total Risk Ass' Score (P.A. + M.A)	
2 = Disturbance = (F+G+H)/3				F - Location		G - Accessibility		H - Extent	
3 = Exposure potential = (I+J+K)/3				I - Number of occupants		J - Frequency of use		K - Average time in use	
4 = Maintenance activity = (L+M)/2				L - Type of maintenance		M - Frequency of maintenance		Recommendation:	
Further Information:								No recommendation required

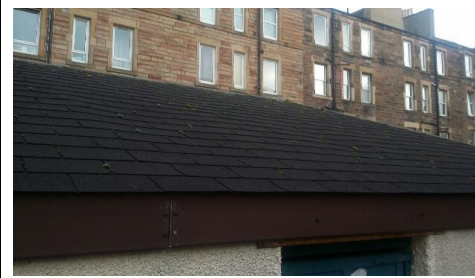
Surveyor		Steven Walker		Room/Area		016 - Cycle Shed 3

Survey Date		20 December 2016		Level of Identification		Sampled			
				Sample No		0007			
Building		25 SINCLAIR PLACE		Item		Roof Felt			
Floor		External		Amount					
A - Product Type:		B - Extent of Damage:		C - Surface Treatment		D - Asbestos Type		Material Ass (M.A) (A+B+C+D):	
Bitumen Products						No Asbestos Detected		0	
1 = Normal Occupant Activity = (E)				E - Main type of activity		Total Priority Score (P.A.) = (1+2+3+4):		Total Risk Ass' Score (P.A. + M.A)	
2 = Disturbance = (F+G+H)/3				F - Location		G - Accessibility		H - Extent	
3 = Exposure potential = (I+J+K)/3				I - Number of occupants		J - Frequency of use		K - Average time in use	
4 = Maintenance activity = (L+M)/2				L - Type of maintenance		M - Frequency of maintenance		Recommendation:	
Further Information:								No recommendation required
