Asbestos Survey Report

Management Survey (With Priority Assessments)

**26 SINCLAIR PLACE
EDINBURGH
EH11 1AN**

Project Number: S-61250
Issue Date: 11th January 2017
Issue No: 1

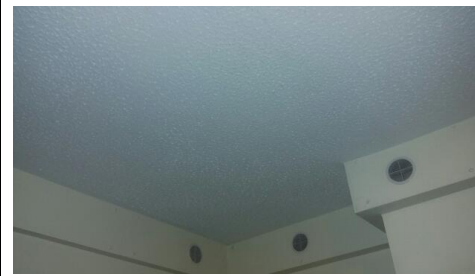
Surveyor		Steven Walker		Room/Area		001 - Ground Floor & Stairs

Survey Date		20 December 2016		Level of Identification		Sampled			
				Sample No		0001			
Building		26 SINCLAIR PLACE		Item		Textured Coating To Concrete Ceiling			
Floor		0		Amount					
A - Product Type:		B - Extent of Damage:		C - Surface Treatment		D - Asbestos Type		Material Ass (M.A) (A+B+C+D):	
Textured Coating						No Asbestos Detected		0	
1 = Normal Occupant Activity = (E)				E - Main type of activity		Total Priority Score (P.A.) = (1+2+3+4):		Total Risk Ass' Score (P.A. + M.A)	
2 = Disturbance = (F+G+H)/3				F - Location		G - Accessibility		H - Extent	
3 = Exposure potential = (I+J+K)/3				I - Number of occupants		J - Frequency of use		K - Average time in use	
4 = Maintenance activity = (L+M)/2				L - Type of maintenance		M - Frequency of maintenance		Recommendation:	
Further Information:								No recommendation required

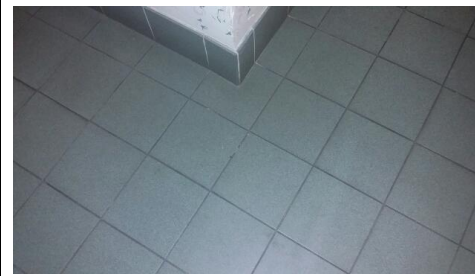
Surveyor		Steven Walker		Room/Area		001 - Ground Floor & Stairs

Survey Date		20 December 2016		Level of Identification		Sampled			
				Sample No		0002			
Building		26 SINCLAIR PLACE		Item		Ceramic Tile Adhesive To Concrete Floor			
Floor		0		Amount					
A - Product Type:		B - Extent of Damage:		C - Surface Treatment		D - Asbestos Type		Material Ass (M.A) (A+B+C+D):	
Reinforced Composites						No Asbestos Detected		0	
1 = Normal Occupant Activity = (E)				E - Main type of activity		Total Priority Score (P.A.) = (1+2+3+4):		Total Risk Ass' Score (P.A. + M.A)	
2 = Disturbance = (F+G+H)/3				F - Location		G - Accessibility		H - Extent	
3 = Exposure potential = (I+J+K)/3				I - Number of occupants		J - Frequency of use		K - Average time in use	
4 = Maintenance activity = (L+M)/2				L - Type of maintenance		M - Frequency of maintenance		Recommendation:	
Further Information:								No recommendation required

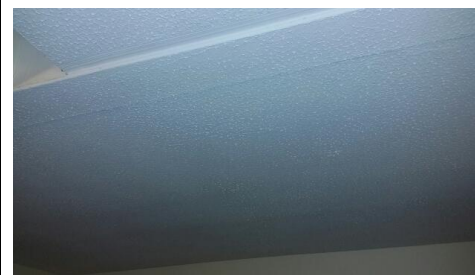
Surveyor		Steven Walker		Room/Area		005 - Landing & Stairs

Survey Date		20 December 2016		Level of Identification		Sampled			
				Sample No		0003			
Building		26 SINCLAIR PLACE		Item		Textured Coating To Concrete Ceiling			
Floor		1		Amount					
A - Product Type:		B - Extent of Damage:		C - Surface Treatment		D - Asbestos Type		Material Ass (M.A) (A+B+C+D):	
Textured Coating						No Asbestos Detected		0	
1 = Normal Occupant Activity = (E)				E - Main type of activity		Total Priority Score (P.A.) = (1+2+3+4):		Total Risk Ass' Score (P.A. + M.A)	
2 = Disturbance = (F+G+H)/3				F - Location		G - Accessibility		H - Extent	
3 = Exposure potential = (I+J+K)/3				I - Number of occupants		J - Frequency of use		K - Average time in use	
4 = Maintenance activity = (L+M)/2				L - Type of maintenance		M - Frequency of maintenance		Recommendation:	
Further Information:								No recommendation required

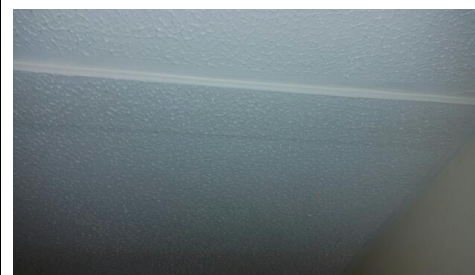
Surveyor		Steven Walker		Room/Area		008 - Landing & Stairs

Survey Date		20 December 2016		Level of Identification		Sampled			
				Sample No		0004			
Building		26 SINCLAIR PLACE		Item		Textured Coating To Concrete Ceiling			
Floor		2		Amount					
A - Product Type:		B - Extent of Damage:		C - Surface Treatment		D - Asbestos Type		Material Ass (M.A) (A+B+C+D):	
Textured Coating						No Asbestos Detected		0	
1 = Normal Occupant Activity = (E)				E - Main type of activity		Total Priority Score (P.A.) = (1+2+3+4):		Total Risk Ass' Score (P.A. + M.A)	
2 = Disturbance = (F+G+H)/3				F - Location		G - Accessibility		H - Extent	
3 = Exposure potential = (I+J+K)/3				I - Number of occupants		J - Frequency of use		K - Average time in use	
4 = Maintenance activity = (L+M)/2				L - Type of maintenance		M - Frequency of maintenance		Recommendation:	
Further Information:								No recommendation required

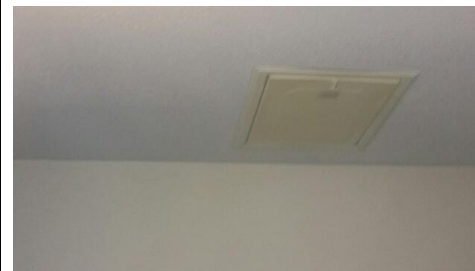
Surveyor		Steven Walker		Room/Area		011 - Landing

Survey Date		20 December 2016		Level of Identification		Sampled			
				Sample No		0005			
Building		26 SINCLAIR PLACE		Item		Textured Coating To Plasterboard Ceiling			
Floor		3		Amount					
A - Product Type:		B - Extent of Damage:		C - Surface Treatment		D - Asbestos Type		Material Ass (M.A) (A+B+C+D):	
Textured Coating						No Asbestos Detected		0	
1 = Normal Occupant Activity = (E)				E - Main type of activity		Total Priority Score (P.A.) = (1+2+3+4):		Total Risk Ass' Score (P.A. + M.A)	
2 = Disturbance = (F+G+H)/3				F - Location		G - Accessibility		H - Extent	
3 = Exposure potential = (I+J+K)/3				I - Number of occupants		J - Frequency of use		K - Average time in use	
4 = Maintenance activity = (L+M)/2				L - Type of maintenance		M - Frequency of maintenance		Recommendation:	
Further Information:								No recommendation required

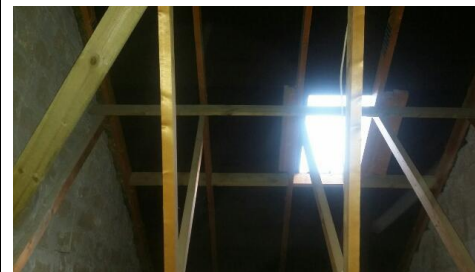
Surveyor		Steven Walker		Room/Area		014 - Loft Above Landing

Survey Date		20 December 2016		Level of Identification		Sampled			
				Sample No		0006			
Building		26 SINCLAIR PLACE		Item		Roof Felt			
Floor		4		Amount					
A - Product Type:		B - Extent of Damage:		C - Surface Treatment		D - Asbestos Type		Material Ass (M.A) (A+B+C+D):	
Bitumen Products						No Asbestos Detected		0	
1 = Normal Occupant Activity = (E)				E - Main type of activity		Total Priority Score (P.A.) = (1+2+3+4):		Total Risk Ass' Score (P.A. + M.A)	
2 = Disturbance = (F+G+H)/3				F - Location		G - Accessibility		H - Extent	
3 = Exposure potential = (I+J+K)/3				I - Number of occupants		J - Frequency of use		K - Average time in use	
4 = Maintenance activity = (L+M)/2				L - Type of maintenance		M - Frequency of maintenance		Recommendation:	
Further Information:								No recommendation required
