Asbestos Survey Report

Management Survey (With Priority Assessments)

**27 SINCLAIR PLACE
EDINBURGH
EH11 1AN**

Project Number: S-61251
Issue Date: 11th January 2017
Issue No: 1

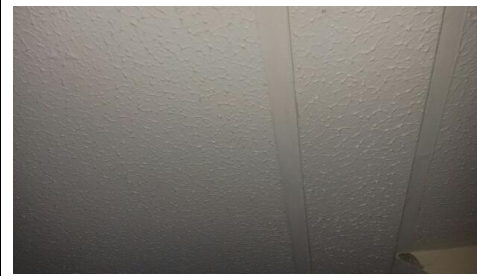
Surveyor		Steven Walker		Room/Area		001 - Ground Floor Entrance & Stairs

Survey Date		20 December 2016		Level of Identification		Sampled			
				Sample No		0001			
Building		27 SINCLAIR PLACE		Item		Textured Coating To Concrete Ceiling			
Floor		0		Amount					
A - Product Type:		B - Extent of Damage:		C - Surface Treatment		D - Asbestos Type		Material Ass (M.A) (A+B+C+D):	
Textured Coating						No Asbestos Detected		0	
1 = Normal Occupant Activity = (E)		1		E - Main type of activity		1		Total Priority Score (P.A.) = (1+2+3+4):	
2 = Disturbance = (F+G+H)/3		0		F - Location				Total Risk Ass' Score (P.A. + M.A)	
3 = Exposure potential = (I+J+K)/3		0		I - Number of occupants				H - Extent	
4 = Maintenance activity = (L+M)/2		0		L - Type of maintenance				J - Frequency of use	
								K - Average time in use	
								Recommendation:	
								No recommendation required	
Further Information:

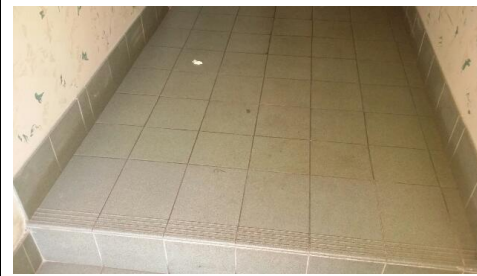
Surveyor		Steven Walker		Room/Area		001 - Ground Floor Entrance & Stairs

Survey Date		20 December 2016		Level of Identification		Sampled			
				Sample No		0002			
Building		27 SINCLAIR PLACE		Item		Ceramic Tile Adhesive To Concrete Floor			
Floor		0		Amount					
A - Product Type:		B - Extent of Damage:		C - Surface Treatment		D - Asbestos Type		Material Ass (M.A) (A+B+C+D):	
Reinforced Composites						No Asbestos Detected		0	
1 = Normal Occupant Activity = (E)		1		E - Main type of activity		1		Total Priority Score (P.A.) = (1+2+3+4):	
2 = Disturbance = (F+G+H)/3		0		F - Location				Total Risk Ass' Score (P.A. + M.A)	
3 = Exposure potential = (I+J+K)/3		0		I - Number of occupants				H - Extent	
4 = Maintenance activity = (L+M)/2		0		L - Type of maintenance				J - Frequency of use	
								K - Average time in use	
								Recommendation:	
								No recommendation required	
Further Information:

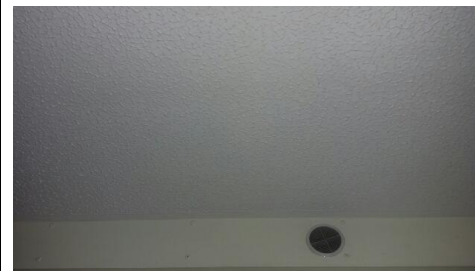
Surveyor		Steven Walker		Room/Area		004 - Ground Floor Vestibule

Survey Date		20 December 2016		Level of Identification		Sampled			
				Sample No		0003			
Building		27 SINCLAIR PLACE		Item		Textured Coating To Concrete Ceiling			
Floor		0		Amount					
A - Product Type:		B - Extent of Damage:		C - Surface Treatment		D - Asbestos Type		Material Ass (M.A) (A+B+C+D):	
Textured Coating						No Asbestos Detected		0	
1 = Normal Occupant Activity = (E)		1		E - Main type of activity		1		Total Priority Score (P.A.) = (1+2+3+4):	
2 = Disturbance = (F+G+H)/3		0		F - Location				Total Risk Ass' Score (P.A. + M.A)	
3 = Exposure potential = (I+J+K)/3		0		I - Number of occupants				H - Extent	
4 = Maintenance activity = (L+M)/2		0		L - Type of maintenance				J - Frequency of use	
								K - Average time in use	
								Recommendation:	
								No recommendation required	
Further Information:

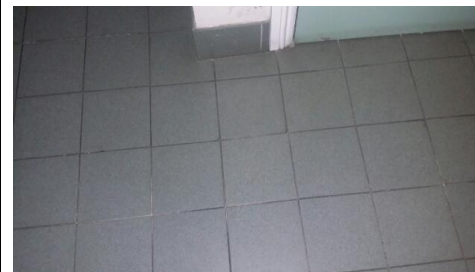
Surveyor		Steven Walker		Room/Area		004 - Ground Floor Vestibule

Survey Date		20 December 2016		Level of Identification		Strong Presumed (X)			
				Sample No		As 0002			
Building		27 SINCLAIR PLACE		Item		Ceramic Tile Adhesive To Concrete Floor			
Floor		0		Amount					
A - Product Type:		B - Extent of Damage:		C - Surface Treatment		D - Asbestos Type		Material Ass (M.A) (A+B+C+D):	
Reinforced Composites						No Asbestos Detected		0	
1 = Normal Occupant Activity = (E)		1		E - Main type of activity		1		Total Priority Score (P.A.) = (1+2+3+4):	
2 = Disturbance = (F+G+H)/3		0		F - Location				Total Risk Ass' Score (P.A. + M.A)	
3 = Exposure potential = (I+J+K)/3		0		I - Number of occupants				H - Extent	
4 = Maintenance activity = (L+M)/2		0		L - Type of maintenance				J - Frequency of use	
								K - Average time in use	
								Recommendation:	
								No recommendation required	
Further Information: Visually consistent with sample number 0002.

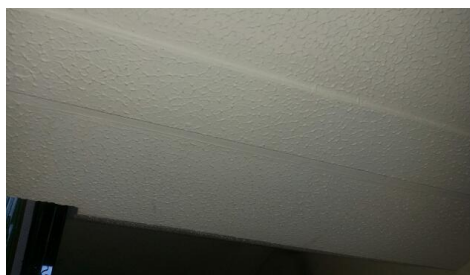
Surveyor		Steven Walker		Room/Area		007 - Landing & Stairs

Survey Date		20 December 2016		Level of Identification		Sampled			
				Sample No		0004			
Building		27 SINCLAIR PLACE		Item		Textured Coating To Concrete Ceiling			
Floor		1		Amount					
A - Product Type:		B - Extent of Damage:		C - Surface Treatment		D - Asbestos Type		Material Ass (M.A) (A+B+C+D):	
Textured Coating						No Asbestos Detected		0	
1 = Normal Occupant Activity = (E)		1		E - Main type of activity		1		Total Priority Score (P.A.) = (1+2+3+4):	
2 = Disturbance = (F+G+H)/3		0		F - Location				Total Risk Ass' Score (P.A. + M.A)	
3 = Exposure potential = (I+J+K)/3		0		I - Number of occupants				H - Extent	
4 = Maintenance activity = (L+M)/2		0		L - Type of maintenance				J - Frequency of use	
								K - Average time in use	
								Recommendation:	
								No recommendation required	
Further Information:

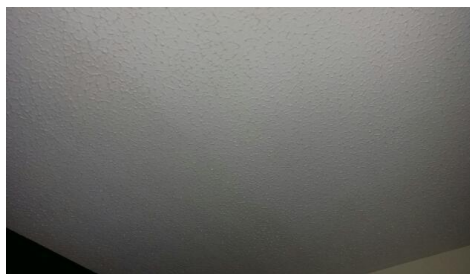
Surveyor		Steven Walker		Room/Area		009 - Landing Vestibule

Survey Date		20 December 2016		Level of Identification		Sampled			
				Sample No		0005			
Building		27 SINCLAIR PLACE		Item		Textured Coating To Concrete Ceiling			
Floor		1		Amount					
A - Product Type:		B - Extent of Damage:		C - Surface Treatment		D - Asbestos Type		Material Ass (M.A) (A+B+C+D):	
Textured Coating						No Asbestos Detected		0	
1 = Normal Occupant Activity = (E)		1		E - Main type of activity		1		Total Priority Score (P.A.) = (1+2+3+4):	
2 = Disturbance = (F+G+H)/3		0		F - Location				Total Risk Ass' Score (P.A. + M.A)	
3 = Exposure potential = (I+J+K)/3		0		I - Number of occupants				H - Extent	
4 = Maintenance activity = (L+M)/2		0		L - Type of maintenance				J - Frequency of use	
								K - Average time in use	
								Recommendation:	
								No recommendation required	
Further Information:

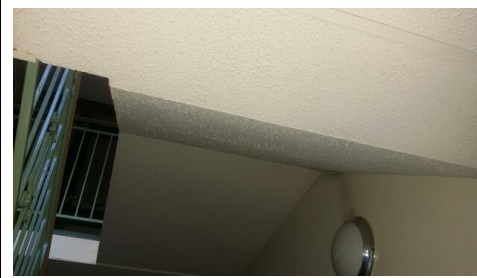
Surveyor		Steven Walker		Room/Area		012 - Landing & Stairs

Survey Date		20 December 2016		Level of Identification		Sampled			
				Sample No		0006			
Building		27 SINCLAIR PLACE		Item		Textured Coating To Concrete Ceiling			
Floor		2		Amount					
A - Product Type:		B - Extent of Damage:		C - Surface Treatment		D - Asbestos Type		Material Ass (M.A) (A+B+C+D):	
Textured Coating						No Asbestos Detected		0	
1 = Normal Occupant Activity = (E)		1		E - Main type of activity		1		Total Priority Score (P.A.) = (1+2+3+4):	
2 = Disturbance = (F+G+H)/3		0		F - Location				Total Risk Ass' Score (P.A. + M.A)	
3 = Exposure potential = (I+J+K)/3		0		I - Number of occupants				H - Extent	
4 = Maintenance activity = (L+M)/2		0		L - Type of maintenance				J - Frequency of use	
								K - Average time in use	
								Recommendation:	
								No recommendation required	
Further Information:

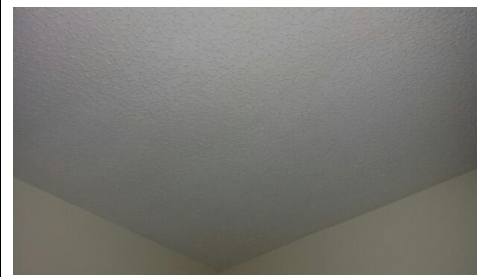
Surveyor		Steven Walker		Room/Area		014 - Landing Vestibule

Survey Date		20 December 2016		Level of Identification		Sampled			
				Sample No		0007			
Building		27 SINCLAIR PLACE		Item		Textured Coating To Concrete Ceiling			
Floor		2		Amount					
A - Product Type:		B - Extent of Damage:		C - Surface Treatment		D - Asbestos Type		Material Ass (M.A) (A+B+C+D):	
Textured Coating						No Asbestos Detected		0	
1 = Normal Occupant Activity = (E)		1		E - Main type of activity		1		Total Priority Score (P.A.) = (1+2+3+4):	
2 = Disturbance = (F+G+H)/3		0		F - Location				Total Risk Ass' Score (P.A. + M.A)	
3 = Exposure potential = (I+J+K)/3		0		I - Number of occupants				H - Extent	
4 = Maintenance activity = (L+M)/2		0		L - Type of maintenance				J - Frequency of use	
								K - Average time in use	
								Recommendation:	
								No recommendation required	
Further Information:

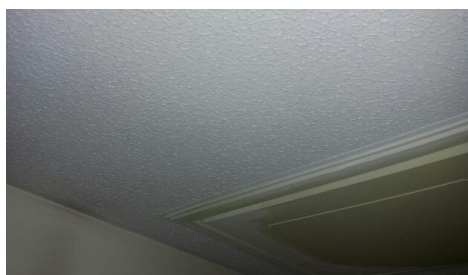
Surveyor		Steven Walker		Room/Area		019 - Landing Vestibule

Survey Date		20 December 2016		Level of Identification		Sampled											
				Sample No		0009											
Building		27 SINCLAIR PLACE		Item		Textured Coating To Plasterboard Ceiling											
Floor		3		Amount													
A - Product Type:		B - Extent of Damage:		C - Surface Treatment		D - Asbestos Type		Material Ass (M.A) (A+B+C+D):									
Textured Coating						No Asbestos Detected		0		0							
1 = Normal Occupant Activity = (E)		1		E - Main type of activity		1		Total Priority Score (P.A.) = (1+2+3+4):		1		Total Risk Ass' Score (P.A. + M.A)		1		Risk Coding	
2 = Disturbance = (F+G+H)/3		0		F - Location				G - Accessibility				H - Extent					
3 = Exposure potential = (I+J+K)/3		0		I - Number of occupants				J - Frequency of use				K - Average time in use					
4 = Maintenance activity = (L+M)/2		0		L - Type of maintenance				M - Frequency of maintenance				Recommendation: No recommendation required

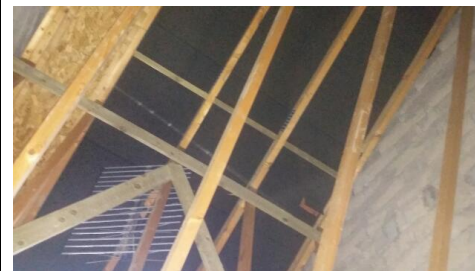
Surveyor		Steven Walker		Room/Area		022 - Loft Above Landing

Survey Date		20 December 2016		Level of Identification		Sampled			
				Sample No		0010			
Building		27 SINCLAIR PLACE		Item		Roof Felt			
Floor		4		Amount					
A - Product Type:		B - Extent of Damage:		C - Surface Treatment		D - Asbestos Type		Material Ass (M.A) (A+B+C+D):	
Bitumen Products						No Asbestos Detected		0	
1 = Normal Occupant Activity = (E)		0		E - Main type of activity		0		Total Priority Score (P.A.) = (1+2+3+4):	
2 = Disturbance = (F+G+H)/3		0		F - Location				G - Accessibility	
3 = Exposure potential = (I+J+K)/3		0		I - Number of occupants				J - Frequency of use	
4 = Maintenance activity = (L+M)/2		0		L - Type of maintenance				M - Frequency of maintenance	
Further Information:								Total Risk Ass' Score (P.A. + M.A)	
								0	
								Risk Coding	
								Recommendation:	
								No recommendation required
