Asbestos Survey Report

Management Survey (With Priority Assessments)

**28 SINCLAIR PLACE
EDINBURGH
EH11 1AN**

Project Number: S-61252
Issue Date: 11th January 2017
Issue No: 1

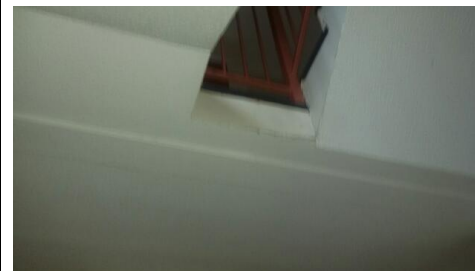
Surveyor		Steven Walker		Room/Area		001 - Ground Floor & Stairs

Survey Date		20 December 2016		Level of Identification		Sampled			
				Sample No		0001			
Building		28 SINCLAIR PLACE		Item		Textured Coating To Concrete Ceiling			
Floor		0		Amount					
A - Product Type:		B - Extent of Damage:		C - Surface Treatment		D - Asbestos Type		Material Ass (M.A) (A+B+C+D):	
Textured Coating						No Asbestos Detected		0	
1 = Normal Occupant Activity = (E)				E - Main type of activity		Total Priority Score (P.A.) = (1+2+3+4):		Total Risk Ass' Score (P.A. + M.A)	
2 = Disturbance = (F+G+H)/3				F - Location		G - Accessibility		H - Extent	
3 = Exposure potential = (I+J+K)/3				I - Number of occupants		J - Frequency of use		K - Average time in use	
4 = Maintenance activity = (L+M)/2				L - Type of maintenance		M - Frequency of maintenance		Recommendation:	
Further Information:								No recommendation required

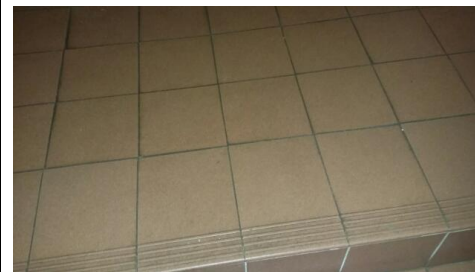
Surveyor		Steven Walker		Room/Area		001 - Ground Floor & Stairs

Survey Date		20 December 2016		Level of Identification		Sampled			
				Sample No		0002			
Building		28 SINCLAIR PLACE		Item		Ceramic Tile Adhesive To Concrete Floor			
Floor		0		Amount					
A - Product Type:		B - Extent of Damage:		C - Surface Treatment		D - Asbestos Type		Material Ass (M.A) (A+B+C+D):	
Reinforced Composites						No Asbestos Detected		0	
1 = Normal Occupant Activity = (E)				E - Main type of activity		Total Priority Score (P.A.) = (1+2+3+4):		Total Risk Ass' Score (P.A. + M.A)	
2 = Disturbance = (F+G+H)/3				F - Location		G - Accessibility		H - Extent	
3 = Exposure potential = (I+J+K)/3				I - Number of occupants		J - Frequency of use		K - Average time in use	
4 = Maintenance activity = (L+M)/2				L - Type of maintenance		M - Frequency of maintenance		Recommendation:	
Further Information:								No recommendation required

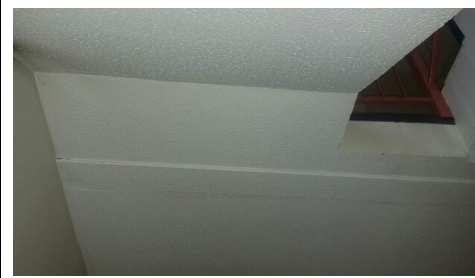
Surveyor		Steven Walker		Room/Area		005 - Landing & Stairs

Survey Date		20 December 2016		Level of Identification		Sampled			
				Sample No		0003			
Building		28 SINCLAIR PLACE		Item		Textured Coating To Concrete Ceiling			
Floor		1		Amount					
A - Product Type:		B - Extent of Damage:		C - Surface Treatment		D - Asbestos Type		Material Ass (M.A) (A+B+C+D):	
Textured Coating						No Asbestos Detected		0	
1 = Normal Occupant Activity = (E)				E - Main type of activity		Total Priority Score (P.A.) = (1+2+3+4):		Total Risk Ass' Score (P.A. + M.A)	
2 = Disturbance = (F+G+H)/3				F - Location		G - Accessibility		H - Extent	
3 = Exposure potential = (I+J+K)/3				I - Number of occupants		J - Frequency of use		K - Average time in use	
4 = Maintenance activity = (L+M)/2				L - Type of maintenance		M - Frequency of maintenance		Recommendation:	
Further Information:								No recommendation required

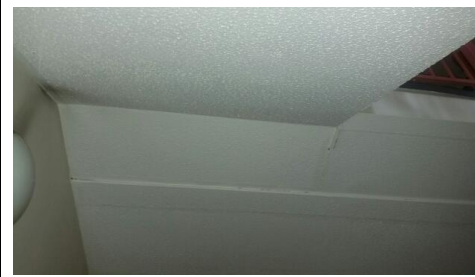
Surveyor		Steven Walker		Room/Area		008 - Landing & Stairs

Survey Date		20 December 2016		Level of Identification		Sampled			
				Sample No		0004			
Building		28 SINCLAIR PLACE		Item		Textured Coating To Concrete Ceiling			
Floor		2		Amount					
A - Product Type:		B - Extent of Damage:		C - Surface Treatment		D - Asbestos Type		Material Ass (M.A) (A+B+C+D):	
Textured Coating						No Asbestos Detected		0	
1 = Normal Occupant Activity = (E)				E - Main type of activity		Total Priority Score (P.A.) = (1+2+3+4):		Total Risk Ass' Score (P.A. + M.A)	
2 = Disturbance = (F+G+H)/3				F - Location		G - Accessibility		H - Extent	
3 = Exposure potential = (I+J+K)/3				I - Number of occupants		J - Frequency of use		K - Average time in use	
4 = Maintenance activity = (L+M)/2				L - Type of maintenance		M - Frequency of maintenance		Recommendation:	
Further Information:								No recommendation required

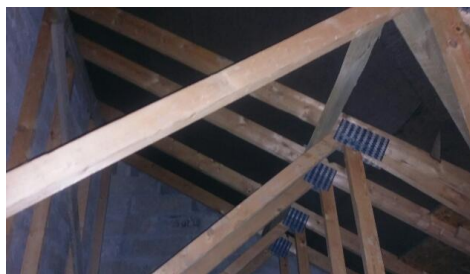
Surveyor		Steven Walker		Room/Area		014 - Loft Above Landing

Survey Date		20 December 2016		Level of Identification		Sampled			
				Sample No		0006			
Building		28 SINCLAIR PLACE		Item		Roof Felt			
Floor		4		Amount					
A - Product Type:		B - Extent of Damage:		C - Surface Treatment		D - Asbestos Type		Material Ass (M.A) (A+B+C+D):	
Bitumen Products						No Asbestos Detected		0	
1 = Normal Occupant Activity = (E)				E - Main type of activity		Total Priority Score (P.A.) = (1+2+3+4):		Total Risk Ass' Score (P.A. + M.A)	
2 = Disturbance = (F+G+H)/3				F - Location		G - Accessibility		H - Extent	
3 = Exposure potential = (I+J+K)/3				I - Number of occupants		J - Frequency of use		K - Average time in use	
4 = Maintenance activity = (L+M)/2				L - Type of maintenance		M - Frequency of maintenance		Recommendation:	
Further Information:								No recommendation required
