Asbestos Survey Report

Management Survey (With Priority Assessments)

28 SINCLAIR PLACE
EDINBURGH
EH11 1AN

Project Number: S-61252
Issue Date: 11th January 2017
Issue No: 1

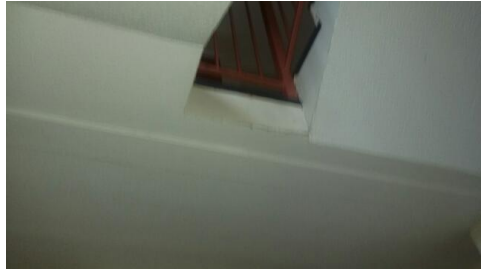
Surveyor		Steven Walker		Room/Area		001 - Ground Floor & Stairs

Survey Date		20 December 2016		Level of Identification		Sampled			
				Sample No		0001			
Building		28 SINCLAIR PLACE		Item		Textured Coating To Concrete Ceiling			
Floor		0		Amount					
A - Product Type:		B - Extent of Damage:		C - Surface Treatment		D - Asbestos Type		Material Ass (M.A) (A+B+C+D):	
Textured Coating						No Asbestos Detected		0	
1 = Normal Occupant Activity = (E)		E - Main type of activity		Total Priority Score (P.A.) = (1+2+3+4):		Total Risk Ass' Score (P.A. + M.A)		0	
2 = Disturbance = (F+G+H)/3		F - Location		G - Accessibility		H - Extent		Risk Coding	
3 = Exposure potential = (I+J+K)/3		I - Number of occupants		J - Frequency of use		K - Average time in use			
4 = Maintenance activity = (L+M)/2		L - Type of maintenance		M - Frequency of maintenance		Recommendation:		No recommendation required	
Further Information:

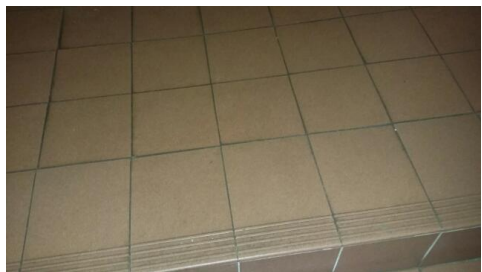
Surveyor		Steven Walker		Room/Area		001 - Ground Floor & Stairs

Survey Date		20 December 2016		Level of Identification		Sampled			
				Sample No		0002			
Building		28 SINCLAIR PLACE		Item		Ceramic Tile Adhesive To Concrete Floor			
Floor		0		Amount					
A - Product Type:		B - Extent of Damage:		C - Surface Treatment		D - Asbestos Type		Material Ass (M.A) (A+B+C+D):	
Reinforced Composites						No Asbestos Detected		0	
1 = Normal Occupant Activity = (E)		E - Main type of activity		Total Priority Score (P.A.) = (1+2+3+4):		Total Risk Ass' Score (P.A. + M.A)		0	
2 = Disturbance = (F+G+H)/3		F - Location		G - Accessibility		H - Extent		Risk Coding	
3 = Exposure potential = (I+J+K)/3		I - Number of occupants		J - Frequency of use		K - Average time in use			
4 = Maintenance activity = (L+M)/2		L - Type of maintenance		M - Frequency of maintenance		Recommendation:		No recommendation required	
Further Information:

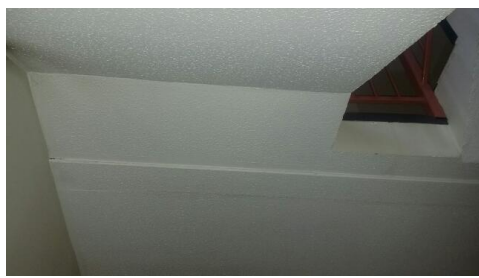
Surveyor		Steven Walker		Room/Area		005 - Landing & Stairs

Survey Date		20 December 2016		Level of Identification		Sampled			
				Sample No		0003			
Building		28 SINCLAIR PLACE		Item		Textured Coating To Concrete Ceiling			
Floor		1		Amount					
A - Product Type:		B - Extent of Damage:		C - Surface Treatment		D - Asbestos Type		Material Ass (M.A) (A+B+C+D):	
Textured Coating						No Asbestos Detected		0	
1 = Normal Occupant Activity = (E)		E - Main type of activity		Total Priority Score (P.A.) = (1+2+3+4):		Total Risk Ass' Score (P.A. + M.A)		0	
2 = Disturbance = (F+G+H)/3		F - Location		G - Accessibility		H - Extent		Risk Coding	
3 = Exposure potential = (I+J+K)/3		I - Number of occupants		J - Frequency of use		K - Average time in use			
4 = Maintenance activity = (L+M)/2		L - Type of maintenance		M - Frequency of maintenance		Recommendation:		No recommendation required	
Further Information:

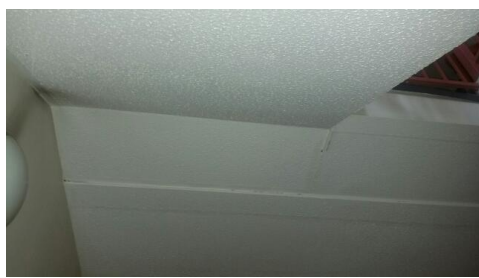
Surveyor		Steven Walker		Room/Area		008 - Landing & Stairs

Survey Date		20 December 2016		Level of Identification		Sampled			
				Sample No		0004			
Building		28 SINCLAIR PLACE		Item		Textured Coating To Concrete Ceiling			
Floor		2		Amount					
A - Product Type:		B - Extent of Damage:		C - Surface Treatment		D - Asbestos Type		Material Ass (M.A) (A+B+C+D):	
Textured Coating						No Asbestos Detected		0	
1 = Normal Occupant Activity = (E)		E - Main type of activity		Total Priority Score (P.A.) = (1+2+3+4):		Total Risk Ass' Score (P.A. + M.A)		0	
2 = Disturbance = (F+G+H)/3		F - Location		G - Accessibility		H - Extent		Risk Coding	
3 = Exposure potential = (I+J+K)/3		I - Number of occupants		J - Frequency of use		K - Average time in use			
4 = Maintenance activity = (L+M)/2		L - Type of maintenance		M - Frequency of maintenance		Recommendation:		No recommendation required	
Further Information:

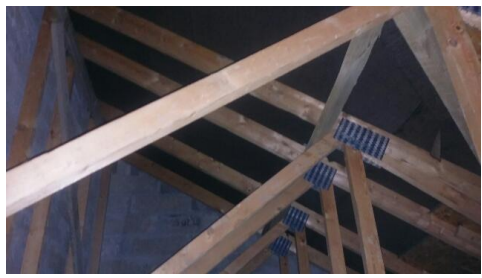
Surveyor		Steven Walker		Room/Area		014 - Loft Above Landing

Survey Date		20 December 2016		Level of Identification		Sampled			
				Sample No		0006			
Building		28 SINCLAIR PLACE		Item		Roof Felt			
Floor		4		Amount					
A - Product Type:		B - Extent of Damage:		C - Surface Treatment		D - Asbestos Type		Material Ass (M.A) (A+B+C+D):	
Bitumen Products						No Asbestos Detected		0	
1 = Normal Occupant Activity = (E)		E - Main type of activity		Total Priority Score (P.A.) = (1+2+3+4):		Total Risk Ass' Score (P.A. + M.A)		0	
2 = Disturbance = (F+G+H)/3		F - Location		G - Accessibility		H - Extent		Risk Coding	
3 = Exposure potential = (I+J+K)/3		I - Number of occupants		J - Frequency of use		K - Average time in use			
4 = Maintenance activity = (L+M)/2		L - Type of maintenance		M - Frequency of maintenance		Recommendation:		No recommendation required	
Further Information:
