# **Asbestos Survey Report**

## **Management Survey (With Priority Assessments)**

**29 SINCLAIR PLACE  
EDINBURGH  
EH11 1AN**

Project Number: S-61253  
Issue Date: 12 January 2017  
Issue No: 1

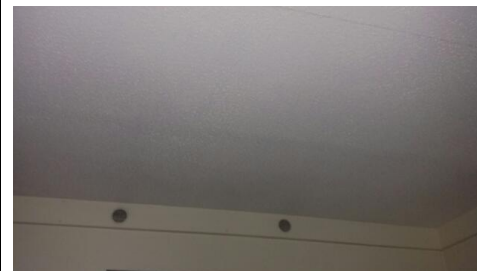
Surveyor		Steven Walker		Room/Area		001 - Ground Floor & Stairs

Survey Date		23 December 2016		Level of Identification		Sampled			
				Sample No		0001			
Building		29 SINCLAIR PLACE		Item		Textured Coating To Concrete Ceiling			
Floor		0		Amount					
A - Product Type:		B - Extent of Damage:		C - Surface Treatment		D - Asbestos Type		Material Ass (M.A) (A+B+C+D):	
Textured Coating						No Asbestos Detected		0	
1 = Normal Occupant Activity = (E)				E - Main type of activity		Total Priority Score (P.A.) = (1+2+3+4):		Total Risk Ass' Score (P.A. + M.A)	
2 = Disturbance = (F+G+H)/3				F - Location		G - Accessibility		H - Extent	
3 = Exposure potential = (I+J+K)/3				I - Number of occupants		J - Frequency of use		K - Average time in use	
4 = Maintenance activity = (L+M)/2				L - Type of maintenance		M - Frequency of maintenance		Recommendation:	
Further Information:								No recommendation required

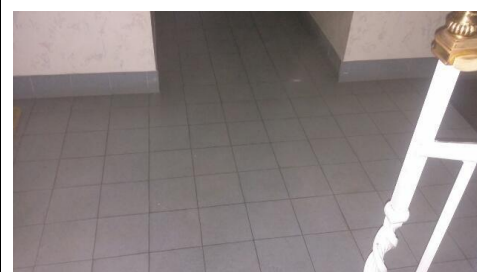
Surveyor		Steven Walker		Room/Area		001 - Ground Floor & Stairs

Survey Date		23 December 2016		Level of Identification		Sampled			
				Sample No		0002			
Building		29 SINCLAIR PLACE		Item		Ceramic Tile Adhesive To Concrete Floor			
Floor		0		Amount					
A - Product Type:		B - Extent of Damage:		C - Surface Treatment		D - Asbestos Type		Material Ass (M.A) (A+B+C+D):	
Reinforced Composites						No Asbestos Detected		0	
1 = Normal Occupant Activity = (E)				E - Main type of activity		Total Priority Score (P.A.) = (1+2+3+4):		Total Risk Ass' Score (P.A. + M.A)	
2 = Disturbance = (F+G+H)/3				F - Location		G - Accessibility		H - Extent	
3 = Exposure potential = (I+J+K)/3				I - Number of occupants		J - Frequency of use		K - Average time in use	
4 = Maintenance activity = (L+M)/2				L - Type of maintenance		M - Frequency of maintenance		Recommendation:	
Further Information:								No recommendation required

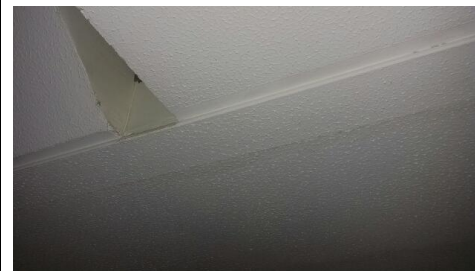
Surveyor		Steven Walker		Room/Area		005 - Landing & Stairs

Survey Date		23 December 2016		Level of Identification		Sampled			
				Sample No		0003			
Building		29 SINCLAIR PLACE		Item		Textured Coating To Concrete Ceiling			
Floor		1		Amount					
A - Product Type:		B - Extent of Damage:		C - Surface Treatment		D - Asbestos Type		Material Ass (M.A) (A+B+C+D):	
Textured Coating						No Asbestos Detected		0	
1 = Normal Occupant Activity = (E)				E - Main type of activity		Total Priority Score (P.A.) = (1+2+3+4):		Total Risk Ass' Score (P.A. + M.A)	
2 = Disturbance = (F+G+H)/3				F - Location		G - Accessibility		H - Extent	
3 = Exposure potential = (I+J+K)/3				I - Number of occupants		J - Frequency of use		K - Average time in use	
4 = Maintenance activity = (L+M)/2				L - Type of maintenance		M - Frequency of maintenance		Recommendation:	
Further Information:								No recommendation required

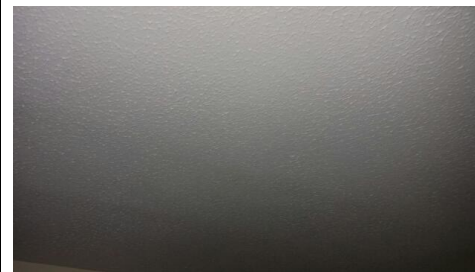
Surveyor		Steven Walker		Room/Area		008 - Landing & Stairs

Survey Date		23 December 2016		Level of Identification		Sampled			
				Sample No		0004			
Building		29 SINCLAIR PLACE		Item		Textured Coating To Concrete Ceiling			
Floor		2		Amount					
A - Product Type:		B - Extent of Damage:		C - Surface Treatment		D - Asbestos Type		Material Ass (M.A) (A+B+C+D):	
Textured Coating						No Asbestos Detected		0	
1 = Normal Occupant Activity = (E)				E - Main type of activity		Total Priority Score (P.A.) = (1+2+3+4):		Total Risk Ass' Score (P.A. + M.A)	
2 = Disturbance = (F+G+H)/3				F - Location		G - Accessibility		H - Extent	
3 = Exposure potential = (I+J+K)/3				I - Number of occupants		J - Frequency of use		K - Average time in use	
4 = Maintenance activity = (L+M)/2				L - Type of maintenance		M - Frequency of maintenance		Recommendation:	
Further Information:								No recommendation required

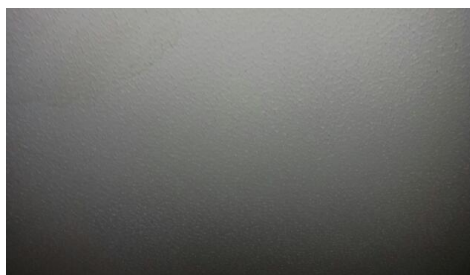
Surveyor		Steven Walker		Room/Area		011 - Landing

Survey Date		23 December 2016		Level of Identification		Sampled			
				Sample No		0005			
Building		29 SINCLAIR PLACE		Item		Textured Coating To Concrete Ceiling			
Floor		3		Amount					
A - Product Type:		B - Extent of Damage:		C - Surface Treatment		D - Asbestos Type		Material Ass (M.A) (A+B+C+D):	
Textured Coating						No Asbestos Detected		0	
1 = Normal Occupant Activity = (E)				E - Main type of activity		Total Priority Score (P.A.) = (1+2+3+4):		Total Risk Ass' Score (P.A. + M.A)	
2 = Disturbance = (F+G+H)/3				F - Location		G - Accessibility		H - Extent	
3 = Exposure potential = (I+J+K)/3				I - Number of occupants		J - Frequency of use		K - Average time in use	
4 = Maintenance activity = (L+M)/2				L - Type of maintenance		M - Frequency of maintenance		Recommendation:	
Further Information:								No recommendation required

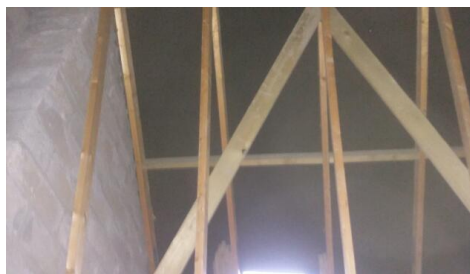
Surveyor		Steven Walker		Room/Area		014 - Loft Above Landing

Survey Date		23 December 2016		Level of Identification		Sampled			
				Sample No		0006			
Building		29 SINCLAIR PLACE		Item		Roof Felt			
Floor		4		Amount					
A - Product Type:		B - Extent of Damage:		C - Surface Treatment		D - Asbestos Type		Material Ass (M.A) (A+B+C+D):	
Bitumen Products						No Asbestos Detected		0	
1 = Normal Occupant Activity = (E)				E - Main type of activity		Total Priority Score (P.A.) = (1+2+3+4):		Total Risk Ass' Score (P.A. + M.A)	
2 = Disturbance = (F+G+H)/3				F - Location		G - Accessibility		H - Extent	
3 = Exposure potential = (I+J+K)/3				I - Number of occupants		J - Frequency of use		K - Average time in use	
4 = Maintenance activity = (L+M)/2				L - Type of maintenance		M - Frequency of maintenance		Recommendation:	
Further Information:								No recommendation required

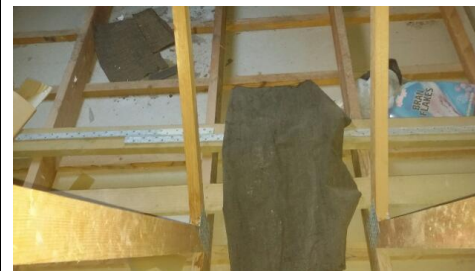
Surveyor		Steven Walker		Room/Area		014 - Loft Above Landing

Survey Date		04 January 2017		Level of Identification		Strong Presumed (X)			
				Sample No		As 0006			
Building		29 SINCLAIR PLACE		Item		Loose Lying Roof Felt			
Floor		4		Amount					
A - Product Type:		B - Extent of Damage:		C - Surface Treatment		D - Asbestos Type		Material Ass (M.A) (A+B+C+D):	
Bitumen Products						No Asbestos Detected		0	
1 = Normal Occupant Activity = (E)				E - Main type of activity		Total Priority Score (P.A.) = (1+2+3+4):		Total Risk Ass' Score (P.A. + M.A)	
2 = Disturbance = (F+G+H)/3				F - Location		G - Accessibility		H - Extent	
3 = Exposure potential = (I+J+K)/3				I - Number of occupants		J - Frequency of use		K - Average time in use	
4 = Maintenance activity = (L+M)/2				L - Type of maintenance		M - Frequency of maintenance		Recommendation:	
Further Information:		Visually consistent with sample number 0006.

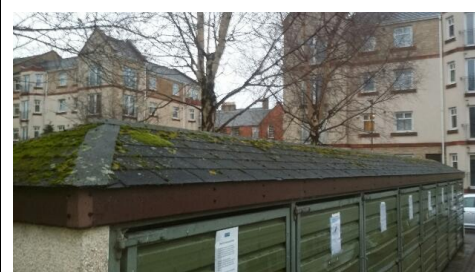
Surveyor		Steven Walker		Room/Area		016 - Bin Store 7

Survey Date		23 December 2016		Level of Identification		Sampled			
				Sample No		0007			
Building		29 SINCLAIR PLACE		Item		Roof Felt			
Floor		External		Amount					
A - Product Type:		B - Extent of Damage:		C - Surface Treatment		D - Asbestos Type		Material Ass (M.A) (A+B+C+D):	
Bitumen Products						No Asbestos Detected		0	
1 = Normal Occupant Activity = (E)				E - Main type of activity		Total Priority Score (P.A.) = (1+2+3+4):		Total Risk Ass' Score (P.A. + M.A)	
2 = Disturbance = (F+G+H)/3				F - Location		G - Accessibility		H - Extent	
3 = Exposure potential = (I+J+K)/3				I - Number of occupants		J - Frequency of use		K - Average time in use	
4 = Maintenance activity = (L+M)/2				L - Type of maintenance		M - Frequency of maintenance		Recommendation:	
Further Information:		No recommendation required
