Asbestos Survey Report

Management Survey (With Priority Assessments)

3 SINCLAIR CLOSE
EDINBURGH
EH11 1AN

Project Number: S-61349
Issue Date: 16th January 2017
Issue No: 1

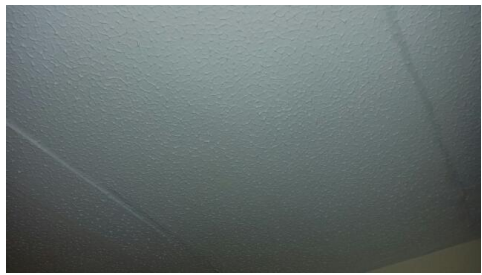
Surveyor		Steven Walker		Room/Area		001 - Ground Floor & Stairs

Survey Date		20 December 2016		Level of Identification		Sampled			
				Sample No		0001			
Building		3 SINCLAIR CLOSE		Item		Textured Coating To Concrete Ceiling			
Floor		0		Amount					
A - Product Type:		B - Extent of Damage:		C - Surface Treatment		D - Asbestos Type		Material Ass (M.A) (A+B+C+D):	
Textured Coating						No Asbestos Detected		0	
1 = Normal Occupant Activity = (E)		E - Main type of activity		Total Priority Score (P.A.) = (1+2+3+4):		Total Risk Ass' Score (P.A. + M.A)		0	
2 = Disturbance = (F+G+H)/3		F - Location		G - Accessibility		H - Extent		Risk Coding	
3 = Exposure potential = (I+J+K)/3		I - Number of occupants		J - Frequency of use		K - Average time in use			
4 = Maintenance activity = (L+M)/2		L - Type of maintenance		M - Frequency of maintenance		Recommendation:		No recommendation required	
Further Information:

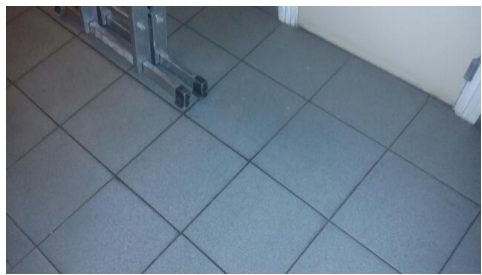
Surveyor		Steven Walker		Room/Area		001 - Ground Floor & Stairs

Survey Date		20 December 2016		Level of Identification		Sampled			
				Sample No		0002			
Building		3 SINCLAIR CLOSE		Item		Ceramic Tile Adhesive To Concrete Floor			
Floor		0		Amount					
A - Product Type:		B - Extent of Damage:		C - Surface Treatment		D - Asbestos Type		Material Ass (M.A) (A+B+C+D):	
Reinforced Composites						No Asbestos Detected		0	
1 = Normal Occupant Activity = (E)		E - Main type of activity		Total Priority Score (P.A.) = (1+2+3+4):		Total Risk Ass' Score (P.A. + M.A)		0	
2 = Disturbance = (F+G+H)/3		F - Location		G - Accessibility		H - Extent		Risk Coding	
3 = Exposure potential = (I+J+K)/3		I - Number of occupants		J - Frequency of use		K - Average time in use			
4 = Maintenance activity = (L+M)/2		L - Type of maintenance		M - Frequency of maintenance		Recommendation:		No recommendation required	
Further Information:

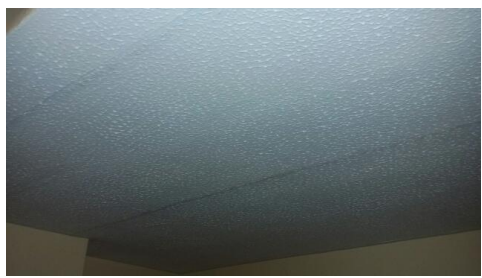
Surveyor		Steven Walker		Room/Area		005 - Landing & Stairs

Survey Date		20 December 2016		Level of Identification		Sampled			
				Sample No		0003			
Building		3 SINCLAIR CLOSE		Item		Textured Coating To Concrete Ceiling			
Floor		1		Amount					
A - Product Type:		B - Extent of Damage:		C - Surface Treatment		D - Asbestos Type		Material Ass (M.A) (A+B+C+D):	
Textured Coating						No Asbestos Detected		0	
1 = Normal Occupant Activity = (E)		E - Main type of activity		Total Priority Score (P.A.) = (1+2+3+4):		Total Risk Ass' Score (P.A. + M.A)		0	
2 = Disturbance = (F+G+H)/3		F - Location		G - Accessibility		H - Extent		Risk Coding	
3 = Exposure potential = (I+J+K)/3		I - Number of occupants		J - Frequency of use		K - Average time in use			
4 = Maintenance activity = (L+M)/2		L - Type of maintenance		M - Frequency of maintenance		Recommendation:		No recommendation required	
Further Information:

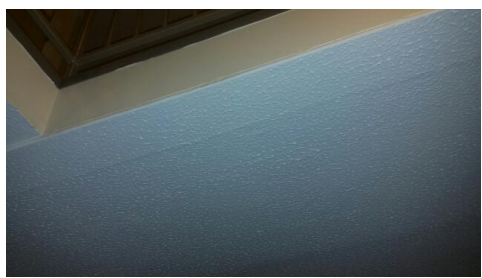
Surveyor		Steven Walker		Room/Area		008 - Landing & Stairs

Survey Date		20 December 2016		Level of Identification		Sampled			
				Sample No		0004			
Building		3 SINCLAIR CLOSE		Item		Textured Coating To Concrete Ceiling			
Floor		2		Amount					
A - Product Type:		B - Extent of Damage:		C - Surface Treatment		D - Asbestos Type		Material Ass (M.A) (A+B+C+D):	
Textured Coating						No Asbestos Detected		0	
1 = Normal Occupant Activity = (E)		E - Main type of activity		Total Priority Score (P.A.) = (1+2+3+4):		Total Risk Ass' Score (P.A. + M.A)		0	
2 = Disturbance = (F+G+H)/3		F - Location		G - Accessibility		H - Extent		Risk Coding	
3 = Exposure potential = (I+J+K)/3		I - Number of occupants		J - Frequency of use		K - Average time in use			
4 = Maintenance activity = (L+M)/2		L - Type of maintenance		M - Frequency of maintenance		Recommendation:		No recommendation required	
Further Information:

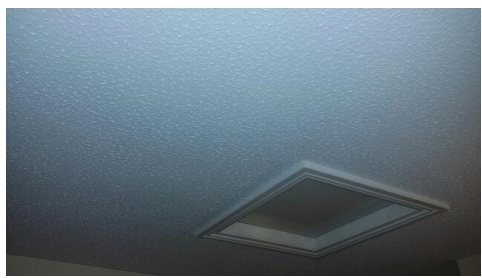
Surveyor		Steven Walker		Room/Area		011 - Landing

Survey Date		20 December 2016		Level of Identification		Sampled			
				Sample No		0005			
Building		3 SINCLAIR CLOSE		Item		Textured Coating To Plasterboard Ceiling			
Floor		3		Amount					
A - Product Type:		B - Extent of Damage:		C - Surface Treatment		D - Asbestos Type		Material Ass (M.A) (A+B+C+D):	
Textured Coating						No Asbestos Detected		0	
1 = Normal Occupant Activity = (E)		E - Main type of activity		Total Priority Score (P.A.) = (1+2+3+4):		Total Risk Ass' Score (P.A. + M.A)		0	
2 = Disturbance = (F+G+H)/3		F - Location		G - Accessibility		H - Extent		Risk Coding	
3 = Exposure potential = (I+J+K)/3		I - Number of occupants		J - Frequency of use		K - Average time in use			
4 = Maintenance activity = (L+M)/2		L - Type of maintenance		M - Frequency of maintenance		Recommendation:		No recommendation required	
Further Information:

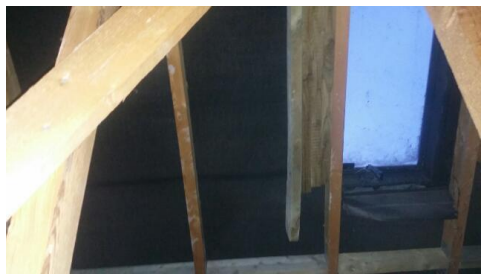
Surveyor		Steven Walker		Room/Area		014 - Loft Above Landing

Survey Date		20 December 2016		Level of Identification		Sampled			
				Sample No		0006			
Building		3 SINCLAIR CLOSE		Item		Roof Felt			
Floor		4		Amount					
A - Product Type:		B - Extent of Damage:		C - Surface Treatment		D - Asbestos Type		Material Ass (M.A) (A+B+C+D):	
Bitumen Products						No Asbestos Detected		0	
1 = Normal Occupant Activity = (E)		E - Main type of activity		Total Priority Score (P.A.) = (1+2+3+4):		Total Risk Ass' Score (P.A. + M.A)		0	
2 = Disturbance = (F+G+H)/3		F - Location		G - Accessibility		H - Extent		Risk Coding	
3 = Exposure potential = (I+J+K)/3		I - Number of occupants		J - Frequency of use		K - Average time in use			
4 = Maintenance activity = (L+M)/2		L - Type of maintenance		M - Frequency of maintenance		Recommendation:		No recommendation required	
Further Information:
