Asbestos Survey Report

Management Survey (With Priority Assessments)

**3 SINCLAIR GARDENS
EDINBURGH
EH11 1AN**

Project Number: S-61218
Issue Date: 9 January 2017
Issue No: 1

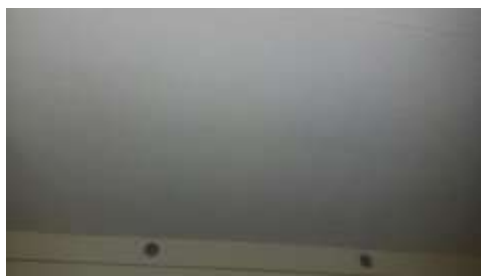
Surveyor		Steven Walker		Room/Area		001 - Ground Floor

Survey Date		19 December 2016		Level of Identification		Sampled			
				Sample No		0001			
Building		3 SINCLAIR GARDENS		Item		Textured Coating To Concrete Ceiling			
Floor		0		Amount					
A - Product Type:		B - Extent of Damage:		C - Surface Treatment		D - Asbestos Type		Material Ass (M.A) (A+B+C+D):	
Textured Coating						No Asbestos Detected		0	
1 = Normal Occupant Activity = (E)		E - Main type of activity		Total Priority Score (P.A.) = (1+2+3+4):		Total Risk Ass' Score (P.A. + M.A)		0	
2 = Disturbance = (F+G+H)/3		F - Location		G - Accessibility		H - Extent		Risk Coding	
3 = Exposure potential = (I+J+K)/3		I - Number of occupants		J - Frequency of use		K - Average time in use			
4 = Maintenance activity = (L+M)/2		L - Type of maintenance		M - Frequency of maintenance		Recommendation:		No recommendation required	
Further Information:

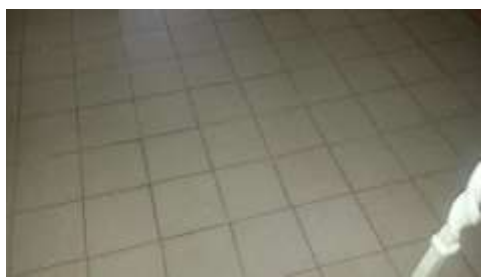
Surveyor		Steven Walker		Room/Area		001 - Ground Floor & Stairs

Survey Date		19 December 2016		Level of Identification		Sampled			
				Sample No		0002			
Building		3 SINCLAIR GARDENS		Item		Ceramic Tile Adhesive To Concrete Floor			
Floor		0		Amount					
A - Product Type:		B - Extent of Damage:		C - Surface Treatment		D - Asbestos Type		Material Ass (M.A) (A+B+C+D):	
Reinforced Composites						No Asbestos Detected		0	
1 = Normal Occupant Activity = (E)		E - Main type of activity		Total Priority Score (P.A.) = (1+2+3+4):		Total Risk Ass' Score (P.A. + M.A)		0	
2 = Disturbance = (F+G+H)/3		F - Location		G - Accessibility		H - Extent		Risk Coding	
3 = Exposure potential = (I+J+K)/3		I - Number of occupants		J - Frequency of use		K - Average time in use			
4 = Maintenance activity = (L+M)/2		L - Type of maintenance		M - Frequency of maintenance		Recommendation:		No recommendation required	
Further Information:

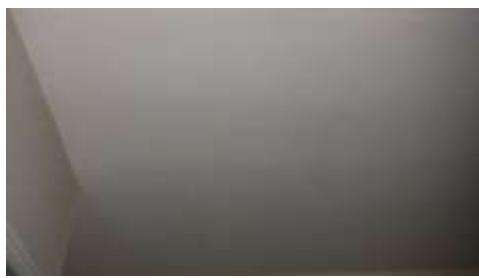
Surveyor		Steven Walker		Room/Area		005 - Landing & Stairs

Survey Date		19 December 2016		Level of Identification		Sampled			
				Sample No		0003			
Building		3 SINCLAIR GARDENS		Item		Textured Coating To Concrete Ceiling			
Floor		1		Amount					
A - Product Type:		B - Extent of Damage:		C - Surface Treatment		D - Asbestos Type		Material Ass (M.A) (A+B+C+D):	
Textured Coating						No Asbestos Detected		0	
1 = Normal Occupant Activity = (E)		E - Main type of activity		Total Priority Score (P.A.) = (1+2+3+4):		Total Risk Ass' Score (P.A. + M.A)		0	
2 = Disturbance = (F+G+H)/3		F - Location		G - Accessibility		H - Extent		Risk Coding	
3 = Exposure potential = (I+J+K)/3		I - Number of occupants		J - Frequency of use		K - Average time in use			
4 = Maintenance activity = (L+M)/2		L - Type of maintenance		M - Frequency of maintenance		Recommendation:		No recommendation required	
Further Information:

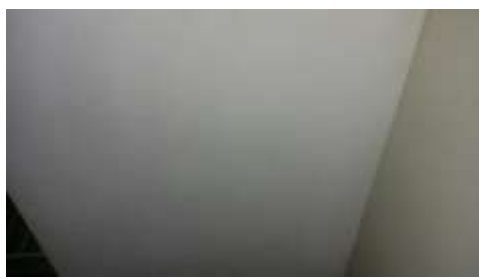
Surveyor		Steven Walker		Room/Area		008 - Landing & Stairs

Survey Date		19 December 2016		Level of Identification		Sampled			
				Sample No		0004			
Building		3 SINCLAIR GARDENS		Item		Textured Coating To Concrete Ceiling			
Floor		2		Amount					
A - Product Type:		B - Extent of Damage:		C - Surface Treatment		D - Asbestos Type		Material Ass (M.A) (A+B+C+D):	
Textured Coating						No Asbestos Detected		0	
1 = Normal Occupant Activity = (E)		E - Main type of activity		Total Priority Score (P.A.) = (1+2+3+4):		Total Risk Ass' Score (P.A. + M.A)		0	
2 = Disturbance = (F+G+H)/3		F - Location		G - Accessibility		H - Extent		Risk Coding	
3 = Exposure potential = (I+J+K)/3		I - Number of occupants		J - Frequency of use		K - Average time in use			
4 = Maintenance activity = (L+M)/2		L - Type of maintenance		M - Frequency of maintenance		Recommendation:		No recommendation required	
Further Information:

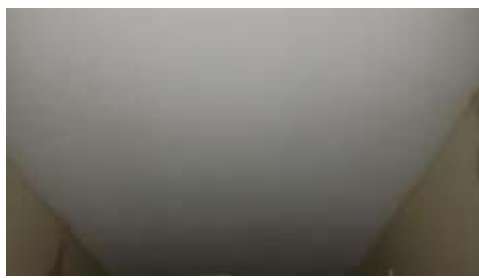
Surveyor		Steven Walker		Room/Area		011 - Landing

Survey Date		19 December 2016		Level of Identification		Sampled			
				Sample No		0005			
Building		3 SINCLAIR GARDENS		Item		Textured Coating To Concrete Ceiling			
Floor		3		Amount					
A - Product Type:		B - Extent of Damage:		C - Surface Treatment		D - Asbestos Type		Material Ass (M.A) (A+B+C+D):	
Textured Coating						No Asbestos Detected		0	
1 = Normal Occupant Activity = (E)		E - Main type of activity		Total Priority Score (P.A.) = (1+2+3+4):		Total Risk Ass' Score (P.A. + M.A)		0	
2 = Disturbance = (F+G+H)/3		F - Location		G - Accessibility		H - Extent		Risk Coding	
3 = Exposure potential = (I+J+K)/3		I - Number of occupants		J - Frequency of use		K - Average time in use			
4 = Maintenance activity = (L+M)/2		L - Type of maintenance		M - Frequency of maintenance		Recommendation:		No recommendation required	
Further Information:

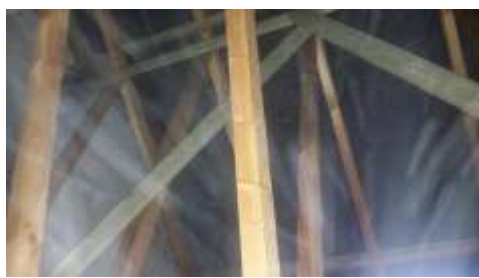
Surveyor		Steven Walker		Room/Area		014 - Loft Above Stairs

Survey Date		19 December 2016		Level of Identification		Sampled			
				Sample No		0006			
Building		3 SINCLAIR GARDENS		Item		Roof Felt			
Floor		4		Amount					
A - Product Type:		B - Extent of Damage:		C - Surface Treatment		D - Asbestos Type		Material Ass (M.A) (A+B+C+D):	
Bitumen Products						No Asbestos Detected		0	
1 = Normal Occupant Activity = (E)		E - Main type of activity		Total Priority Score (P.A.) = (1+2+3+4):		Total Risk Ass' Score (P.A. + M.A)		0	
2 = Disturbance = (F+G+H)/3		F - Location		G - Accessibility		H - Extent		Risk Coding	
3 = Exposure potential = (I+J+K)/3		I - Number of occupants		J - Frequency of use		K - Average time in use			
4 = Maintenance activity = (L+M)/2		L - Type of maintenance		M - Frequency of maintenance		Recommendation:		No recommendation required	
Further Information:
