Asbestos Survey Report

Management Survey (With Priority Assessments)

**3 SINCLAIR PLACE
EDINBURGH
EH11 1AN**

Project Number: S-61212
Issue Date: 11th January 2017
Issue No: 1

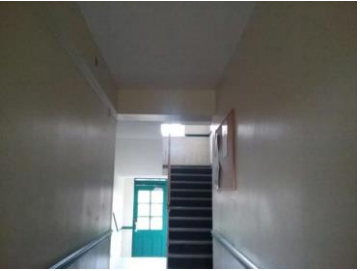
Surveyor		William Stevenson		Room/Area		001 - Ground Floor Landing And Stairs

Survey Date		19 December 2016		Level of Identification		Sampled			
				Sample No		0001			
Building		3 SINCLAIR PLACE		Item		Textured Coating To Plasterboard Ceiling			
Floor		0		Amount					
A - Product Type:		B - Extent of Damage:		C - Surface Treatment		D - Asbestos Type		Material Ass (M.A) (A+B+C+D):	
Textured Coating						No Asbestos Detected		0	
1 = Normal Occupant Activity = (E)		E - Main type of activity		Total Priority Score (P.A.) = (1+2+3+4):		Total Risk Ass' Score (P.A. + M.A)		0	
2 = Disturbance = (F+G+H)/3		F - Location		G - Accessibility		H - Extent		Risk Coding	
3 = Exposure potential = (I+J+K)/3		I - Number of occupants		J - Frequency of use		K - Average time in use			
4 = Maintenance activity = (L+M)/2		L - Type of maintenance		M - Frequency of maintenance		Recommendation:		No recommendation required

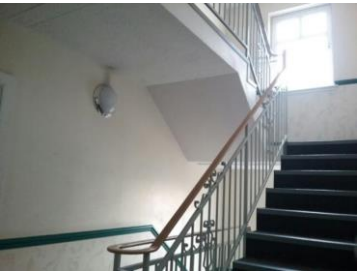
Surveyor		William Stevenson		Room/Area		005 - First Floor Landing And Stairs

Survey Date		19 December 2016		Level of Identification		Sampled			
				Sample No		0002			
Building		3 SINCLAIR PLACE		Item		Textured Coating To Plasterboard Ceiling			
Floor		1		Amount					
A - Product Type:		B - Extent of Damage:		C - Surface Treatment		D - Asbestos Type		Material Ass (M.A) (A+B+C+D):	
Textured Coating						No Asbestos Detected		0	
1 = Normal Occupant Activity = (E)		E - Main type of activity		Total Priority Score (P.A.) = (1+2+3+4):		Total Risk Ass' Score (P.A. + M.A)		0	
2 = Disturbance = (F+G+H)/3		F - Location		G - Accessibility		H - Extent		Risk Coding	
3 = Exposure potential = (I+J+K)/3		I - Number of occupants		J - Frequency of use		K - Average time in use			
4 = Maintenance activity = (L+M)/2		L - Type of maintenance		M - Frequency of maintenance		Recommendation:		No recommendation required

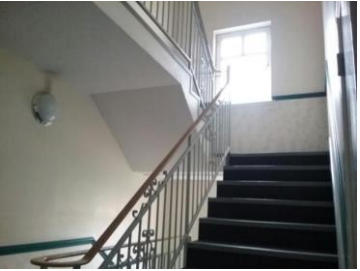
Surveyor		William Stevenson		Room/Area		008 - Second Floor Landing And Stairs

Survey Date		19 December 2016		Level of Identification		Sampled			
				Sample No		0003			
Building		3 SINCLAIR PLACE		Item		Textured Coating To Plasterboard Ceiling			
Floor		2		Amount					
A - Product Type:		B - Extent of Damage:		C - Surface Treatment		D - Asbestos Type		Material Ass (M.A) (A+B+C+D):	
Textured Coating						No Asbestos Detected		0	
1 = Normal Occupant Activity = (E)		E - Main type of activity		Total Priority Score (P.A.) = (1+2+3+4):		Total Risk Ass' Score (P.A. + M.A)		0	
2 = Disturbance = (F+G+H)/3		F - Location		G - Accessibility		H - Extent		Risk Coding	
3 = Exposure potential = (I+J+K)/3		I - Number of occupants		J - Frequency of use		K - Average time in use			
4 = Maintenance activity = (L+M)/2		L - Type of maintenance		M - Frequency of maintenance		Recommendation:		No recommendation required

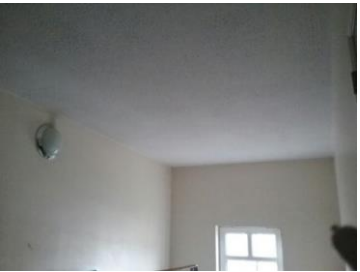
Surveyor		William Stevenson		Room/Area		011 - Third Floor Landing

Survey Date		19 December 2016		Level of Identification		Sampled			
				Sample No		0004			
Building		3 SINCLAIR PLACE		Item		Textured Coating To Plasterboard Ceiling			
Floor		3		Amount					
A - Product Type:		B - Extent of Damage:		C - Surface Treatment		D - Asbestos Type		Material Ass (M.A) (A+B+C+D):	
Textured Coating						No Asbestos Detected		0	
1 = Normal Occupant Activity = (E)		E - Main type of activity		Total Priority Score (P.A.) = (1+2+3+4):		Total Risk Ass' Score (P.A. + M.A)		0	
2 = Disturbance = (F+G+H)/3		F - Location		G - Accessibility		H - Extent		Risk Coding	
3 = Exposure potential = (I+J+K)/3		I - Number of occupants		J - Frequency of use		K - Average time in use			
4 = Maintenance activity = (L+M)/2		L - Type of maintenance		M - Frequency of maintenance		Recommendation:		No recommendation required	
Further Information:

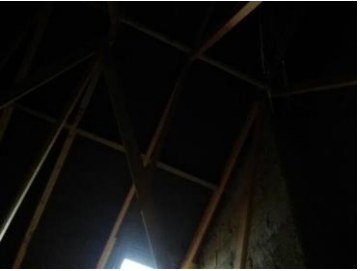
Surveyor		William Stevenson		Room/Area		014 - Roof Void

Survey Date		19 December 2016		Level of Identification		Sampled			
				Sample No		0005			
Building		3 SINCLAIR PLACE		Item		Roof Lining			
Floor		4		Amount					
A - Product Type:		B - Extent of Damage:		C - Surface Treatment		D - Asbestos Type		Material Ass (M.A) (A+B+C+D):	
Roofing Felt / Bitumen						No Asbestos Detected		0	
1 = Normal Occupant Activity = (E)		E - Main type of activity		Total Priority Score (P.A.) = (1+2+3+4):		Total Risk Ass' Score (P.A. + M.A)		0	
2 = Disturbance = (F+G+H)/3		F - Location		G - Accessibility		H - Extent		Risk Coding	
3 = Exposure potential = (I+J+K)/3		I - Number of occupants		J - Frequency of use		K - Average time in use			
4 = Maintenance activity = (L+M)/2		L - Type of maintenance		M - Frequency of maintenance		Recommendation:		No recommendation required	
Further Information:
