Asbestos Survey Report

Management Survey (With Priority Assessments)

**30 SINCLAIR PLACE
EDINBURGH
EH11 1AN**

Project Number: S-61254
Issue Date: 13th January 2017
Issue No: 1

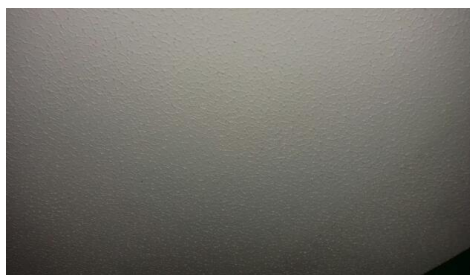
Surveyor		Steven Walker		Room/Area		001 - Entrance Vestibule

Survey Date		04 January 2017		Level of Identification		Sampled			
				Sample No		0001			
Building		30 SINCLAIR PLACE		Item		Textured Coating To Concrete Ceiling			
Floor		0		Amount					
A - Product Type:		B - Extent of Damage:		C - Surface Treatment		D - Asbestos Type		Material Ass (M.A) (A+B+C+D):	
Textured Coating						No Asbestos Detected		0	
1 = Normal Occupant Activity = (E)				E - Main type of activity		Total Priority Score (P.A.) = (1+2+3+4):		Total Risk Ass' Score (P.A. + M.A)	
2 = Disturbance = (F+G+H)/3				F - Location		G - Accessibility		H - Extent	
3 = Exposure potential = (I+J+K)/3				I - Number of occupants		J - Frequency of use		K - Average time in use	
4 = Maintenance activity = (L+M)/2				L - Type of maintenance		M - Frequency of maintenance		Recommendation:	
Further Information:								No recommendation required

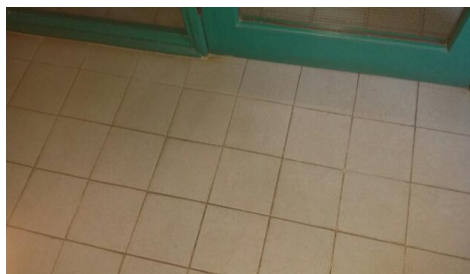
Surveyor		Steven Walker		Room/Area		001 - Entrance Vestibule

Survey Date		04 January 2017		Level of Identification		Sampled			
				Sample No		0002			
Building		30 SINCLAIR PLACE		Item		Ceramic Tile Adhesive To Concrete Floor			
Floor		0		Amount					
A - Product Type:		B - Extent of Damage:		C - Surface Treatment		D - Asbestos Type		Material Ass (M.A) (A+B+C+D):	
Reinforced Composites						No Asbestos Detected		0	
1 = Normal Occupant Activity = (E)				E - Main type of activity		Total Priority Score (P.A.) = (1+2+3+4):		Total Risk Ass' Score (P.A. + M.A)	
2 = Disturbance = (F+G+H)/3				F - Location		G - Accessibility		H - Extent	
3 = Exposure potential = (I+J+K)/3				I - Number of occupants		J - Frequency of use		K - Average time in use	
4 = Maintenance activity = (L+M)/2				L - Type of maintenance		M - Frequency of maintenance		Recommendation:	
Further Information:								No recommendation required

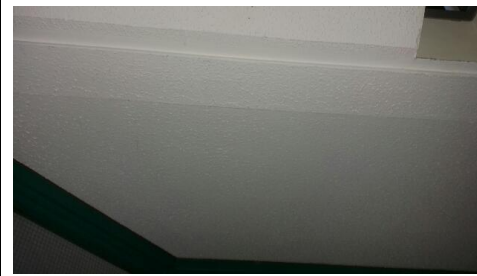
Surveyor		Steven Walker		Room/Area		004 - Landing & Stairs

Survey Date		04 January 2017		Level of Identification		Sampled			
				Sample No		0003			
Building		30 SINCLAIR PLACE		Item		Textured Coating To Concrete Ceiling			
Floor		0		Amount					
A - Product Type:		B - Extent of Damage:		C - Surface Treatment		D - Asbestos Type		Material Ass (M.A) (A+B+C+D):	
Textured Coating						No Asbestos Detected		0	
1 = Normal Occupant Activity = (E)				E - Main type of activity		Total Priority Score (P.A.) = (1+2+3+4):		Total Risk Ass' Score (P.A. + M.A)	
2 = Disturbance = (F+G+H)/3				F - Location		G - Accessibility		H - Extent	
3 = Exposure potential = (I+J+K)/3				I - Number of occupants		J - Frequency of use		K - Average time in use	
4 = Maintenance activity = (L+M)/2				L - Type of maintenance		M - Frequency of maintenance		Recommendation:	
Further Information:								No recommendation required

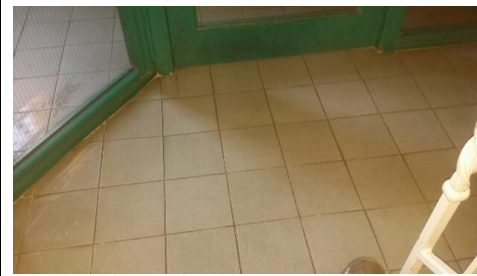
Surveyor		Steven Walker		Room/Area		004 - Landing & Stairs

Survey Date		04 January 2017		Level of Identification		Strong Presumed (X)			
				Sample No		As 0002			
Building		30 SINCLAIR PLACE		Item		Ceramic Tile Adhesive To Concrete Floor			
Floor		0		Amount					
A - Product Type:		B - Extent of Damage:		C - Surface Treatment		D - Asbestos Type		Material Ass (M.A) (A+B+C+D):	
Reinforced Composites						No Asbestos Detected		0	
1 = Normal Occupant Activity = (E)				E - Main type of activity		Total Priority Score (P.A.) = (1+2+3+4):		Total Risk Ass' Score (P.A. + M.A)	
2 = Disturbance = (F+G+H)/3				F - Location		G - Accessibility		H - Extent	
3 = Exposure potential = (I+J+K)/3				I - Number of occupants		J - Frequency of use		K - Average time in use	
4 = Maintenance activity = (L+M)/2				L - Type of maintenance		M - Frequency of maintenance		Recommendation:	
Further Information:		Visually consistent with sample number 0002.						No recommendation required

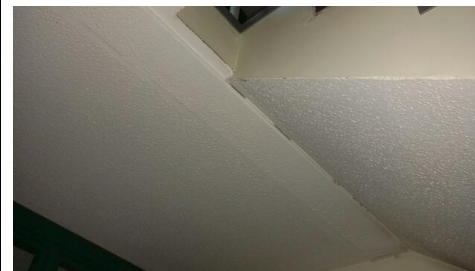
Surveyor		Steven Walker		Room/Area		007 - Landing & Stairs

Survey Date		04 January 2017		Level of Identification		Sampled			
				Sample No		0004			
Building		30 SINCLAIR PLACE		Item		Textured Coating To Concrete Ceiling			
Floor		1		Amount					
A - Product Type:		B - Extent of Damage:		C - Surface Treatment		D - Asbestos Type		Material Ass (M.A) (A+B+C+D):	
Textured Coating						No Asbestos Detected		0	
1 = Normal Occupant Activity = (E)				E - Main type of activity		Total Priority Score (P.A.) = (1+2+3+4):		Total Risk Ass' Score (P.A. + M.A)	
2 = Disturbance = (F+G+H)/3				F - Location		G - Accessibility		H - Extent	
3 = Exposure potential = (I+J+K)/3				I - Number of occupants		J - Frequency of use		K - Average time in use	
4 = Maintenance activity = (L+M)/2				L - Type of maintenance		M - Frequency of maintenance		Recommendation:	
Further Information:								No recommendation required

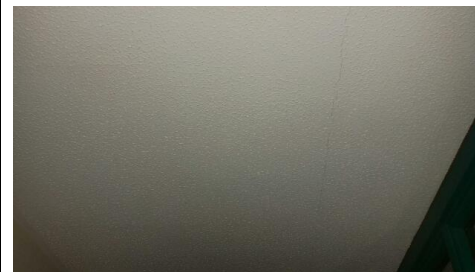
Surveyor		Steven Walker		Room/Area		009 - Vestibule

Survey Date		04 January 2017		Level of Identification		Sampled			
				Sample No		0005			
Building		30 SINCLAIR PLACE		Item		Textured Coating To Concrete Ceiling			
Floor		1		Amount					
A - Product Type:		B - Extent of Damage:		C - Surface Treatment		D - Asbestos Type		Material Ass (M.A) (A+B+C+D):	
Textured Coating						No Asbestos Detected		0	
1 = Normal Occupant Activity = (E)				E - Main type of activity		Total Priority Score (P.A.) = (1+2+3+4):		Total Risk Ass' Score (P.A. + M.A)	
2 = Disturbance = (F+G+H)/3				F - Location		G - Accessibility		H - Extent	
3 = Exposure potential = (I+J+K)/3				I - Number of occupants		J - Frequency of use		K - Average time in use	
4 = Maintenance activity = (L+M)/2				L - Type of maintenance		M - Frequency of maintenance		Recommendation:	
Further Information:								No recommendation required

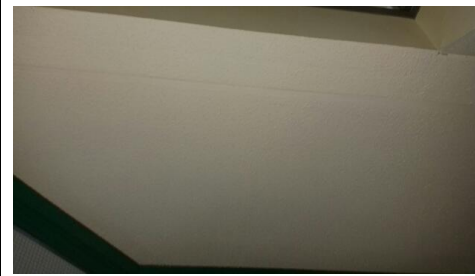
Surveyor		Steven Walker		Room/Area		012 - Landing & Stairs

Survey Date		04 January 2017		Level of Identification		Sampled			
				Sample No		0006			
Building		30 SINCLAIR PLACE		Item		Textured Coating To Concrete Ceiling			
Floor		2		Amount					
A - Product Type:		B - Extent of Damage:		C - Surface Treatment		D - Asbestos Type		Material Ass (M.A) (A+B+C+D):	
Textured Coating						No Asbestos Detected		0	
1 = Normal Occupant Activity = (E)				E - Main type of activity		Total Priority Score (P.A.) = (1+2+3+4):		Total Risk Ass' Score (P.A. + M.A)	
2 = Disturbance = (F+G+H)/3				F - Location		G - Accessibility		H - Extent	
3 = Exposure potential = (I+J+K)/3				I - Number of occupants		J - Frequency of use		K - Average time in use	
4 = Maintenance activity = (L+M)/2				L - Type of maintenance		M - Frequency of maintenance		Recommendation:	
Further Information:								No recommendation required

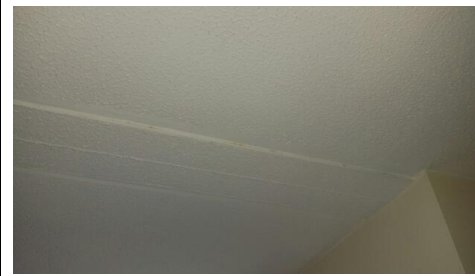
Surveyor		Steven Walker		Room/Area		014 - Vestibule

Survey Date		04 January 2017		Level of Identification		Sampled			
				Sample No		0007			
Building		30 SINCLAIR PLACE		Item		Textured Coating To Concrete Ceiling			
Floor		2		Amount					
A - Product Type:		B - Extent of Damage:		C - Surface Treatment		D - Asbestos Type		Material Ass (M.A) (A+B+C+D):	
Textured Coating						No Asbestos Detected		0	
1 = Normal Occupant Activity = (E)				E - Main type of activity		Total Priority Score (P.A.) = (1+2+3+4):		Total Risk Ass' Score (P.A. + M.A)	
2 = Disturbance = (F+G+H)/3				F - Location		G - Accessibility		H - Extent	
3 = Exposure potential = (I+J+K)/3				I - Number of occupants		J - Frequency of use		K - Average time in use	
4 = Maintenance activity = (L+M)/2				L - Type of maintenance		M - Frequency of maintenance		Recommendation:	
Further Information:								No recommendation required

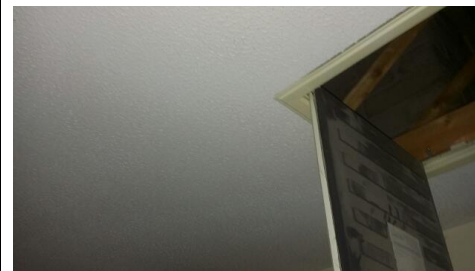
Surveyor		Steven Walker		Room/Area		017 - Landing

Survey Date		04 January 2017		Level of Identification		Sampled			
				Sample No		0008			
Building		30 SINCLAIR PLACE		Item		Textured Coating To Plasterboard Ceiling			
Floor		3		Amount					
A - Product Type:		B - Extent of Damage:		C - Surface Treatment		D - Asbestos Type		Material Ass (M.A) (A+B+C+D):	
Textured Coating						No Asbestos Detected		0	
1 = Normal Occupant Activity = (E)				E - Main type of activity		Total Priority Score (P.A.) = (1+2+3+4):		Total Risk Ass' Score (P.A. + M.A)	
2 = Disturbance = (F+G+H)/3				F - Location		G - Accessibility		H - Extent	
3 = Exposure potential = (I+J+K)/3				I - Number of occupants		J - Frequency of use		K - Average time in use	
4 = Maintenance activity = (L+M)/2				L - Type of maintenance		M - Frequency of maintenance		Recommendation:	
Further Information:								No recommendation required

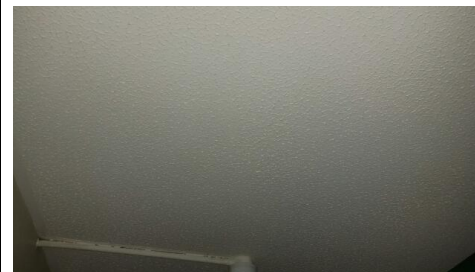
Surveyor		Steven Walker		Room/Area		019 - Vestibule

Survey Date		04 January 2017		Level of Identification		Sampled			
				Sample No		0009			
Building		30 SINCLAIR PLACE		Item		Textured Coating To Plasterboard Ceiling			
Floor		3		Amount					
A - Product Type:		B - Extent of Damage:		C - Surface Treatment		D - Asbestos Type		Material Ass (M.A) (A+B+C+D):	
Textured Coating						No Asbestos Detected		0	
1 = Normal Occupant Activity = (E)				E - Main type of activity		Total Priority Score (P.A.) = (1+2+3+4):		Total Risk Ass' Score (P.A. + M.A)	
2 = Disturbance = (F+G+H)/3				F - Location		G - Accessibility		H - Extent	
3 = Exposure potential = (I+J+K)/3				I - Number of occupants		J - Frequency of use		K - Average time in use	
4 = Maintenance activity = (L+M)/2				L - Type of maintenance		M - Frequency of maintenance		Recommendation:	
Further Information:								No recommendation required

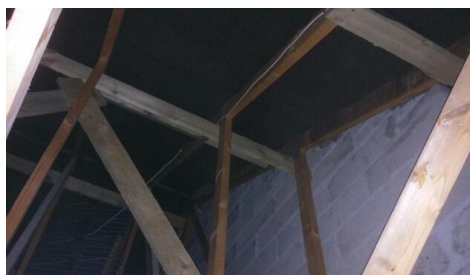
Surveyor		Steven Walker		Room/Area		022 - Loft Above Landing

Survey Date		04 January 2017		Level of Identification		Sampled			
				Sample No		0010			
Building		30 SINCLAIR PLACE		Item		Roof Felt			
Floor		4		Amount					
A - Product Type:		B - Extent of Damage:		C - Surface Treatment		D - Asbestos Type		Material Ass (M.A) (A+B+C+D):	
Bitumen Products						No Asbestos Detected		0	
1 = Normal Occupant Activity = (E)				E - Main type of activity		Total Priority Score (P.A.) = (1+2+3+4):		Total Risk Ass' Score (P.A. + M.A)	
2 = Disturbance = (F+G+H)/3				F - Location		G - Accessibility		H - Extent	
3 = Exposure potential = (I+J+K)/3				I - Number of occupants		J - Frequency of use		K - Average time in use	
4 = Maintenance activity = (L+M)/2				L - Type of maintenance		M - Frequency of maintenance		Recommendation:	
Further Information:								No recommendation required

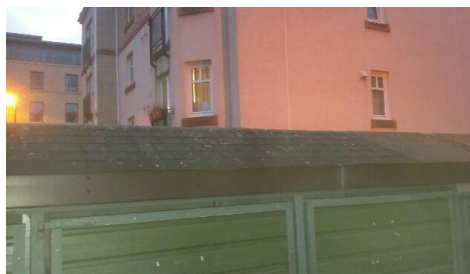
Surveyor		Steven Walker		Room/Area		024 - Cycle Shed 4

Survey Date		23 December 2016		Level of Identification		Sampled			
				Sample No		0011			
Building		30 SINCLAIR PLACE		Item		Roof Felt			
Floor		External		Amount					
A - Product Type:		B - Extent of Damage:		C - Surface Treatment		D - Asbestos Type		Material Ass (M.A) (A+B+C+D):	
Bitumen Products						No Asbestos Detected		0	
1 = Normal Occupant Activity = (E)				E - Main type of activity		Total Priority Score (P.A.) = (1+2+3+4):		Total Risk Ass' Score (P.A. + M.A)	
2 = Disturbance = (F+G+H)/3				F - Location		G - Accessibility		H - Extent	
3 = Exposure potential = (I+J+K)/3				I - Number of occupants		J - Frequency of use		K - Average time in use	
4 = Maintenance activity = (L+M)/2				L - Type of maintenance		M - Frequency of maintenance		Recommendation:	
Further Information:								No recommendation required
