Asbestos Survey Report

Management Survey (With Priority Assessments)

31 SINCLAIR PLACE
EDINBURGH
EH11 1AN

Project Number: S-61295
Issue Date: 12 January 2017
Issue No: 1

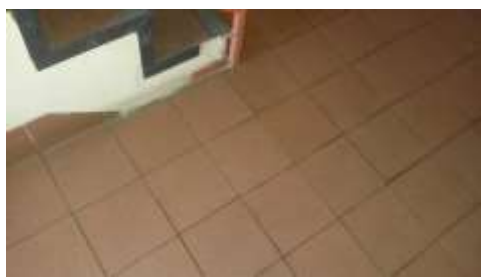
Surveyor		Steven Walker		Room/Area		001 - Entrance & Stairs

Survey Date		04 January 2017		Level of Identification		Sampled											
				Sample No		0002											
Building		31 SINCLAIR PLACE		Item		Ceramic Tile Adhesive To Concrete Floor											
Floor		0		Amount													
A - Product Type:		B - Extent of Damage:		C - Surface Treatment		D - Asbestos Type		Material Ass (M.A) (A+B+C+D):									
Reinforced Composites						No Asbestos Detected		0									
1 = Normal Occupant Activity = (E)		1		E - Main type of activity		1		Total Priority Score (P.A.) = (1+2+3+4):		1		Total Risk Ass' Score (P.A. + M.A)		1		Risk Coding	
2 = Disturbance = (F+G+H)/3		0		F - Location				G - Accessibility				H - Extent					
3 = Exposure potential = (I+J+K)/3		0		I - Number of occupants				J - Frequency of use				K - Average time in use					
4 = Maintenance activity = (L+M)/2		0		L - Type of maintenance				M - Frequency of maintenance				Recommendation: No recommendation required

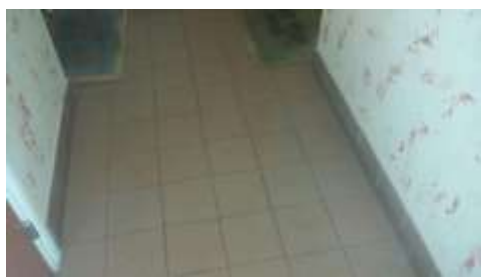
Surveyor		Steven Walker		Room/Area		003 - Vestibule

Survey Date		04 January 2017		Level of Identification		Strong Presumed (X)											
				Sample No		As 0002											
Building		31 SINCLAIR PLACE		Item		Ceramic Tile Adhesive To Concrete Floor											
Floor		0		Amount													
A - Product Type:		B - Extent of Damage:		C - Surface Treatment		D - Asbestos Type		Material Ass (M.A) (A+B+C+D):									
Reinforced Composites						No Asbestos Detected		0									
1 = Normal Occupant Activity = (E)		1		E - Main type of activity		1		Total Priority Score (P.A.) = (1+2+3+4):		1		Total Risk Ass' Score (P.A. + M.A)		1		Risk Coding	
2 = Disturbance = (F+G+H)/3		0		F - Location				G - Accessibility				H - Extent					
3 = Exposure potential = (I+J+K)/3		0		I - Number of occupants				J - Frequency of use				K - Average time in use					
4 = Maintenance activity = (L+M)/2		0		L - Type of maintenance				M - Frequency of maintenance				Recommendation: No recommendation required

Further Information: Visually consistent with sample number 0002.

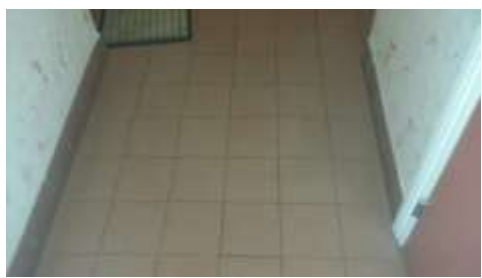
Surveyor		Steven Walker		Room/Area		007 - Vestibule

Survey Date		04 January 2017		Level of Identification		Strong Presumed (X)											
				Sample No		As 0002											
Building		31 SINCLAIR PLACE		Item		Ceramic Tile Adhesive To Concrete Floor											
Floor		0		Amount													
A - Product Type:		B - Extent of Damage:		C - Surface Treatment		D - Asbestos Type		Material Ass (M.A) (A+B+C+D):									
Reinforced Composites						No Asbestos Detected		0									
1 = Normal Occupant Activity = (E)		1		E - Main type of activity		1		Total Priority Score (P.A.) = (1+2+3+4):		1		Total Risk Ass' Score (P.A. + M.A)		1		Risk Coding	
2 = Disturbance = (F+G+H)/3		0		F - Location				G - Accessibility				H - Extent					
3 = Exposure potential = (I+J+K)/3		0		I - Number of occupants				J - Frequency of use				K - Average time in use					
4 = Maintenance activity = (L+M)/2		0		L - Type of maintenance				M - Frequency of maintenance				Recommendation: No recommendation required

Further Information: Visually consistent with sample number 0002.

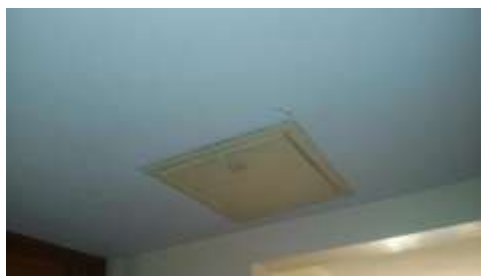
Surveyor		Steven Walker		Room/Area		023 - Landing

Survey Date		04 January 2017		Level of Identification		Sampled											
				Sample No		0011											
Building		31 SINCLAIR PLACE		Item		Textured Coating To Plasterboard Ceiling											
Floor		3		Amount													
A - Product Type:		B - Extent of Damage:		C - Surface Treatment		D - Asbestos Type		Material Ass (M.A) (A+B+C+D):									
Textured Coating						No Asbestos Detected		0									
1 = Normal Occupant Activity = (E)		1		E - Main type of activity		1		Total Priority Score (P.A.) = (1+2+3+4):		1		Total Risk Ass' Score (P.A. + M.A)		1		Risk Coding	
2 = Disturbance = (F+G+H)/3		0		F - Location				G - Accessibility				H - Extent					
3 = Exposure potential = (I+J+K)/3		0		I - Number of occupants				J - Frequency of use				K - Average time in use					
4 = Maintenance activity = (L+M)/2		0		L - Type of maintenance				M - Frequency of maintenance				Recommendation: No recommendation required

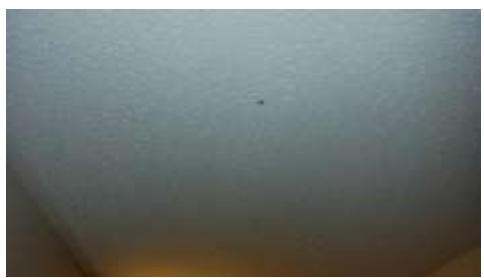
Surveyor		Steven Walker		Room/Area		024 - Vestibule

Survey Date		04 January 2017		Level of Identification		Sampled											
				Sample No		0012											
Building		31 SINCLAIR PLACE		Item		Textured Coating To Plasterboard Ceiling											
Floor		3		Amount													
A - Product Type:		B - Extent of Damage:		C - Surface Treatment		D - Asbestos Type		Material Ass (M.A) (A+B+C+D):									
Textured Coating						No Asbestos Detected		0									
1 = Normal Occupant Activity = (E)		1		E - Main type of activity		1		Total Priority Score (P.A.) = (1+2+3+4):		1		Total Risk Ass' Score (P.A. + M.A)		1		Risk Coding	
2 = Disturbance = (F+G+H)/3		0		F - Location				G - Accessibility				H - Extent					
3 = Exposure potential = (I+J+K)/3		0		I - Number of occupants				J - Frequency of use				K - Average time in use					
4 = Maintenance activity = (L+M)/2		0		L - Type of maintenance				M - Frequency of maintenance				Recommendation: No recommendation required

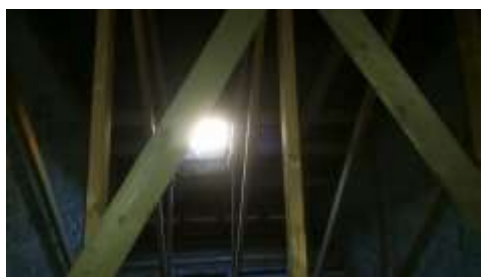
Surveyor		Steven Walker		Room/Area		030 - Loft Above Landing

Survey Date		04 January 2017		Level of Identification		Sampled											
				Sample No		0014											
Building		31 SINCLAIR PLACE		Item		Roof Felt											
Floor		4		Amount													
A - Product Type:		B - Extent of Damage:		C - Surface Treatment		D - Asbestos Type		Material Ass (M.A) (A+B+C+D):									
Bitumen Products						No Asbestos Detected		0									
1 = Normal Occupant Activity = (E)		0		E - Main type of activity		0		Total Priority Score (P.A.) = (1+2+3+4):		0		Total Risk Ass' Score (P.A. + M.A)		0		Risk Coding	
2 = Disturbance = (F+G+H)/3		0		F - Location				G - Accessibility				H - Extent					
3 = Exposure potential = (I+J+K)/3		0		I - Number of occupants				J - Frequency of use				K - Average time in use					
4 = Maintenance activity = (L+M)/2		0		L - Type of maintenance				M - Frequency of maintenance				Recommendation: No recommendation required
