Asbestos Survey Report

Management Survey (With Priority Assessments)

**32 SINCLAIR PLACE
EDINBURGH
EH11 1AN**

Project Number: S-61348
Issue Date: 16th January 2017
Issue No: 1

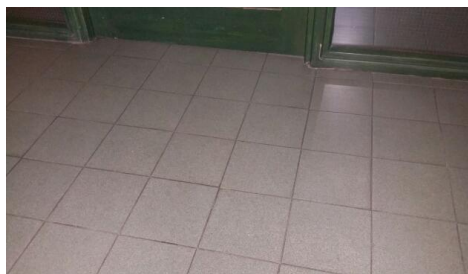
| Surveyor | | Steven Walker | | Room/Area | | 004 - Ground Floor & Stairs | | | |

| Further Information: | | Visually consistent with sample number 0002. | | | | | | No recommendation required | |
