Asbestos Survey Report

Management Survey (With Priority Assessments)

**4 SINCLAIR CLOSE
EDINBURGH
EH11 1AN**

Project Number: S-61392
Issue Date: 16th January 2017
Issue No: 1

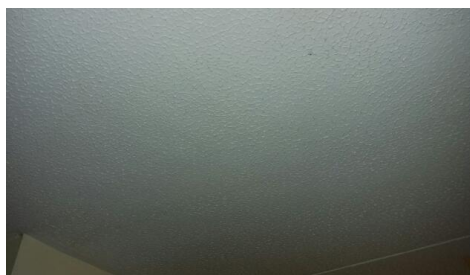
Surveyor		Steven Walker		Room/Area		001 - Ground Floor & Stairs

Survey Date		23 December 2016		Level of Identification		Sampled			
				Sample No		0001			
Building		4 SINCLAIR CLOSE		Item		Textured Coating To Concrete Ceiling			
Floor		0		Amount					
A - Product Type:		B - Extent of Damage:		C - Surface Treatment		D - Asbestos Type		Material Ass (M.A) (A+B+C+D):	
Textured Coating						No Asbestos Detected		0	
1 = Normal Occupant Activity = (E)				E - Main type of activity		Total Priority Score (P.A.) = (1+2+3+4):		Total Risk Ass' Score (P.A. + M.A)	
2 = Disturbance = (F+G+H)/3				F - Location		G - Accessibility		H - Extent	
3 = Exposure potential = (I+J+K)/3				I - Number of occupants		J - Frequency of use		K - Average time in use	
4 = Maintenance activity = (L+M)/2				L - Type of maintenance		M - Frequency of maintenance		Recommendation:	
Further Information:								No recommendation required

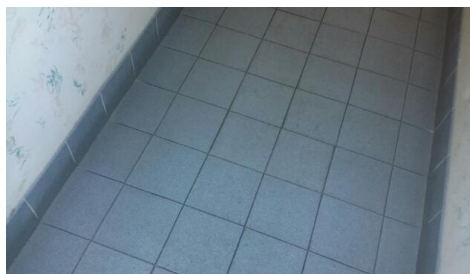
Surveyor		Steven Walker		Room/Area		001 - Ground Floor & Stairs

Survey Date		23 December 2016		Level of Identification		Sampled			
				Sample No		0002			
Building		4 SINCLAIR CLOSE		Item		Ceramic Tile Adhesive To Concrete Floor			
Floor		0		Amount					
A - Product Type:		B - Extent of Damage:		C - Surface Treatment		D - Asbestos Type		Material Ass (M.A) (A+B+C+D):	
Reinforced Composites						No Asbestos Detected		0	
1 = Normal Occupant Activity = (E)				E - Main type of activity		Total Priority Score (P.A.) = (1+2+3+4):		Total Risk Ass' Score (P.A. + M.A)	
2 = Disturbance = (F+G+H)/3				F - Location		G - Accessibility		H - Extent	
3 = Exposure potential = (I+J+K)/3				I - Number of occupants		J - Frequency of use		K - Average time in use	
4 = Maintenance activity = (L+M)/2				L - Type of maintenance		M - Frequency of maintenance		Recommendation:	
Further Information:								No recommendation required

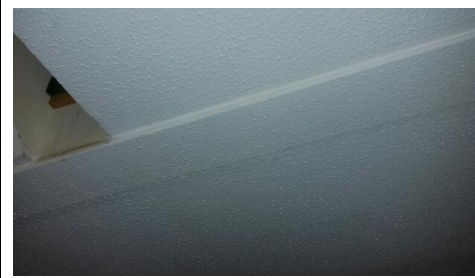
Surveyor		Steven Walker		Room/Area		005 - Landing & Stairs

Survey Date		23 December 2016		Level of Identification		Sampled			
				Sample No		0003			
Building		4 SINCLAIR CLOSE		Item		Textured Coating To Concrete Ceiling			
Floor		1		Amount					
A - Product Type:		B - Extent of Damage:		C - Surface Treatment		D - Asbestos Type		Material Ass (M.A) (A+B+C+D):	
Textured Coating						No Asbestos Detected		0	
1 = Normal Occupant Activity = (E)				E - Main type of activity		Total Priority Score (P.A.) = (1+2+3+4):		Total Risk Ass' Score (P.A. + M.A)	
2 = Disturbance = (F+G+H)/3				F - Location		G - Accessibility		H - Extent	
3 = Exposure potential = (I+J+K)/3				I - Number of occupants		J - Frequency of use		K - Average time in use	
4 = Maintenance activity = (L+M)/2				L - Type of maintenance		M - Frequency of maintenance		Recommendation:	
Further Information:								No recommendation required

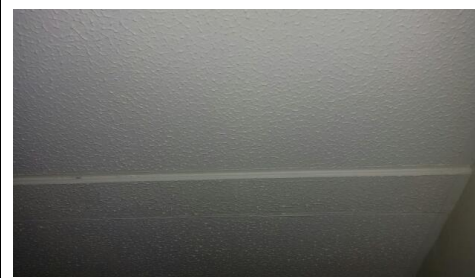
Surveyor		Steven Walker		Room/Area		008 - Landing & Stairs

Survey Date		23 December 2016		Level of Identification		Sampled			
				Sample No		0004			
Building		4 SINCLAIR CLOSE		Item		Textured Coating To Concrete Ceiling			
Floor		2		Amount					
A - Product Type:		B - Extent of Damage:		C - Surface Treatment		D - Asbestos Type		Material Ass (M.A) (A+B+C+D):	
Textured Coating						No Asbestos Detected		0	
1 = Normal Occupant Activity = (E)				E - Main type of activity		Total Priority Score (P.A.) = (1+2+3+4):		Total Risk Ass' Score (P.A. + M.A)	
2 = Disturbance = (F+G+H)/3				F - Location		G - Accessibility		H - Extent	
3 = Exposure potential = (I+J+K)/3				I - Number of occupants		J - Frequency of use		K - Average time in use	
4 = Maintenance activity = (L+M)/2				L - Type of maintenance		M - Frequency of maintenance		Recommendation:	
Further Information:								No recommendation required

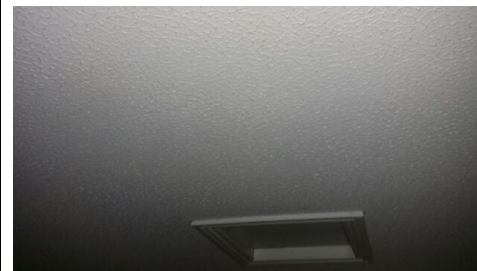
Surveyor		Steven Walker		Room/Area		011 - Landing

Survey Date		23 December 2016		Level of Identification		Sampled			
				Sample No		0005			
Building		4 SINCLAIR CLOSE		Item		Textured Coating To Plasterboard Ceiling			
Floor		3		Amount					
A - Product Type:		B - Extent of Damage:		C - Surface Treatment		D - Asbestos Type		Material Ass (M.A) (A+B+C+D):	
Textured Coating						No Asbestos Detected		0	
1 = Normal Occupant Activity = (E)				E - Main type of activity		Total Priority Score (P.A.) = (1+2+3+4):		Total Risk Ass' Score (P.A. + M.A)	
2 = Disturbance = (F+G+H)/3				F - Location		G - Accessibility		H - Extent	
3 = Exposure potential = (I+J+K)/3				I - Number of occupants		J - Frequency of use		K - Average time in use	
4 = Maintenance activity = (L+M)/2				L - Type of maintenance		M - Frequency of maintenance		Recommendation:	
Further Information:								No recommendation required

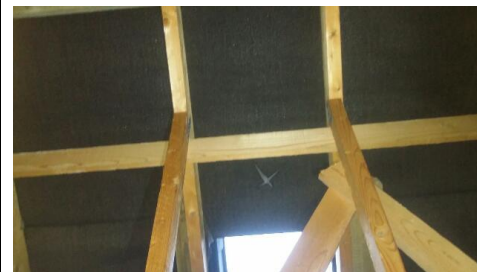
Surveyor		Steven Walker		Room/Area		014 - Loft Above Landing

Survey Date		23 December 2016		Level of Identification		Sampled			
				Sample No		0006			
Building		4 SINCLAIR CLOSE		Item		Roof Felt			
Floor		4		Amount					
A - Product Type:		B - Extent of Damage:		C - Surface Treatment		D - Asbestos Type		Material Ass (M.A) (A+B+C+D):	
Bitumen Products						No Asbestos Detected		0	
1 = Normal Occupant Activity = (E)				E - Main type of activity		Total Priority Score (P.A.) = (1+2+3+4):		Total Risk Ass' Score (P.A. + M.A)	
2 = Disturbance = (F+G+H)/3				F - Location		G - Accessibility		H - Extent	
3 = Exposure potential = (I+J+K)/3				I - Number of occupants		J - Frequency of use		K - Average time in use	
4 = Maintenance activity = (L+M)/2				L - Type of maintenance		M - Frequency of maintenance		Recommendation:	
Further Information:								No recommendation required
