Asbestos Survey Report

Management Survey (With Priority Assessments)

**4 SINCLAIR GARDENS
EDINBURGH
EH11 1AN**

Project Number: S-61219
Issue Date: 9 January 2017
Issue No: 1

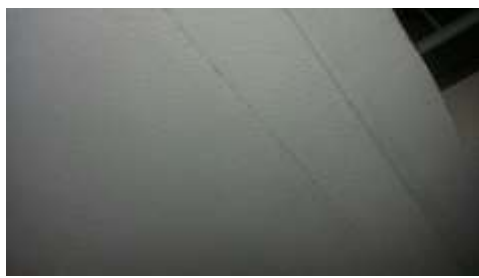
Surveyor		Steven Walker		Room/Area		001 - Ground Floor

Survey Date		19 December 2016		Level of Identification		Sampled			
				Sample No		0001			
Building		4 SINCLAIR GARDENS		Item		Textured Coating To Concrete Ceiling			
Floor		0		Amount					
A - Product Type:		B - Extent of Damage:		C - Surface Treatment		D - Asbestos Type		Material Ass (M.A) (A+B+C+D):	
Textured Coating						No Asbestos Detected		0	
1 = Normal Occupant Activity = (E)		E - Main type of activity		Total Priority Score (P.A.) = (1+2+3+4):		Total Risk Ass' Score (P.A. + M.A)		0	
2 = Disturbance = (F+G+H)/3		F - Location		G - Accessibility		H - Extent		Risk Coding	
3 = Exposure potential = (I+J+K)/3		I - Number of occupants		J - Frequency of use		K - Average time in use			
4 = Maintenance activity = (L+M)/2		L - Type of maintenance		M - Frequency of maintenance		Recommendation:		No recommendation required	
Further Information:

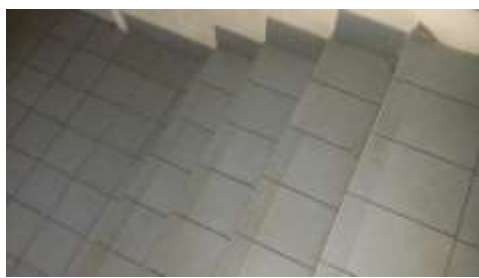
Surveyor		Steven Walker		Room/Area		001 - Ground Floor & Stairs

Survey Date		19 December 2016		Level of Identification		Sampled			
				Sample No		0002			
Building		4 SINCLAIR GARDENS		Item		Ceramic Tile Adhesive To Concrete Floor			
Floor		0		Amount					
A - Product Type:		B - Extent of Damage:		C - Surface Treatment		D - Asbestos Type		Material Ass (M.A) (A+B+C+D):	
Reinforced Composites						No Asbestos Detected		0	
1 = Normal Occupant Activity = (E)		E - Main type of activity		Total Priority Score (P.A.) = (1+2+3+4):		Total Risk Ass' Score (P.A. + M.A)		0	
2 = Disturbance = (F+G+H)/3		F - Location		G - Accessibility		H - Extent		Risk Coding	
3 = Exposure potential = (I+J+K)/3		I - Number of occupants		J - Frequency of use		K - Average time in use			
4 = Maintenance activity = (L+M)/2		L - Type of maintenance		M - Frequency of maintenance		Recommendation:		No recommendation required	
Further Information:

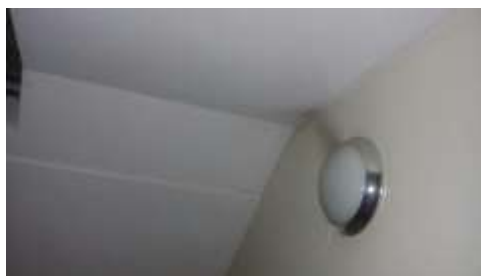
Surveyor		Steven Walker		Room/Area		005 - Landing & Stairs

Survey Date		19 December 2016		Level of Identification		Sampled			
				Sample No		0003			
Building		4 SINCLAIR GARDENS		Item		Textured Coating To Concrete Ceiling			
Floor		1		Amount					
A - Product Type:		B - Extent of Damage:		C - Surface Treatment		D - Asbestos Type		Material Ass (M.A) (A+B+C+D):	
Textured Coating						No Asbestos Detected		0	
1 = Normal Occupant Activity = (E)		E - Main type of activity		Total Priority Score (P.A.) = (1+2+3+4):		Total Risk Ass' Score (P.A. + M.A)		0	
2 = Disturbance = (F+G+H)/3		F - Location		G - Accessibility		H - Extent		Risk Coding	
3 = Exposure potential = (I+J+K)/3		I - Number of occupants		J - Frequency of use		K - Average time in use			
4 = Maintenance activity = (L+M)/2		L - Type of maintenance		M - Frequency of maintenance		Recommendation:		No recommendation required	
Further Information:

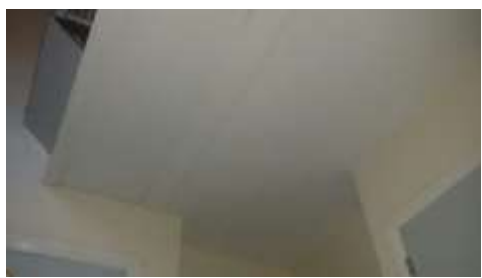
Surveyor		Steven Walker		Room/Area		008 - Landing & Stairs

Survey Date		19 December 2016		Level of Identification		Sampled			
				Sample No		0004			
Building		4 SINCLAIR GARDENS		Item		Textured Coating To Concrete Ceiling			
Floor		2		Amount					
A - Product Type:		B - Extent of Damage:		C - Surface Treatment		D - Asbestos Type		Material Ass (M.A) (A+B+C+D):	
Textured Coating						No Asbestos Detected		0	
1 = Normal Occupant Activity = (E)		E - Main type of activity		Total Priority Score (P.A.) = (1+2+3+4):		Total Risk Ass' Score (P.A. + M.A)		0	
2 = Disturbance = (F+G+H)/3		F - Location		G - Accessibility		H - Extent		Risk Coding	
3 = Exposure potential = (I+J+K)/3		I - Number of occupants		J - Frequency of use		K - Average time in use			
4 = Maintenance activity = (L+M)/2		L - Type of maintenance		M - Frequency of maintenance		Recommendation:		No recommendation required	
Further Information:

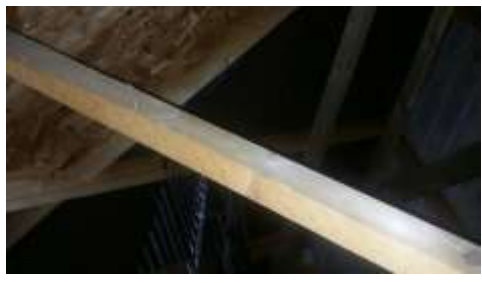
Surveyor		Steven Walker		Room/Area		014 - Loft Above Stairs

Survey Date		19 December 2016		Level of Identification		Sampled				
				Sample No		0006				
Building		4 SINCLAIR GARDENS		Item		Roof Felt				
Floor		4		Amount						
A - Product Type:		B - Extent of Damage:		C - Surface Treatment		D - Asbestos Type		Material Ass (M.A) (A+B+C+D):		
Bitumen Products						No Asbestos Detected		0		0
1 = Normal Occupant Activity = (E)		E - Main type of activity		Total Priority Score (P.A.) = (1+2+3+4):		Total Risk Ass' Score (P.A. + M.A)		0	Risk Coding	
2 = Disturbance = (F+G+H)/3		F - Location		G - Accessibility		H - Extent				
3 = Exposure potential = (I+J+K)/3		I - Number of occupants		J - Frequency of use		K - Average time in use				
4 = Maintenance activity = (L+M)/2		L - Type of maintenance		M - Frequency of maintenance		Recommendation:		No recommendation required		
Further Information:
