Asbestos Survey Report

Management Survey (With Priority Assessments)

**4 SINCLAIR PLACE
EDINBURGH
EH11 1AN**

Project Number: S-61213
Issue Date: 10 January 2017
Issue No: 1

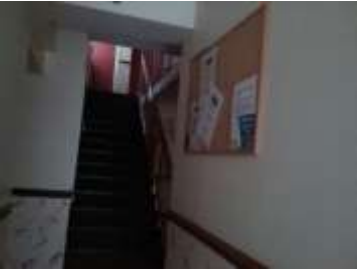
Surveyor		William Stevenson		Room/Area		001 - Ground Floor Landing And Stairs

Survey Date		19 December 2016		Level of Identification		Sampled			
				Sample No		0001			
Building		4 SINCLAIR PLACE		Item		Textured Coating To Plasterboard Ceiling			
Floor		0		Amount					
A - Product Type:		B - Extent of Damage:		C - Surface Treatment		D - Asbestos Type		Material Ass (M.A) (A+B+C+D):	
Textured Coating						No Asbestos Detected		0	
1 = Normal Occupant Activity = (E)		E - Main type of activity		Total Priority Score (P.A.) = (1+2+3+4):		Total Risk Ass' Score (P.A. + M.A)		0	
2 = Disturbance = (F+G+H)/3		F - Location		G - Accessibility		H - Extent		Risk Coding	
3 = Exposure potential = (I+J+K)/3		I - Number of occupants		J - Frequency of use		K - Average time in use			
4 = Maintenance activity = (L+M)/2		L - Type of maintenance		M - Frequency of maintenance		Recommendation:		No recommendation required

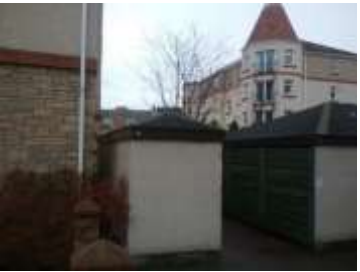
Surveyor		William Stevenson		Room/Area		006 - Bin Store 1

Survey Date		06 January 2017		Level of Identification		Sampled			
				Sample No		0002			
Building		4 SINCLAIR PLACE		Item		Roof Tile			
Floor		External		Amount					
A - Product Type:		B - Extent of Damage:		C - Surface Treatment		D - Asbestos Type		Material Ass (M.A) (A+B+C+D):	
Roofing Felt / Bitumen						No Asbestos Detected		0	
1 = Normal Occupant Activity = (E)		E - Main type of activity		Total Priority Score (P.A.) = (1+2+3+4):		Total Risk Ass' Score (P.A. + M.A)		0	
2 = Disturbance = (F+G+H)/3		F - Location		G - Accessibility		H - Extent		Risk Coding	
3 = Exposure potential = (I+J+K)/3		I - Number of occupants		J - Frequency of use		K - Average time in use			
4 = Maintenance activity = (L+M)/2		L - Type of maintenance		M - Frequency of maintenance		Recommendation:		No recommendation required	
Further Information:

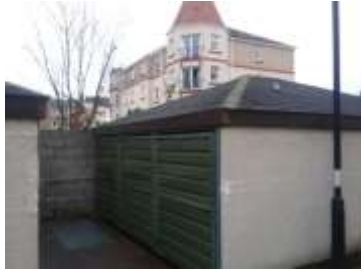
Surveyor		William Stevenson		Room/Area		007 - Bin Store 2

Survey Date		06 January 2017		Level of Identification		Strong Presumed (X)			
				Sample No		As 0002			
Building		4 SINCLAIR PLACE		Item		Roof Tile			
Floor		External		Amount					
A - Product Type:		B - Extent of Damage:		C - Surface Treatment		D - Asbestos Type		Material Ass (M.A) (A+B+C+D):	
Roofing Felt / Bitumen						No Asbestos Detected		0	
1 = Normal Occupant Activity = (E)		E - Main type of activity		Total Priority Score (P.A.) = (1+2+3+4):		Total Risk Ass' Score (P.A. + M.A)		0	
2 = Disturbance = (F+G+H)/3		F - Location		G - Accessibility		H - Extent		Risk Coding	
3 = Exposure potential = (I+J+K)/3		I - Number of occupants		J - Frequency of use		K - Average time in use			
4 = Maintenance activity = (L+M)/2		L - Type of maintenance		M - Frequency of maintenance		Recommendation:		No recommendation required	
Further Information:		Visually consistent with sample number 0002.

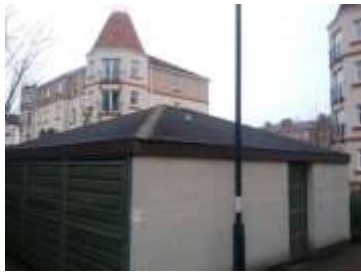
Surveyor		William Stevenson		Room/Area		008 - Cycle Shed

Survey Date		06 January 2017		Level of Identification		Strong Presumed (X)			
				Sample No		As 0002			
Building		4 SINCLAIR PLACE		Item		Roof Tile			
Floor		External		Amount					
A - Product Type:		B - Extent of Damage:		C - Surface Treatment		D - Asbestos Type		Material Ass (M.A) (A+B+C+D):	
Roofing Felt / Bitumen						No Asbestos Detected		0	
1 = Normal Occupant Activity = (E)		E - Main type of activity		Total Priority Score (P.A.) = (1+2+3+4):		Total Risk Ass' Score (P.A. + M.A)		0	
2 = Disturbance = (F+G+H)/3		F - Location		G - Accessibility		H - Extent		Risk Coding	
3 = Exposure potential = (I+J+K)/3		I - Number of occupants		J - Frequency of use		K - Average time in use			
4 = Maintenance activity = (L+M)/2		L - Type of maintenance		M - Frequency of maintenance		Recommendation:		No recommendation required	
Further Information:		Visually consistent with sample number 0002.
