Asbestos Survey Report

Management Survey (With Priority Assessments)

5 SINCLAIR CLOSE
EDINBURGH
EH11 1AN

Project Number: S-61393
Issue Date: 16th January 2017
Issue No: 1

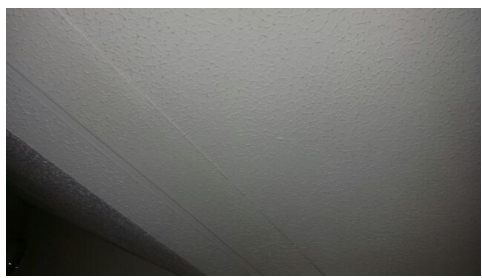
Surveyor		Steven Walker		Room/Area		001 - Ground Floor & Stairs

Survey Date		23 December 2016		Level of Identification		Sampled			
				Sample No		0001			
Building		5 SINCLAIR CLOSE		Item		Textured Coating To Concrete Ceiling			
Floor		0		Amount					
A - Product Type:		B - Extent of Damage:		C - Surface Treatment		D - Asbestos Type		Material Ass (M.A) (A+B+C+D):	
Textured Coating						No Asbestos Detected		0	
1 = Normal Occupant Activity = (E)		E - Main type of activity		Total Priority Score (P.A.) = (1+2+3+4):		Total Risk Ass' Score (P.A. + M.A)		0	
2 = Disturbance = (F+G+H)/3		F - Location		G - Accessibility		H - Extent		Risk Coding	
3 = Exposure potential = (I+J+K)/3		I - Number of occupants		J - Frequency of use		K - Average time in use			
4 = Maintenance activity = (L+M)/2		L - Type of maintenance		M - Frequency of maintenance		Recommendation:		No recommendation required	
Further Information:

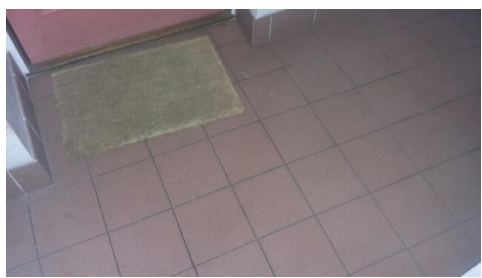
Surveyor		Steven Walker		Room/Area		001 - Ground Floor & Stairs

Survey Date		23 December 2016		Level of Identification		Sampled			
				Sample No		0002			
Building		5 SINCLAIR CLOSE		Item		Ceramic Tile Adhesive To Concrete Floor			
Floor		0		Amount					
A - Product Type:		B - Extent of Damage:		C - Surface Treatment		D - Asbestos Type		Material Ass (M.A) (A+B+C+D):	
Reinforced Composites						No Asbestos Detected		0	
1 = Normal Occupant Activity = (E)		E - Main type of activity		Total Priority Score (P.A.) = (1+2+3+4):		Total Risk Ass' Score (P.A. + M.A)		0	
2 = Disturbance = (F+G+H)/3		F - Location		G - Accessibility		H - Extent		Risk Coding	
3 = Exposure potential = (I+J+K)/3		I - Number of occupants		J - Frequency of use		K - Average time in use			
4 = Maintenance activity = (L+M)/2		L - Type of maintenance		M - Frequency of maintenance		Recommendation:		No recommendation required	
Further Information:

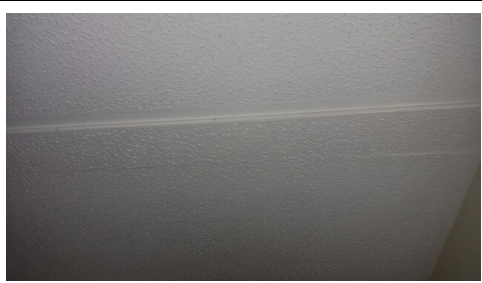
Surveyor		Steven Walker		Room/Area		005 - Landing & Stairs

Survey Date		23 December 2016		Level of Identification		Sampled			
				Sample No		0003			
Building		5 SINCLAIR CLOSE		Item		Textured Coating To Concrete Ceiling			
Floor		1		Amount					
A - Product Type:		B - Extent of Damage:		C - Surface Treatment		D - Asbestos Type		Material Ass (M.A) (A+B+C+D):	
Textured Coating						No Asbestos Detected		0	
1 = Normal Occupant Activity = (E)		E - Main type of activity		Total Priority Score (P.A.) = (1+2+3+4):		Total Risk Ass' Score (P.A. + M.A)		0	
2 = Disturbance = (F+G+H)/3		F - Location		G - Accessibility		H - Extent		Risk Coding	
3 = Exposure potential = (I+J+K)/3		I - Number of occupants		J - Frequency of use		K - Average time in use			
4 = Maintenance activity = (L+M)/2		L - Type of maintenance		M - Frequency of maintenance		Recommendation:		No recommendation required	
Further Information:

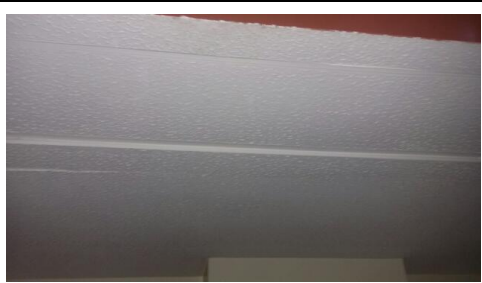
Surveyor		Steven Walker		Room/Area		008 - Landing & Stairs

Survey Date		23 December 2016		Level of Identification		Sampled			
				Sample No		0004			
Building		5 SINCLAIR CLOSE		Item		Textured Coating To Concrete Ceiling			
Floor		2		Amount					
A - Product Type:		B - Extent of Damage:		C - Surface Treatment		D - Asbestos Type		Material Ass (M.A) (A+B+C+D):	
Textured Coating						No Asbestos Detected		0	
1 = Normal Occupant Activity = (E)		E - Main type of activity		Total Priority Score (P.A.) = (1+2+3+4):		Total Risk Ass' Score (P.A. + M.A)		0	
2 = Disturbance = (F+G+H)/3		F - Location		G - Accessibility		H - Extent		Risk Coding	
3 = Exposure potential = (I+J+K)/3		I - Number of occupants		J - Frequency of use		K - Average time in use			
4 = Maintenance activity = (L+M)/2		L - Type of maintenance		M - Frequency of maintenance		Recommendation:		No recommendation required	
Further Information:

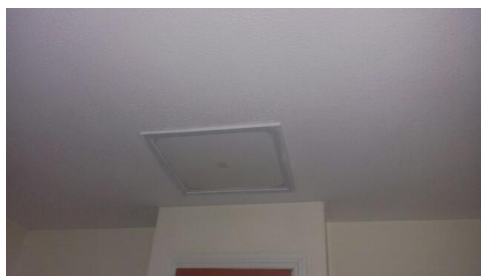
Surveyor		Steven Walker		Room/Area		011 - Landing

Survey Date		23 December 2016		Level of Identification		Sampled			
				Sample No		0005			
Building		5 SINCLAIR CLOSE		Item		Textured Coating To Concrete Ceiling			
Floor		3		Amount					
A - Product Type:		B - Extent of Damage:		C - Surface Treatment		D - Asbestos Type		Material Ass (M.A) (A+B+C+D):	
Textured Coating						No Asbestos Detected		0	
1 = Normal Occupant Activity = (E)		E - Main type of activity		Total Priority Score (P.A.) = (1+2+3+4):		Total Risk Ass' Score (P.A. + M.A)		0	
2 = Disturbance = (F+G+H)/3		F - Location		G - Accessibility		H - Extent		Risk Coding	
3 = Exposure potential = (I+J+K)/3		I - Number of occupants		J - Frequency of use		K - Average time in use			
4 = Maintenance activity = (L+M)/2		L - Type of maintenance		M - Frequency of maintenance		Recommendation:		No recommendation required	
Further Information:

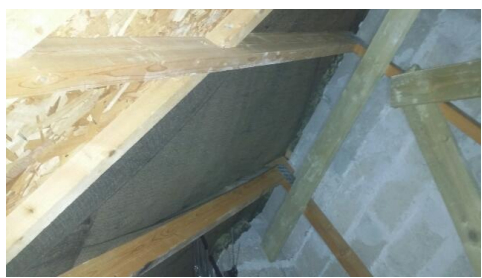
Surveyor		Steven Walker		Room/Area		014 - Loft Above Landing

Survey Date		23 December 2016		Level of Identification		Sampled			
				Sample No		0006			
Building		5 SINCLAIR CLOSE		Item		Roof Felt			
Floor		4		Amount					
A - Product Type:		B - Extent of Damage:		C - Surface Treatment		D - Asbestos Type		Material Ass (M.A) (A+B+C+D):	
Bitumen Products						No Asbestos Detected		0	
1 = Normal Occupant Activity = (E)		E - Main type of activity		Total Priority Score (P.A.) = (1+2+3+4):		Total Risk Ass' Score (P.A. + M.A)		0	
2 = Disturbance = (F+G+H)/3		F - Location		G - Accessibility		H - Extent		Risk Coding	
3 = Exposure potential = (I+J+K)/3		I - Number of occupants		J - Frequency of use		K - Average time in use			
4 = Maintenance activity = (L+M)/2		L - Type of maintenance		M - Frequency of maintenance		Recommendation:		No recommendation required	
Further Information:
