Asbestos Survey Report

Management Survey (With Priority Assessments)

**5 SINCLAIR GARDENS
EDINBURGH
EH11 1AN**

Project Number: S-61220
Issue Date: 9th January 2017
Issue No: 1

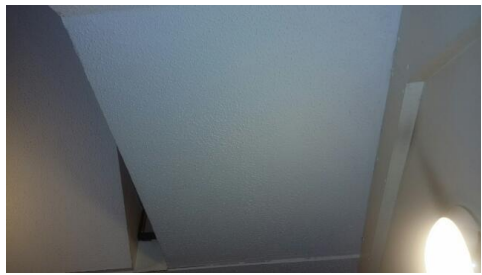
Surveyor		Steven Walker		Room/Area		001 - Ground Floor

Survey Date		19 December 2016		Level of Identification		Sampled			
				Sample No		0001			
Building		5 SINCLAIR GARDENS		Item		Textured Coating To Concrete Ceiling			
Floor		0		Amount					
A - Product Type:		B - Extent of Damage:		C - Surface Treatment		D - Asbestos Type		Material Ass (M.A) (A+B+C+D):	
Textured Coating						No Asbestos Detected		0	
1 = Normal Occupant Activity = (E)		E - Main type of activity		Total Priority Score (P.A.) = (1+2+3+4):		Total Risk Ass' Score (P.A. + M.A)		0	
2 = Disturbance = (F+G+H)/3		F - Location		G - Accessibility		H - Extent		Risk Coding	
3 = Exposure potential = (I+J+K)/3		I - Number of occupants		J - Frequency of use		K - Average time in use			
4 = Maintenance activity = (L+M)/2		L - Type of maintenance		M - Frequency of maintenance		Recommendation:		No recommendation required	
Further Information:

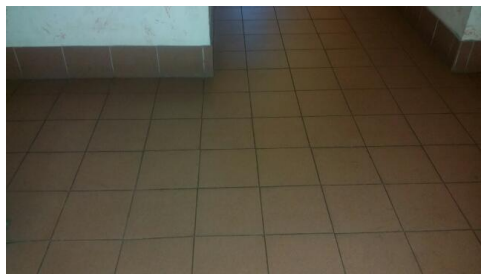
Surveyor		Steven Walker		Room/Area		001 - Ground Floor & Stairs

Survey Date		19 December 2016		Level of Identification		Sampled			
				Sample No		0002			
Building		5 SINCLAIR GARDENS		Item		Ceramic Tile Adhesive To Concrete Floor			
Floor		0		Amount					
A - Product Type:		B - Extent of Damage:		C - Surface Treatment		D - Asbestos Type		Material Ass (M.A) (A+B+C+D):	
Reinforced Composites						No Asbestos Detected		0	
1 = Normal Occupant Activity = (E)		E - Main type of activity		Total Priority Score (P.A.) = (1+2+3+4):		Total Risk Ass' Score (P.A. + M.A)		0	
2 = Disturbance = (F+G+H)/3		F - Location		G - Accessibility		H - Extent		Risk Coding	
3 = Exposure potential = (I+J+K)/3		I - Number of occupants		J - Frequency of use		K - Average time in use			
4 = Maintenance activity = (L+M)/2		L - Type of maintenance		M - Frequency of maintenance		Recommendation:		No recommendation required	
Further Information:

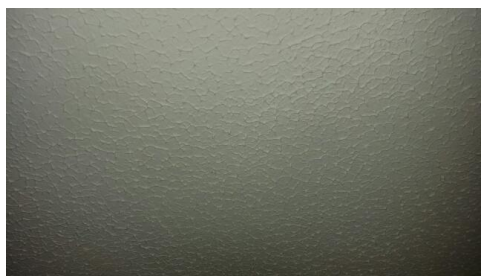
Surveyor		Steven Walker		Room/Area		005 - Landing & Stairs

Survey Date		19 December 2016		Level of Identification		Sampled			
				Sample No		0003			
Building		5 SINCLAIR GARDENS		Item		Textured Coating To Concrete Ceiling			
Floor		1		Amount					
A - Product Type:		B - Extent of Damage:		C - Surface Treatment		D - Asbestos Type		Material Ass (M.A) (A+B+C+D):	
Textured Coating						No Asbestos Detected		0	
1 = Normal Occupant Activity = (E)		E - Main type of activity		Total Priority Score (P.A.) = (1+2+3+4):		Total Risk Ass' Score (P.A. + M.A)		0	
2 = Disturbance = (F+G+H)/3		F - Location		G - Accessibility		H - Extent		Risk Coding	
3 = Exposure potential = (I+J+K)/3		I - Number of occupants		J - Frequency of use		K - Average time in use			
4 = Maintenance activity = (L+M)/2		L - Type of maintenance		M - Frequency of maintenance		Recommendation:		No recommendation required	
Further Information:

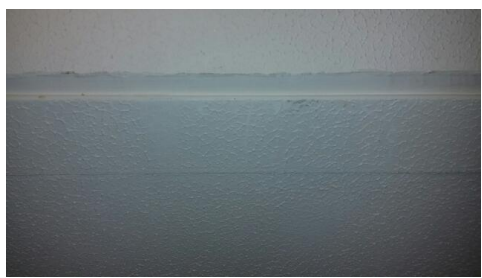
Surveyor		Steven Walker		Room/Area		008 - Landing & Stairs

Survey Date		19 December 2016		Level of Identification		Sampled			
				Sample No		0004			
Building		5 SINCLAIR GARDENS		Item		Textured Coating To Concrete Ceiling			
Floor		1		Amount					
A - Product Type:		B - Extent of Damage:		C - Surface Treatment		D - Asbestos Type		Material Ass (M.A) (A+B+C+D):	
Textured Coating						No Asbestos Detected		0	
1 = Normal Occupant Activity = (E)		E - Main type of activity		Total Priority Score (P.A.) = (1+2+3+4):		Total Risk Ass' Score (P.A. + M.A)		0	
2 = Disturbance = (F+G+H)/3		F - Location		G - Accessibility		H - Extent		Risk Coding	
3 = Exposure potential = (I+J+K)/3		I - Number of occupants		J - Frequency of use		K - Average time in use			
4 = Maintenance activity = (L+M)/2		L - Type of maintenance		M - Frequency of maintenance		Recommendation:		No recommendation required	
Further Information:

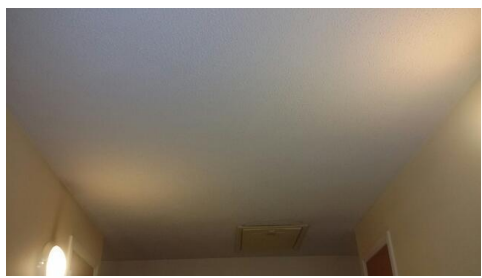
Surveyor		Steven Walker		Room/Area		011 - Landing

Survey Date		19 December 2016		Level of Identification		Sampled			
				Sample No		0005			
Building		5 SINCLAIR GARDENS		Item		Textured Coating To Plasterboard Ceiling			
Floor		3		Amount					
A - Product Type:		B - Extent of Damage:		C - Surface Treatment		D - Asbestos Type		Material Ass (M.A) (A+B+C+D):	
Textured Coating						No Asbestos Detected		0	
1 = Normal Occupant Activity = (E)		E - Main type of activity		Total Priority Score (P.A.) = (1+2+3+4):		Total Risk Ass' Score (P.A. + M.A)		0	
2 = Disturbance = (F+G+H)/3		F - Location		G - Accessibility		H - Extent		Risk Coding	
3 = Exposure potential = (I+J+K)/3		I - Number of occupants		J - Frequency of use		K - Average time in use			
4 = Maintenance activity = (L+M)/2		L - Type of maintenance		M - Frequency of maintenance		Recommendation:		No recommendation required	
Further Information:

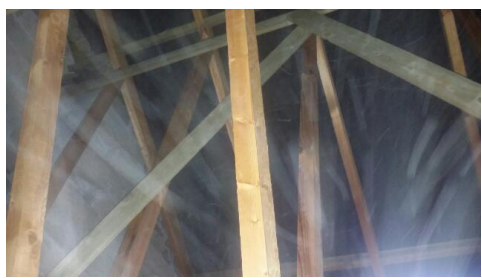
Surveyor		Steven Walker		Room/Area		014 - Loft Above Stairs

Survey Date		19 December 2016		Level of Identification		Sampled			
				Sample No		0006			
Building		5 SINCLAIR GARDENS		Item		Roof Felt			
Floor		4		Amount					
A - Product Type:		B - Extent of Damage:		C - Surface Treatment		D - Asbestos Type		Material Ass (M.A) (A+B+C+D):	
Bitumen Products						No Asbestos Detected		0	
1 = Normal Occupant Activity = (E)		E - Main type of activity		Total Priority Score (P.A.) = (1+2+3+4):		Total Risk Ass' Score (P.A. + M.A)		0	
2 = Disturbance = (F+G+H)/3		F - Location		G - Accessibility		H - Extent		Risk Coding	
3 = Exposure potential = (I+J+K)/3		I - Number of occupants		J - Frequency of use		K - Average time in use			
4 = Maintenance activity = (L+M)/2		L - Type of maintenance		M - Frequency of maintenance		Recommendation:		No recommendation required	
Further Information:
