# **Asbestos Survey Report**

## **Management Survey**

**5 SINCLAIR PLACE  
EDINBURGH  
EH11 1AN**

Project Number: S-61214  
Issue Date: 13<sup>th</sup> January 2017  
Issue No: 1

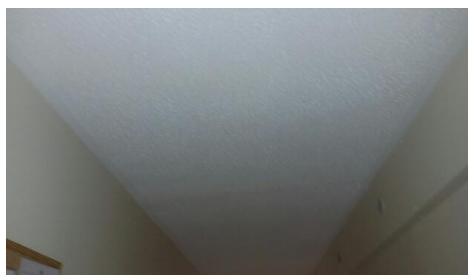
Surveyor		Steven Walker		Room/Area		001 - Entrance Vestibule

Survey Date		20 December 2016		Level of Identification		Sampled			
				Sample No		0001			
Building		5 SINCLAIR PLACE		Item		Textured Coating To Concrete Ceiling			
Floor		0		Amount					
A - Product Type:		B - Extent of Damage:		C - Surface Treatment		D - Asbestos Type		Material Ass (M.A) (A+B+C+D):	
Textured Coating						No Asbestos Detected		0	
1 = Normal Occupant Activity = (E)		1		E - Main type of activity		1		Total Priority Score (P.A.) = (1+2+3+4):	
2 = Disturbance = (F+G+H)/3		0		F - Location				Total Risk Ass' Score (P.A. + M.A)	
3 = Exposure potential = (I+J+K)/3		0		I - Number of occupants				H - Extent	
4 = Maintenance activity = (L+M)/2		0		L - Type of maintenance				J - Frequency of use	
								K - Average time in use	
								Recommendation:	
								No recommendation required	
Further Information:

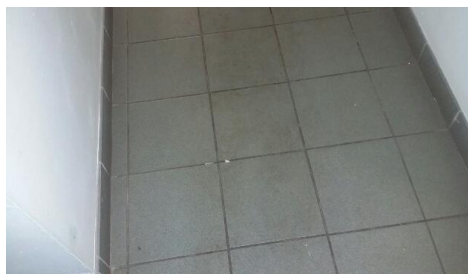
Surveyor		Steven Walker		Room/Area		001 - Entrance Vestibule

Survey Date		20 December 2016		Level of Identification		Sampled			
				Sample No		0002			
Building		5 SINCLAIR PLACE		Item		Ceramic Tile Adhesive To Concrete Floor			
Floor		0		Amount					
A - Product Type:		B - Extent of Damage:		C - Surface Treatment		D - Asbestos Type		Material Ass (M.A) (A+B+C+D):	
Reinforced Composites						No Asbestos Detected		0	
1 = Normal Occupant Activity = (E)		1		E - Main type of activity		1		Total Priority Score (P.A.) = (1+2+3+4):	
2 = Disturbance = (F+G+H)/3		0		F - Location				Total Risk Ass' Score (P.A. + M.A)	
3 = Exposure potential = (I+J+K)/3		0		I - Number of occupants				H - Extent	
4 = Maintenance activity = (L+M)/2		0		L - Type of maintenance				J - Frequency of use	
								K - Average time in use	
								Recommendation:	
								No recommendation required	
Further Information:

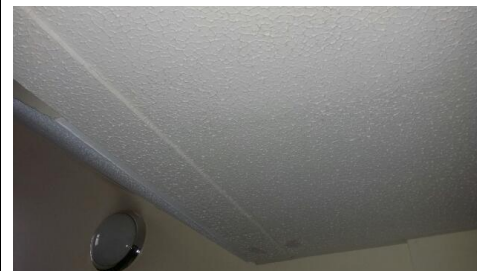
Surveyor		Steven Walker		Room/Area		004 - Ground Floor & Stairs

Survey Date		20 December 2016		Level of Identification		Sampled			
				Sample No		0003			
Building		5 SINCLAIR PLACE		Item		Textured Coating To Concrete Ceiling			
Floor		0		Amount					
A - Product Type:		B - Extent of Damage:		C - Surface Treatment		D - Asbestos Type		Material Ass (M.A) (A+B+C+D):	
Textured Coating						No Asbestos Detected		0	
1 = Normal Occupant Activity = (E)		1		E - Main type of activity		1		Total Priority Score (P.A.) = (1+2+3+4):	
2 = Disturbance = (F+G+H)/3		0		F - Location				Total Risk Ass' Score (P.A. + M.A)	
3 = Exposure potential = (I+J+K)/3		0		I - Number of occupants				H - Extent	
4 = Maintenance activity = (L+M)/2		0		L - Type of maintenance				J - Frequency of use	
								K - Average time in use	
								Recommendation:	
								No recommendation required	
Further Information:

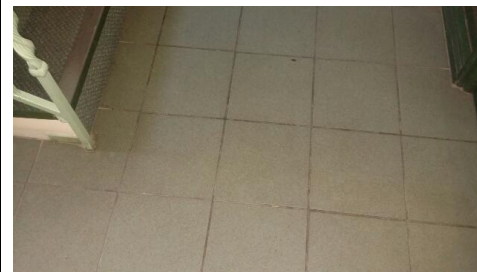
Surveyor		Steven Walker		Room/Area		004 - Ground Floor & Stairs

Survey Date		20 December 2016		Level of Identification		Strong Presumed (X)			
				Sample No		As 0002			
Building		5 SINCLAIR PLACE		Item		Ceramic Tile Adhesive To Concrete Floor			
Floor		0		Amount					
A - Product Type:		B - Extent of Damage:		C - Surface Treatment		D - Asbestos Type		Material Ass (M.A) (A+B+C+D):	
Reinforced Composites						No Asbestos Detected		0	
1 = Normal Occupant Activity = (E)		1		E - Main type of activity		1		Total Priority Score (P.A.) = (1+2+3+4):	
2 = Disturbance = (F+G+H)/3		0		F - Location				Total Risk Ass' Score (P.A. + M.A)	
3 = Exposure potential = (I+J+K)/3		0		I - Number of occupants				H - Extent	
4 = Maintenance activity = (L+M)/2		0		L - Type of maintenance				J - Frequency of use	
								K - Average time in use	
								Recommendation:	
								No recommendation required	
Further Information: Visually consistent with sample number 0002.

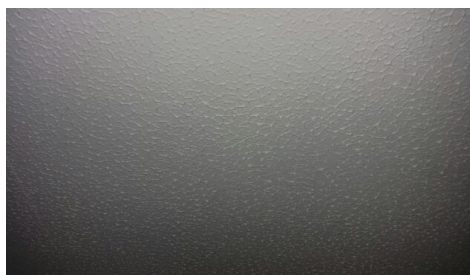
Surveyor		Steven Walker		Room/Area		007 - Landing & Stairs

Survey Date		20 December 2016		Level of Identification		Sampled			
				Sample No		0004			
Building		5 SINCLAIR PLACE		Item		Textured Coating To Concrete Ceiling			
Floor		1		Amount					
A - Product Type:		B - Extent of Damage:		C - Surface Treatment		D - Asbestos Type		Material Ass (M.A) (A+B+C+D):	
Textured Coating						No Asbestos Detected		0	
1 = Normal Occupant Activity = (E)		1		E - Main type of activity		1		Total Priority Score (P.A.) = (1+2+3+4):	
2 = Disturbance = (F+G+H)/3		0		F - Location				Total Risk Ass' Score (P.A. + M.A)	
3 = Exposure potential = (I+J+K)/3		0		I - Number of occupants				H - Extent	
4 = Maintenance activity = (L+M)/2		0		L - Type of maintenance				J - Frequency of use	
								K - Average time in use	
								M - Frequency of maintenance	
								Recommendation:	
								No recommendation required	
Further Information:

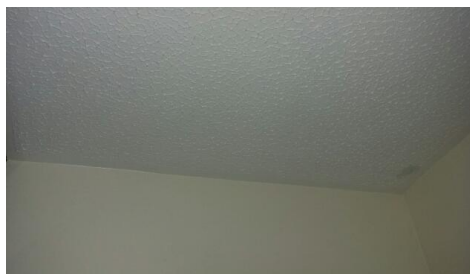
Surveyor		Steven Walker		Room/Area		009 - Vestibule

Survey Date		20 December 2016		Level of Identification		Sampled			
				Sample No		0005			
Building		5 SINCLAIR PLACE		Item		Textured Coating To Concrete Ceiling			
Floor		1		Amount					
A - Product Type:		B - Extent of Damage:		C - Surface Treatment		D - Asbestos Type		Material Ass (M.A) (A+B+C+D):	
Textured Coating						No Asbestos Detected		0	
1 = Normal Occupant Activity = (E)		1		E - Main type of activity		1		Total Priority Score (P.A.) = (1+2+3+4):	
2 = Disturbance = (F+G+H)/3		0		F - Location				Total Risk Ass' Score (P.A. + M.A)	
3 = Exposure potential = (I+J+K)/3		0		I - Number of occupants				H - Extent	
4 = Maintenance activity = (L+M)/2		0		L - Type of maintenance				J - Frequency of use	
								K - Average time in use	
								M - Frequency of maintenance	
								Recommendation:	
								No recommendation required	
Further Information:

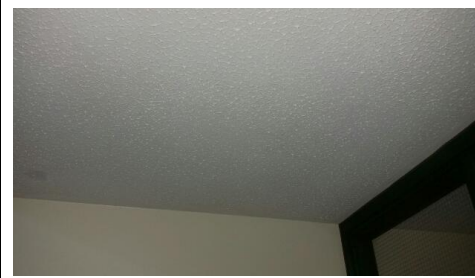
Surveyor		Steven Walker		Room/Area		012 - Landing & Stairs

Survey Date		20 December 2016		Level of Identification		Sampled			
				Sample No		0006			
Building		5 SINCLAIR PLACE		Item		Textured Coating To Concrete Ceiling			
Floor		2		Amount					
A - Product Type:		B - Extent of Damage:		C - Surface Treatment		D - Asbestos Type		Material Ass (M.A) (A+B+C+D):	
Textured Coating						No Asbestos Detected		0	
1 = Normal Occupant Activity = (E)		1		E - Main type of activity		1		Total Priority Score (P.A.) = (1+2+3+4):	
2 = Disturbance = (F+G+H)/3		0		F - Location				Total Risk Ass' Score (P.A. + M.A)	
3 = Exposure potential = (I+J+K)/3		0		I - Number of occupants				H - Extent	
4 = Maintenance activity = (L+M)/2		0		L - Type of maintenance				J - Frequency of use	
								K - Average time in use	
								Recommendation:	
								No recommendation required	
Further Information:

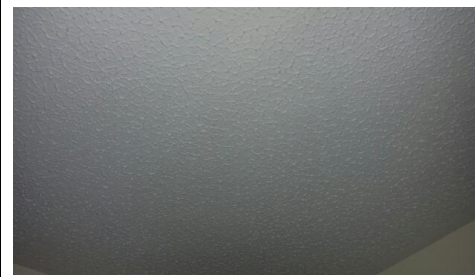
Surveyor		Steven Walker		Room/Area		014 - Vestibule

Survey Date		20 December 2016		Level of Identification		Sampled			
				Sample No		0007			
Building		5 SINCLAIR PLACE		Item		Textured Coating To Concrete Ceiling			
Floor		2		Amount					
A - Product Type:		B - Extent of Damage:		C - Surface Treatment		D - Asbestos Type		Material Ass (M.A) (A+B+C+D):	
Textured Coating						No Asbestos Detected		0	
1 = Normal Occupant Activity = (E)		1		E - Main type of activity		1		Total Priority Score (P.A.) = (1+2+3+4):	
2 = Disturbance = (F+G+H)/3		0		F - Location				Total Risk Ass' Score (P.A. + M.A)	
3 = Exposure potential = (I+J+K)/3		0		I - Number of occupants				H - Extent	
4 = Maintenance activity = (L+M)/2		0		L - Type of maintenance				J - Frequency of use	
								K - Average time in use	
								Recommendation:	
								No recommendation required	
Further Information:

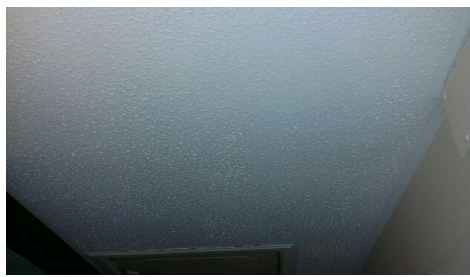
Surveyor		Steven Walker		Room/Area		019 - Vestibule

Survey Date		20 December 2016		Level of Identification		Sampled			
				Sample No		0009			
Building		5 SINCLAIR PLACE		Item		Textured Coating To Plasterboard Ceiling			
Floor		3		Amount					
A - Product Type:		B - Extent of Damage:		C - Surface Treatment		D - Asbestos Type		Material Ass (M.A) (A+B+C+D):	
Textured Coating						No Asbestos Detected		0	
1 = Normal Occupant Activity = (E)		1		E - Main type of activity		1		Total Priority Score (P.A.) = (1+2+3+4):	
2 = Disturbance = (F+G+H)/3		0		F - Location				Total Risk Ass' Score (P.A. + M.A)	
3 = Exposure potential = (I+J+K)/3		0		I - Number of occupants				H - Extent	
4 = Maintenance activity = (L+M)/2		0		L - Type of maintenance				J - Frequency of use	
								K - Average time in use	
								Recommendation:	
								No recommendation required	
Further Information:

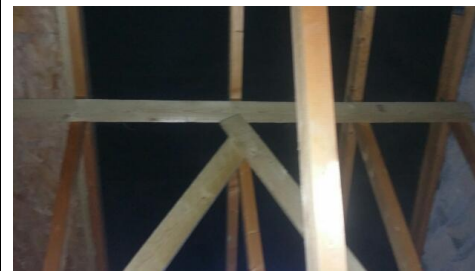
Surveyor		Steven Walker		Room/Area		022 - Loft Above Landing

Survey Date		20 December 2016		Level of Identification		Sampled			
				Sample No		0010			
Building		5 SINCLAIR PLACE		Item		Roof Felt			
Floor		4		Amount					
A - Product Type:		B - Extent of Damage:		C - Surface Treatment		D - Asbestos Type		Material Ass (M.A) (A+B+C+D):	
Bitumen Products						No Asbestos Detected		0	
1 = Normal Occupant Activity = (E)		0		E - Main type of activity		0		Total Priority Score (P.A.) = (1+2+3+4):	
2 = Disturbance = (F+G+H)/3		0		F - Location				G - Accessibility	
3 = Exposure potential = (I+J+K)/3		0		I - Number of occupants				J - Frequency of use	
4 = Maintenance activity = (L+M)/2		0		L - Type of maintenance				M - Frequency of maintenance	
Further Information:								Total Risk Ass' Score (P.A. + M.A)	
								0	
								Risk Coding	
								Recommendation:	
								No recommendation required
