# **Asbestos Survey Report**

## **Management Survey (With Priority Assessments)**

**6 SINCLAIR CLOSE  
EDINBURGH  
EH11 1AN**

Project Number: S-61394  
Issue Date: 16 January 2017  
Issue No: 1

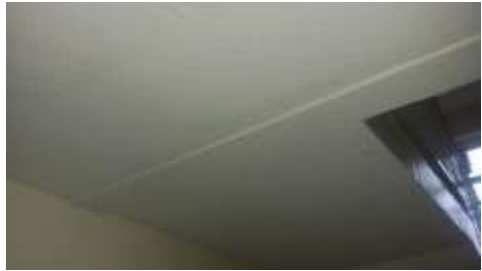
Surveyor		Steven Walker		Room/Area		001 - Ground Floor & Stairs

Survey Date		23 December 2016		Level of Identification		Sampled			
				Sample No		0001			
Building		6 SINCLAIR CLOSE6 SINCLAIR CLOSE		Item		Textured Coating To Concrete Ceiling			
Floor		0		Amount					
A - Product Type:		B - Extent of Damage:		C - Surface Treatment		D - Asbestos Type		Material Ass (M.A) (A+B+C+D):	
Textured Coating						No Asbestos Detected		0	
1 = Normal Occupant Activity = (E)		1		E - Main type of activity		1		Total Priority Score (P.A.) = (1+2+3+4):	
2 = Disturbance = (F+G+H)/3		0		F - Location				Total Risk Ass' Score (P.A. + M.A)	
3 = Exposure potential = (I+J+K)/3		0		I - Number of occupants				1	
4 = Maintenance activity = (L+M)/2		0		L - Type of maintenance				Risk Coding	
								Recommendation: No recommendation required	
Further Information:

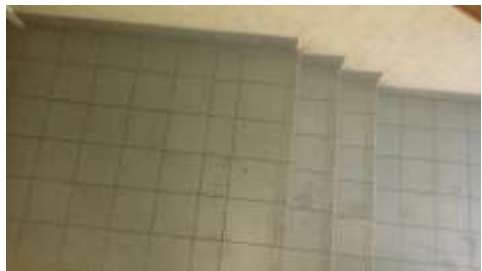
Surveyor		Steven Walker		Room/Area		001 - Ground Floor & Stairs

Survey Date		23 December 2016		Level of Identification		Sampled			
				Sample No		0002			
Building		6 SINCLAIR CLOSE6 SINCLAIR CLOSE		Item		Ceramic Tile Adhesive To Concrete Floor			
Floor		0		Amount					
A - Product Type:		B - Extent of Damage:		C - Surface Treatment		D - Asbestos Type		Material Ass (M.A) (A+B+C+D):	
Reinforced Composites						No Asbestos Detected		0	
1 = Normal Occupant Activity = (E)		1		E - Main type of activity		1		Total Priority Score (P.A.) = (1+2+3+4):	
2 = Disturbance = (F+G+H)/3		0		F - Location				Total Risk Ass' Score (P.A. + M.A)	
3 = Exposure potential = (I+J+K)/3		0		I - Number of occupants				1	
4 = Maintenance activity = (L+M)/2		0		L - Type of maintenance				Risk Coding	
								Recommendation: No recommendation required	
Further Information:

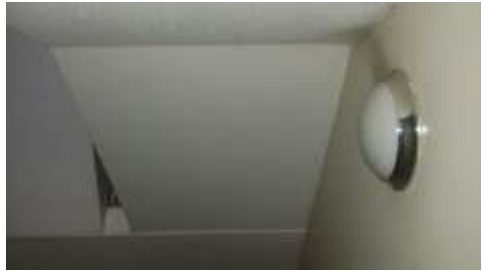
Surveyor		Steven Walker		Room/Area		005 - Landing & Stairs

Survey Date		23 December 2016		Level of Identification		Sampled			
				Sample No		0003			
Building		6 SINCLAIR CLOSE6 SINCLAIR CLOSE		Item		Textured Coating To Concrete Ceiling			
Floor		1		Amount					
A - Product Type:		B - Extent of Damage:		C - Surface Treatment		D - Asbestos Type		Material Ass (M.A) (A+B+C+D):	
Textured Coating						No Asbestos Detected		0	
1 = Normal Occupant Activity = (E)		1		E - Main type of activity		1		Total Priority Score (P.A.) = (1+2+3+4):	
2 = Disturbance = (F+G+H)/3		0		F - Location				Total Risk Ass' Score (P.A. + M.A)	
3 = Exposure potential = (I+J+K)/3		0		I - Number of occupants				1	
4 = Maintenance activity = (L+M)/2		0		L - Type of maintenance				Risk Coding	
								Recommendation: No recommendation required	
Further Information:

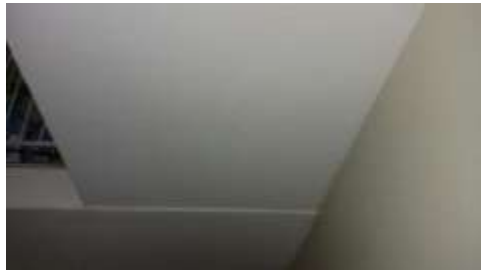
Surveyor		Steven Walker		Room/Area		008 - Landing & Stairs

Survey Date		23 December 2016		Level of Identification		Sampled			
				Sample No		0004			
Building		6 SINCLAIR CLOSE6 SINCLAIR CLOSE		Item		Textured Coating To Concrete Ceiling			
Floor		2		Amount					
A - Product Type:		B - Extent of Damage:		C - Surface Treatment		D - Asbestos Type		Material Ass (M.A) (A+B+C+D):	
Textured Coating						No Asbestos Detected		0	
1 = Normal Occupant Activity = (E)		1		E - Main type of activity		1		Total Priority Score (P.A.) = (1+2+3+4):	
2 = Disturbance = (F+G+H)/3		0		F - Location				Total Risk Ass' Score (P.A. + M.A)	
3 = Exposure potential = (I+J+K)/3		0		I - Number of occupants				1	
4 = Maintenance activity = (L+M)/2		0		L - Type of maintenance				Risk Coding	
								Recommendation: No recommendation required	
Further Information:

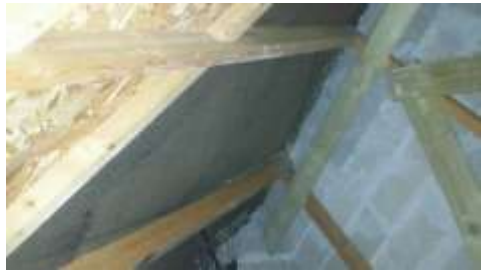
Surveyor		Steven Walker		Room/Area		014 - Loft Above Landing

Survey Date		23 December 2016		Level of Identification		Sampled			
				Sample No		0006			
Building		6 SINCLAIR CLOSE6 SINCLAIR CLOSE		Item		Roof Felt			
Floor		4		Amount					
A - Product Type:		B - Extent of Damage:		C - Surface Treatment		D - Asbestos Type		Material Ass (M.A) (A+B+C+D):	
Bitumen Products						No Asbestos Detected		0	
1 = Normal Occupant Activity = (E)		0		E - Main type of activity		0		Total Priority Score (P.A.) = (1+2+3+4):	
2 = Disturbance = (F+G+H)/3		0		F - Location				Total Risk Ass' Score (P.A. + M.A)	
3 = Exposure potential = (I+J+K)/3		0		I - Number of occupants				0	
4 = Maintenance activity = (L+M)/2		0		L - Type of maintenance				Risk Coding	
								Recommendation: No recommendation required	
Further Information:

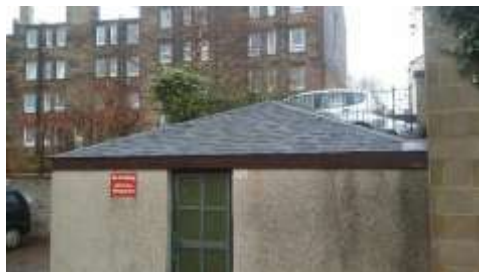
Surveyor		Steven Walker		Room/Area		016 - Cycle Shed 1

Survey Date		23 December 2016		Level of Identification		Sampled											
				Sample No		0007											
Building		6 SINCLAIR CLOSE6 SINCLAIR CLOSE		Item		Roof Felt											
Floor		External		Amount													
A - Product Type:		B - Extent of Damage:		C - Surface Treatment		D - Asbestos Type		Material Ass (M.A) (A+B+C+D):									
Bitumen Products						No Asbestos Detected		0		0							
1 = Normal Occupant Activity = (E)		0		E - Main type of activity		0		Total Priority Score (P.A.) = (1+2+3+4):		0		Total Risk Ass' Score (P.A. + M.A)		0		Risk Coding	
2 = Disturbance = (F+G+H)/3		0		F - Location				G - Accessibility				H - Extent					
3 = Exposure potential = (I+J+K)/3		0		I - Number of occupants				J - Frequency of use				K - Average time in use					
4 = Maintenance activity = (L+M)/2		0		L - Type of maintenance				M - Frequency of maintenance				<b>Recommendation:</b> No recommendation required

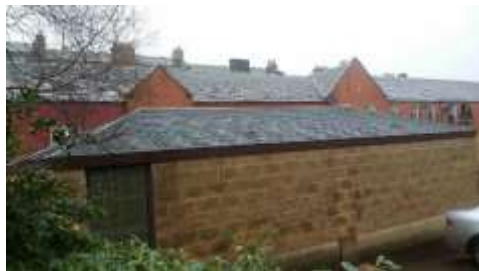
Surveyor		Steven Walker		Room/Area		017 - Cycle Shed 2

Survey Date		23 December 2016		Level of Identification		Sampled											
				Sample No		0008											
Building		6 SINCLAIR CLOSE6 SINCLAIR CLOSE		Item		Roof Felt											
Floor		External		Amount													
A - Product Type:		B - Extent of Damage:		C - Surface Treatment		D - Asbestos Type		Material Ass (M.A) (A+B+C+D):									
Bitumen Products						No Asbestos Detected		0		0							
1 = Normal Occupant Activity = (E)		0		E - Main type of activity		0		Total Priority Score (P.A.) = (1+2+3+4):		0		Total Risk Ass' Score (P.A. + M.A)		0		Risk Coding	
2 = Disturbance = (F+G+H)/3		0		F - Location				G - Accessibility				H - Extent					
3 = Exposure potential = (I+J+K)/3		0		I - Number of occupants				J - Frequency of use				K - Average time in use					
4 = Maintenance activity = (L+M)/2		0		L - Type of maintenance				M - Frequency of maintenance				<b>Recommendation:</b> No recommendation required
