Asbestos Survey Report

Management Survey (With Priority Assessments)

**6 SINCLAIR PLACE
EDINBURGH
EH11 1AN**

Project Number: S-61215
Issue Date: 13th January 2017
Issue No: 1

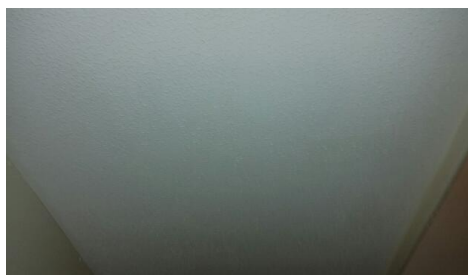
Surveyor		Steven Walker		Room/Area		001 - Entrance & Stairs

Survey Date		04 January 2017		Level of Identification		Sampled			
				Sample No		0001			
Building		6 SINCLAIR PLACE		Item		Textured Coating To Concrete Ceiling			
Floor		0		Amount					
A - Product Type:		B - Extent of Damage:		C - Surface Treatment		D - Asbestos Type		Material Ass (M.A) (A+B+C+D):	
Textured Coating						No Asbestos Detected		0	
1 = Normal Occupant Activity = (E)				E - Main type of activity		Total Priority Score (P.A.) = (1+2+3+4):		Total Risk Ass' Score (P.A. + M.A)	
2 = Disturbance = (F+G+H)/3				F - Location		G - Accessibility		H - Extent	
3 = Exposure potential = (I+J+K)/3				I - Number of occupants		J - Frequency of use		K - Average time in use	
4 = Maintenance activity = (L+M)/2				L - Type of maintenance		M - Frequency of maintenance		Recommendation:	
Further Information:								No recommendation required

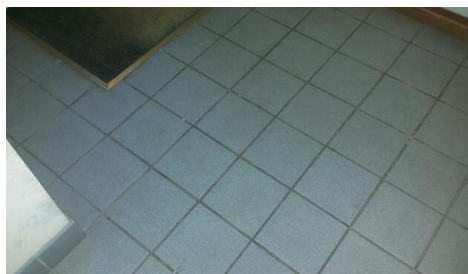
Surveyor		Steven Walker		Room/Area		001 - Entrance & Stairs

Survey Date		04 January 2017		Level of Identification		Sampled			
				Sample No		0002			
Building		6 SINCLAIR PLACE		Item		Ceramic Tile Adhesive To Concrete Floor			
Floor		0		Amount					
A - Product Type:		B - Extent of Damage:		C - Surface Treatment		D - Asbestos Type		Material Ass (M.A) (A+B+C+D):	
Reinforced Composites						No Asbestos Detected		0	
1 = Normal Occupant Activity = (E)				E - Main type of activity		Total Priority Score (P.A.) = (1+2+3+4):		Total Risk Ass' Score (P.A. + M.A)	
2 = Disturbance = (F+G+H)/3				F - Location		G - Accessibility		H - Extent	
3 = Exposure potential = (I+J+K)/3				I - Number of occupants		J - Frequency of use		K - Average time in use	
4 = Maintenance activity = (L+M)/2				L - Type of maintenance		M - Frequency of maintenance		Recommendation:	
Further Information:								No recommendation required

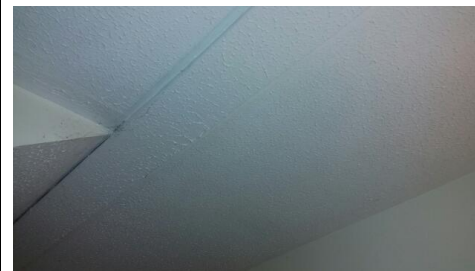
Surveyor		Steven Walker		Room/Area		006 - Landing & Stairs

Survey Date		04 January 2017		Level of Identification		Sampled			
				Sample No		0003			
Building		6 SINCLAIR PLACE		Item		Textured Coating To Concrete Ceiling			
Floor		1		Amount					
A - Product Type:		B - Extent of Damage:		C - Surface Treatment		D - Asbestos Type		Material Ass (M.A) (A+B+C+D):	
Textured Coating						No Asbestos Detected		0	
1 = Normal Occupant Activity = (E)				E - Main type of activity		Total Priority Score (P.A.) = (1+2+3+4):		Total Risk Ass' Score (P.A. + M.A)	
2 = Disturbance = (F+G+H)/3				F - Location		G - Accessibility		H - Extent	
3 = Exposure potential = (I+J+K)/3				I - Number of occupants		J - Frequency of use		K - Average time in use	
4 = Maintenance activity = (L+M)/2				L - Type of maintenance		M - Frequency of maintenance		Recommendation:	
Further Information:								No recommendation required

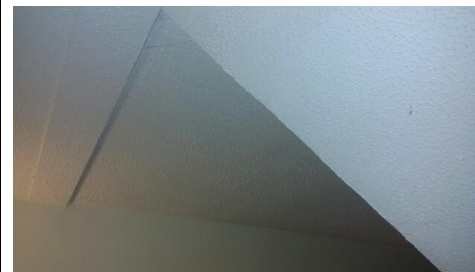
Surveyor		Steven Walker		Room/Area		010 - Landing & Stairs

Survey Date		04 January 2017		Level of Identification		Sampled			
				Sample No		0004			
Building		6 SINCLAIR PLACE		Item		Textured Coating To Concrete Ceiling			
Floor		2		Amount					
A - Product Type:		B - Extent of Damage:		C - Surface Treatment		D - Asbestos Type		Material Ass (M.A) (A+B+C+D):	
Textured Coating						No Asbestos Detected		0	
1 = Normal Occupant Activity = (E)				E - Main type of activity		Total Priority Score (P.A.) = (1+2+3+4):		Total Risk Ass' Score (P.A. + M.A)	
2 = Disturbance = (F+G+H)/3				F - Location		G - Accessibility		H - Extent	
3 = Exposure potential = (I+J+K)/3				I - Number of occupants		J - Frequency of use		K - Average time in use	
4 = Maintenance activity = (L+M)/2				L - Type of maintenance		M - Frequency of maintenance		Recommendation:	
Further Information:								No recommendation required

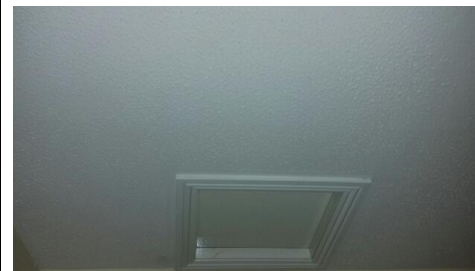
Surveyor		Steven Walker		Room/Area		014 - Landing

Survey Date		04 January 2017		Level of Identification		Sampled			
				Sample No		0005			
Building		6 SINCLAIR PLACE		Item		Textured Coating To Plasterboard Ceiling			
Floor		3		Amount					
A - Product Type:		B - Extent of Damage:		C - Surface Treatment		D - Asbestos Type		Material Ass (M.A) (A+B+C+D):	
Textured Coating						No Asbestos Detected		0	
1 = Normal Occupant Activity = (E)				E - Main type of activity		Total Priority Score (P.A.) = (1+2+3+4):		Total Risk Ass' Score (P.A. + M.A)	
2 = Disturbance = (F+G+H)/3				F - Location		G - Accessibility		H - Extent	
3 = Exposure potential = (I+J+K)/3				I - Number of occupants		J - Frequency of use		K - Average time in use	
4 = Maintenance activity = (L+M)/2				L - Type of maintenance		M - Frequency of maintenance		Recommendation:	
Further Information:								No recommendation required

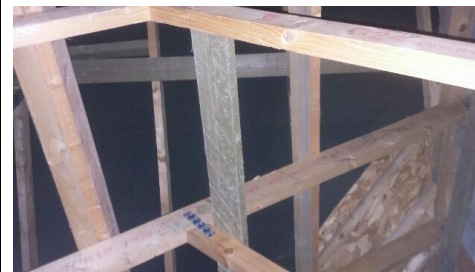
Surveyor		Steven Walker		Room/Area		018 - Loft Above Landing

Survey Date		04 January 2017		Level of Identification		Sampled			
				Sample No		0006			
Building		6 SINCLAIR PLACE		Item		Roof Felt			
Floor		4		Amount					
A - Product Type:		B - Extent of Damage:		C - Surface Treatment		D - Asbestos Type		Material Ass (M.A) (A+B+C+D):	
Bitumen Products						No Asbestos Detected		0	
1 = Normal Occupant Activity = (E)				E - Main type of activity		Total Priority Score (P.A.) = (1+2+3+4):		Total Risk Ass' Score (P.A. + M.A)	
2 = Disturbance = (F+G+H)/3				F - Location		G - Accessibility		H - Extent	
3 = Exposure potential = (I+J+K)/3				I - Number of occupants		J - Frequency of use		K - Average time in use	
4 = Maintenance activity = (L+M)/2				L - Type of maintenance		M - Frequency of maintenance		Recommendation:	
Further Information:								No recommendation required

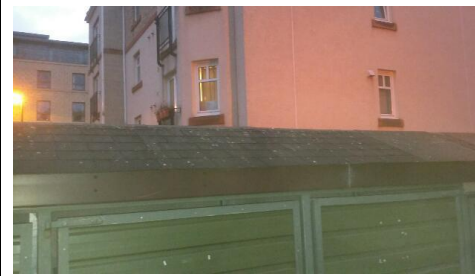
Surveyor		Steven Walker		Room/Area		020 - Bin Store 8

Survey Date		04 January 2017		Level of Identification		Sampled			
				Sample No		0007			
Building		6 SINCLAIR PLACE		Item		Roof Felt			
Floor		External		Amount					
A - Product Type:		B - Extent of Damage:		C – Surface Treatment		D – Asbestos Type		Material Ass (M.A) (A+B+C+D):	
Bitumen Products						No Asbestos Detected		0	
1 = Normal Occupant Activity = (E)				E – Main type of activity		Total Priority Score (P.A.) = (1+2+3+4):		Total Risk Ass' Score (P.A. + M.A)	
2 = Disturbance = (F+G+H)/3				F – Location		G – Accessibility		H – Extent	
3 = Exposure potential = (I+J+K)/3				I – Number of occupants		J – Frequency of use		K – Average time in use	
4 = Maintenance activity = (L+M)/2				L – Type of maintenance		M – Frequency of maintenance		Recommendation:	
Further Information:								No recommendation required
